Aviation Investigation Preliminary Report

Location:	Gaithersburg, MD	Accident Number:	ERA23LA071
Date & Time:	November 27, 2022, 17:29 Local	Registration:	N201RF
Aircraft:	Mooney M20J	Injuries:	2 Serious
Flight Conducted Under:	Part 91: General aviation - Personal

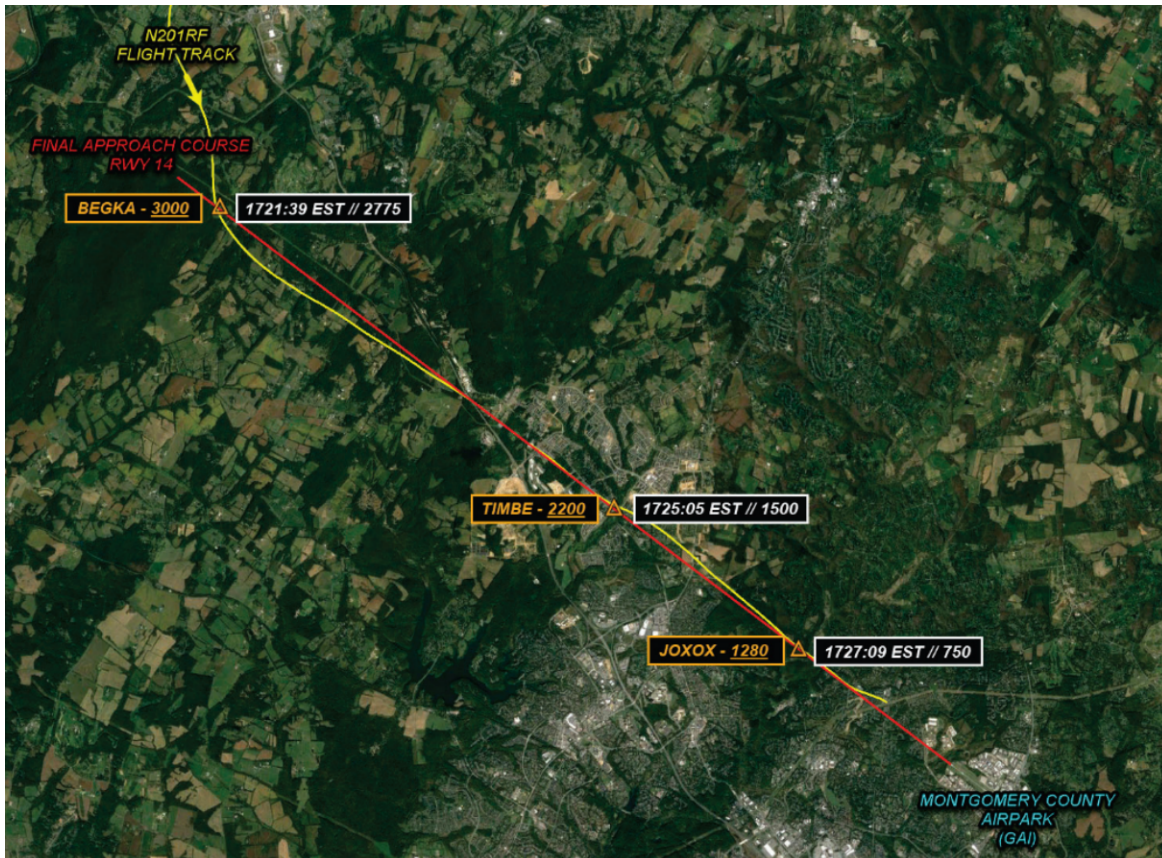
Figure 1 - Preliminary ADS-B flight track information

The controller instructed the accident pilot to proceed direct to BEGKA and cleared him for the RNAV (GPS) RWY 14 approach. The minimum altitude at BEGKA, 11.3 nautical miles (nm) from the runway, was 3,000 ft mean sea level (msl). The airplane crossed BEGKA about 2,775 ft as it aligned with the final approach course and continued its descent. The minimum altitude at the final approach fix (TIMBE), 5.2 nm from the runway, was 2,200 ft msl. The airplane crossed TIMBE at 1,725 ft msl. The minimum altitude at JOXOX waypoint, about 2.3 nm from the runway, was 1,280 ft msl; the airplane crossed JOXOX at 750 ft. The decision altitude (DA) for the final segment of the approach was 789 ft msl (The DA defines the altitude at which the pilot must initiate a missed approach procedure if specified visual references to the runway are not acquired).

About 1.25 miles from the runway and left of the runway centerline, the airplane impacted and became suspended in a power line tower at an elevation about 600 ft msl and 100 ft agl. Between JOXOX and the collision with the tower, the airplane descended as low as 475 ft. The published field elevation at GAI was 539 ft msl.

Figure 1 shows preliminary flight track information in relation to the runway 14 final approach course, with minimum altitudes for each segment of the approach shown in orange, and the airplane's altitude at those locations shown in white.
