Bridge No.: 0066 D.O.I.: 02/10/2021
Name: Pedestrian Bridge over Kenilworth Avenue near Lane Place, N.E.

★ ★ ★ D.C. Department of Transportation
Transportation Operations Administration
Asset Management Division

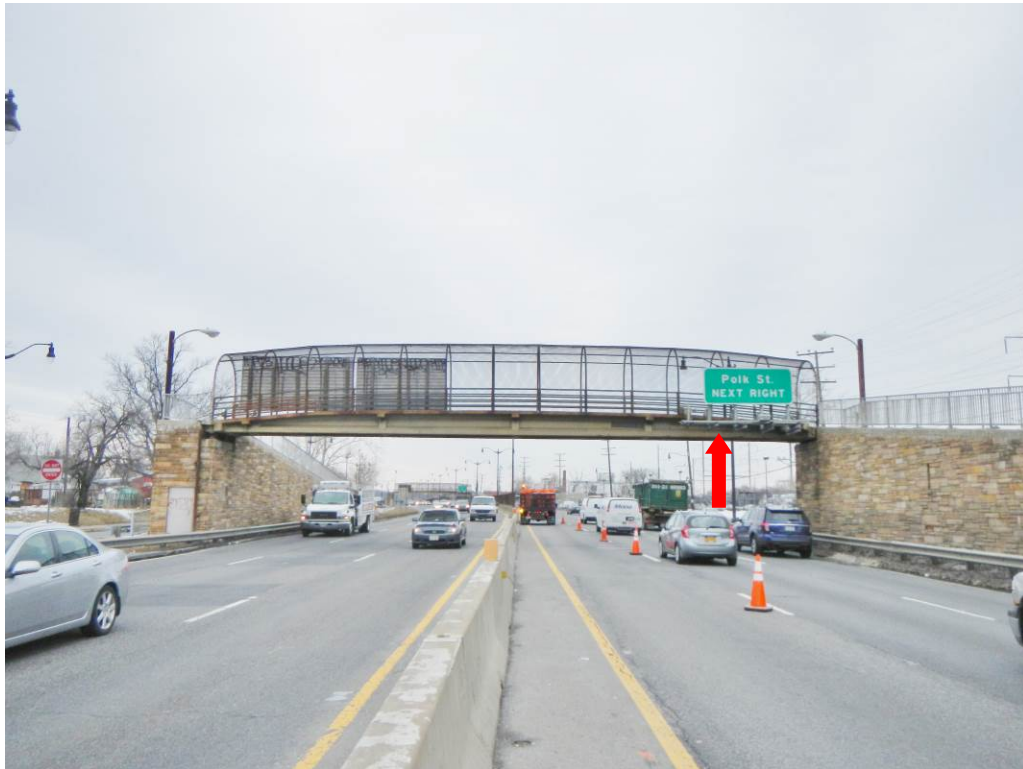
Photograph No. 1 – South Elevation (Looking North): Showing Location of Delaminated and Loose Concrete

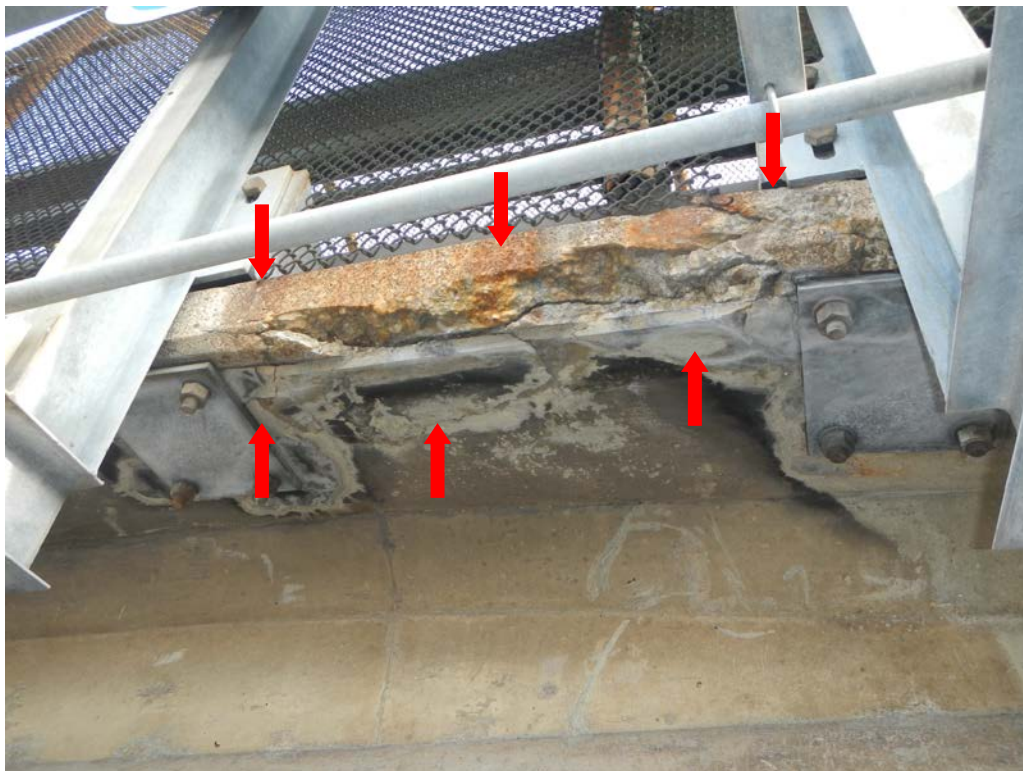
Photograph No. 2 – Area of Delaminated and Loose Concrete on South Overhang

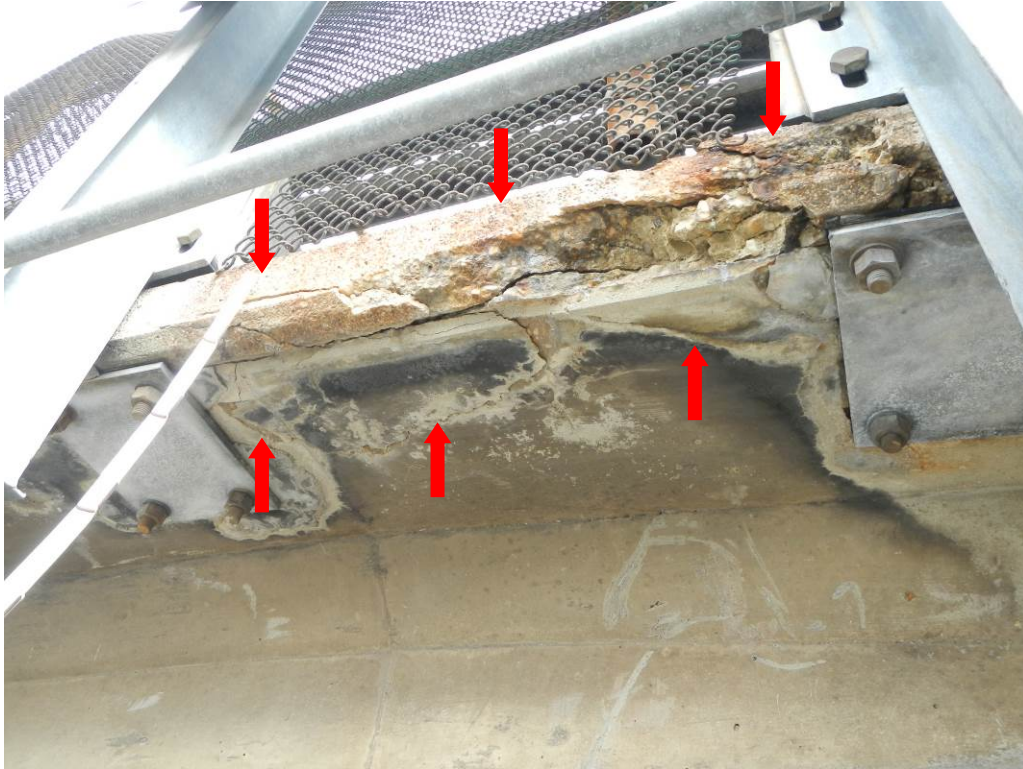
Photograph No. 3 – 2019 Photo: Area of Delaminated and Loose Concrete on South Overhang

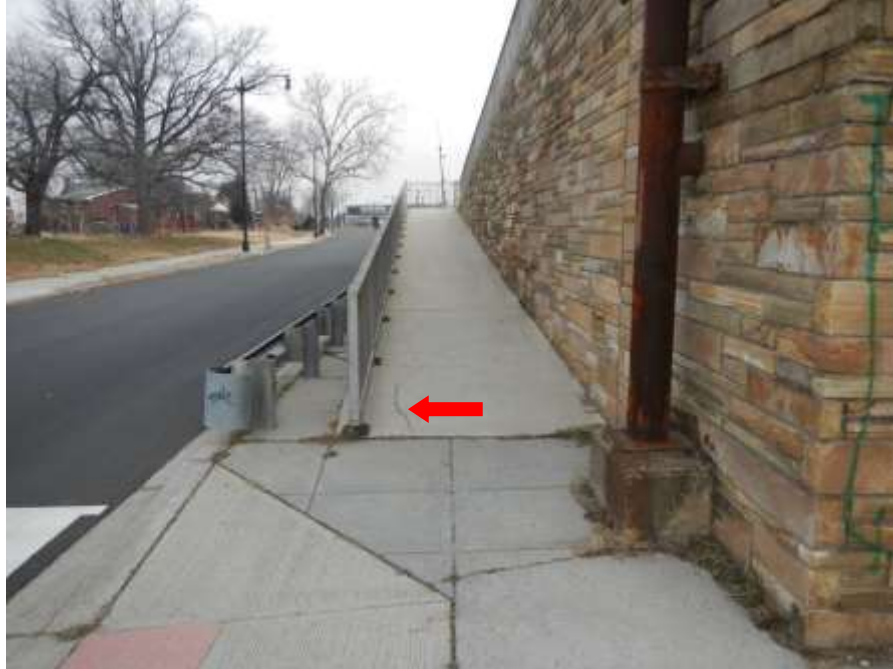
Photograph No. 3 – Lower Northwest Approach Pedestrian Ramp (Looking North):
Note Portion of Full-Length Longitudinal Crack with Water Stains in Walking Surface

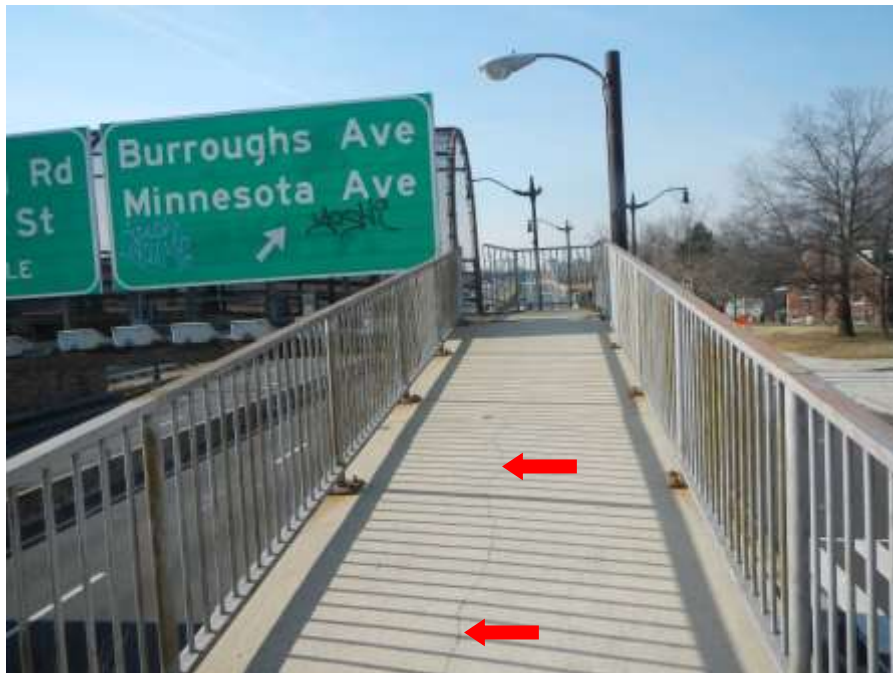
Photograph No. 4 – Upper Northwest Approach Pedestrian Ramp (Looking South):
Note Portion of Full-Length Longitudinal Crack in Walking Surface

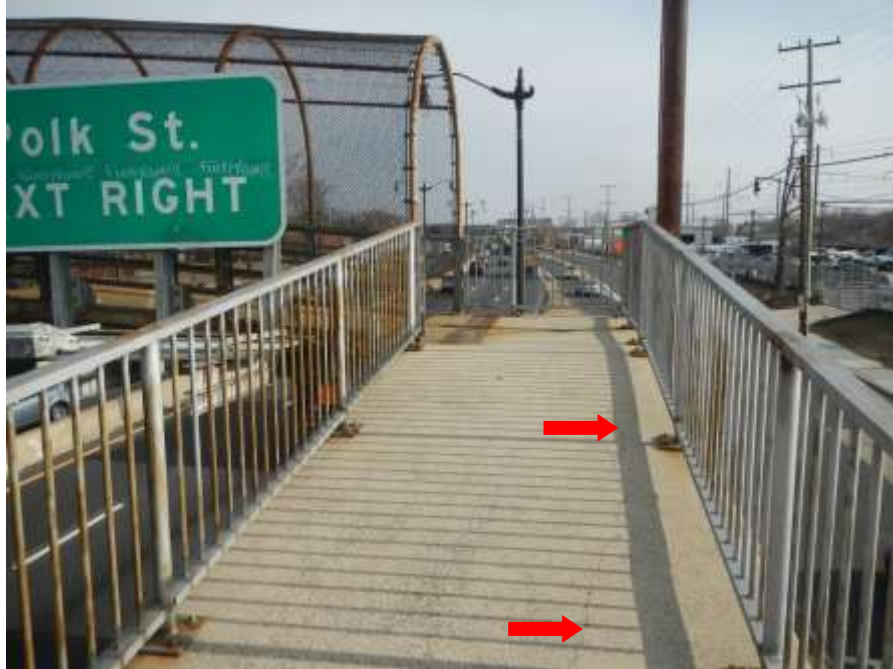
Photograph No. 7 – Upper Southeast Approach Pedestrian Ramp (Looking North): Note Portion of Full-Length Longitudinal Crack in Walking Surface

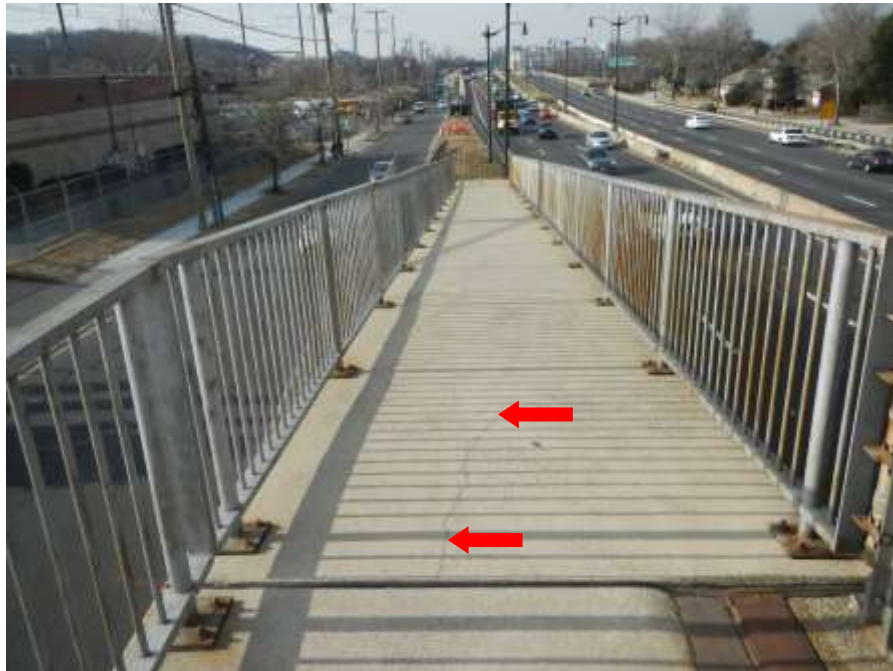
Photograph No. 8 – Upper Southeast Approach Pedestrian Ramp (Looking South): Note Portion of Full-Length Longitudinal Crack in Walking Surface

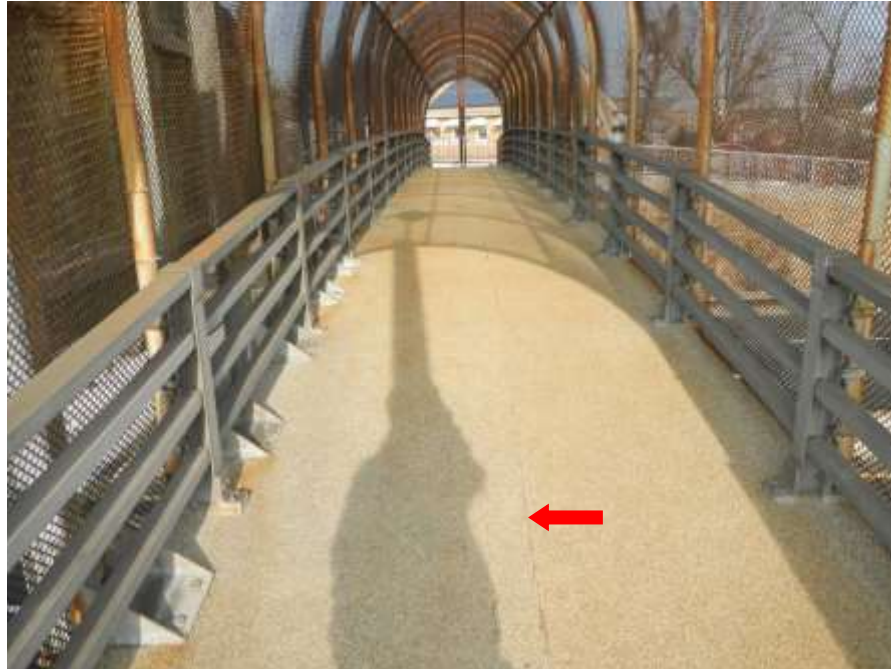
Photograph No. 11 – Typical Deck Wearing Surface, Steel Bridge Railings and Steel Arch Safety Fence (Looking West): Note Longitudinal Crack

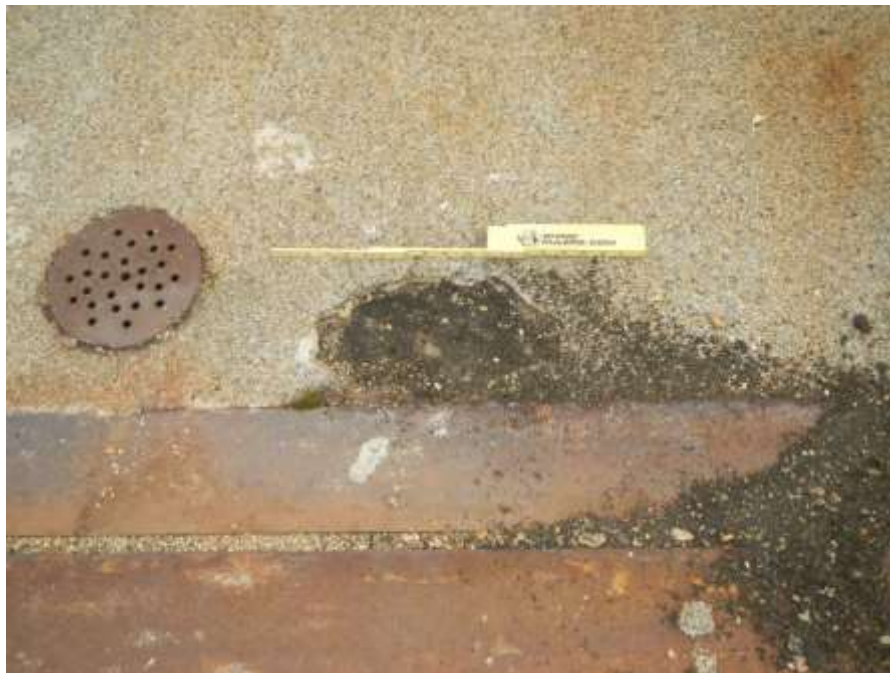
Photograph No. 12 – Spall in Deck Wearing Surface Adjacent to West Abutment Joint (Looking East)

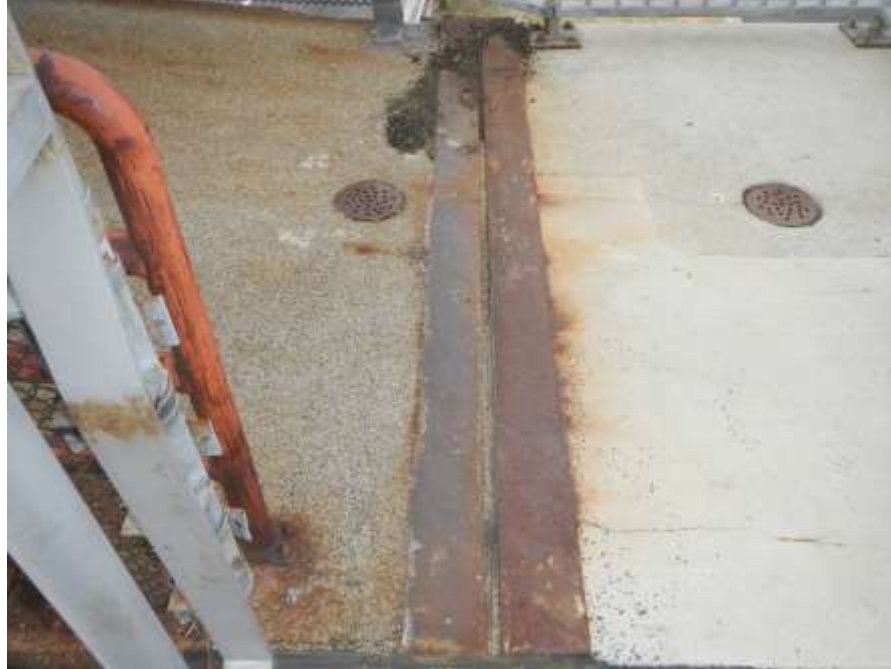
Photograph No. 13 – Typical Compression Joint Seal (West Abutment Shown, Looking South): Note Corrosion on Joint Armor

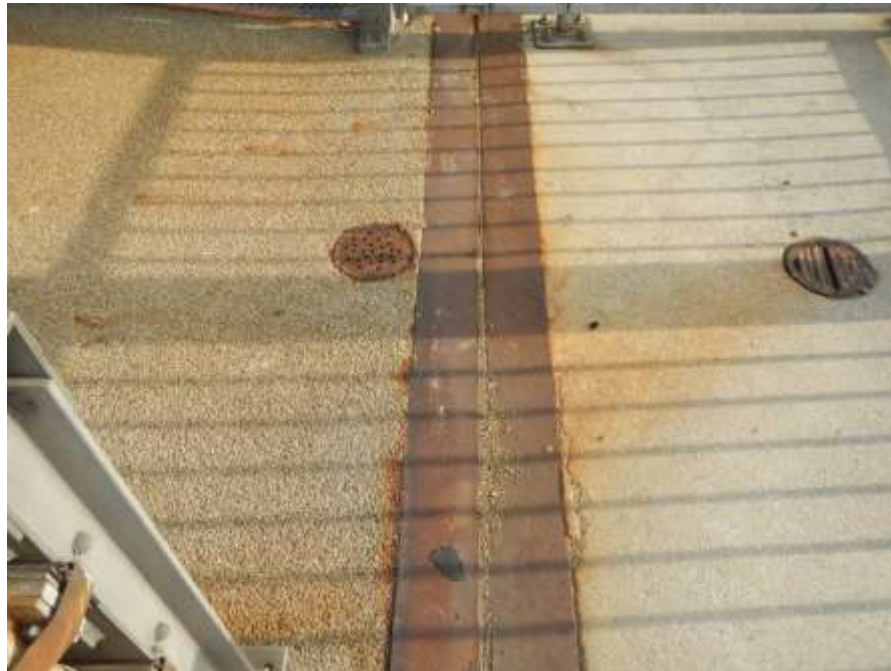
Photograph No. 14 – Typical Compression Joint Seal (East Abutment Shown, Looking North): Note Corrosion on Joint Armor

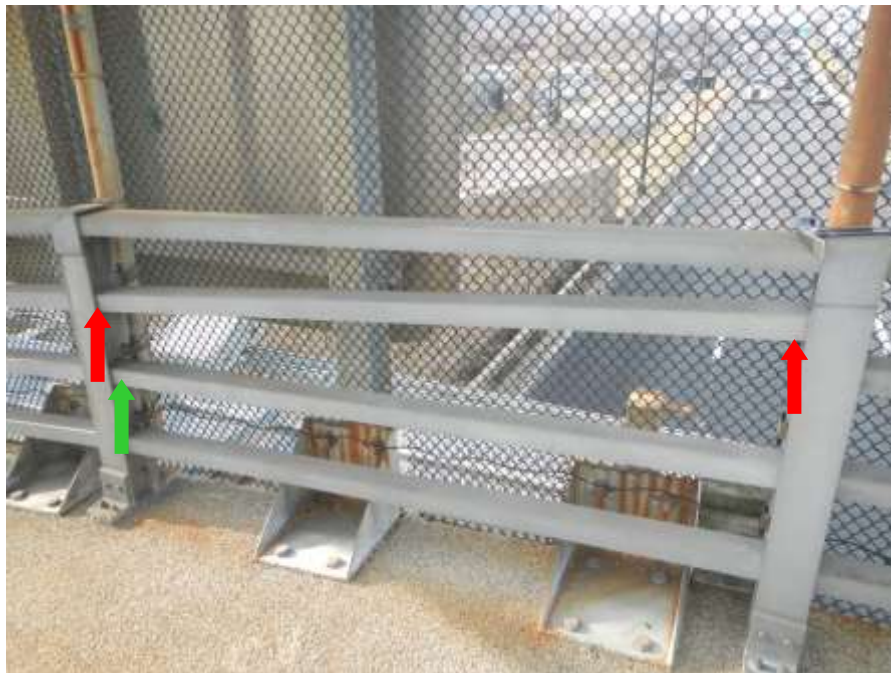
Photograph No. 18 – South Bridge Railing, Third Section from East: Both Connection Bolts Missing at Second Rail from Top – Rail Unsecured (Looking South): Note One Missing Connection Bolt at Third Rail from Top

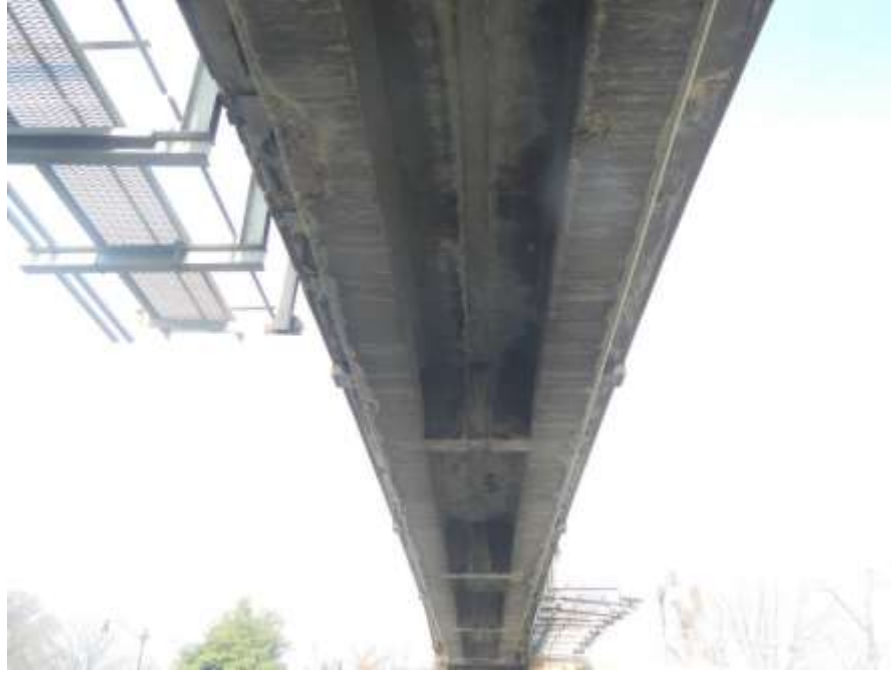
Photograph No. 19 – Typical View of Concrete Soffit/Underside of T-Beam Top Flange and Underside of Concrete T-Beams (Looking West): Note Prior Water Leakage Stains and Efflorescence Throughout Soffit

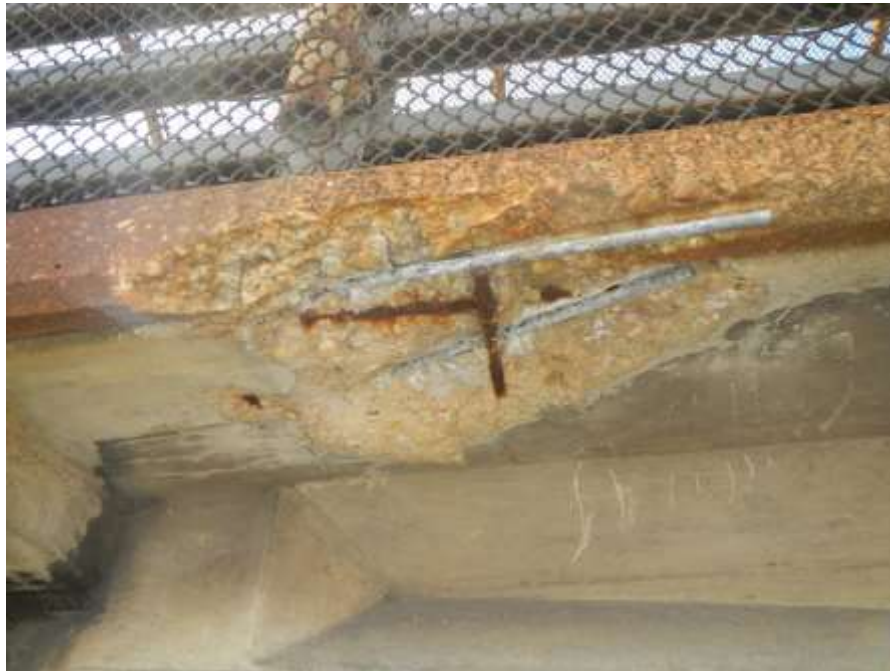
Photograph No. 20 – Spall with Exposed Corroded Reinforcing Steel Near East End of North Deck Overhang Above Right Northbound Lane (Looking South)

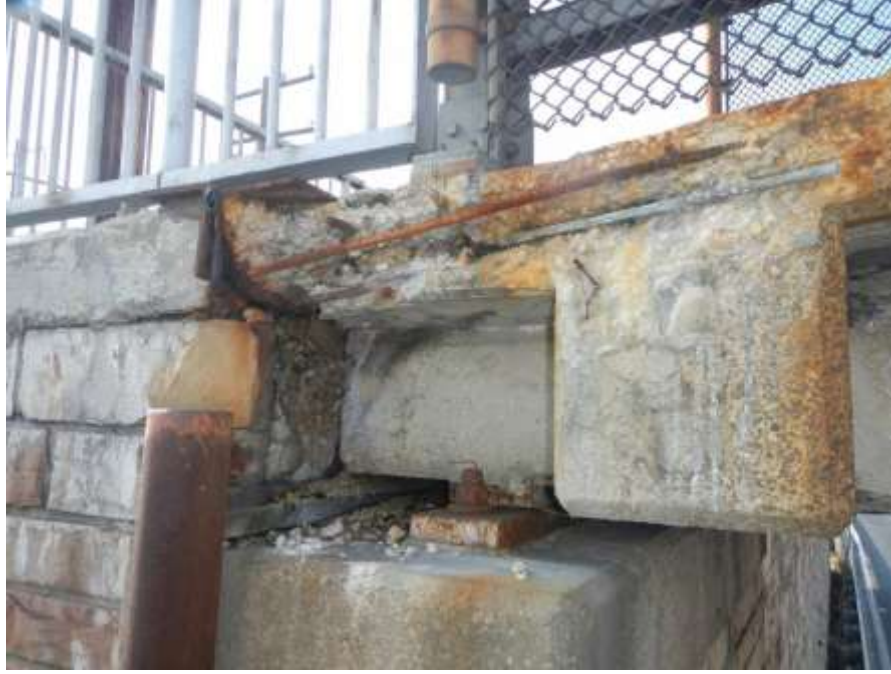
Photograph No. 21 – Spall with Exposed Corroded Reinforcing Steel at Northeast Corner of Deck Fascia/Overhang Under First Safety Fence Post (Looking Southeast)

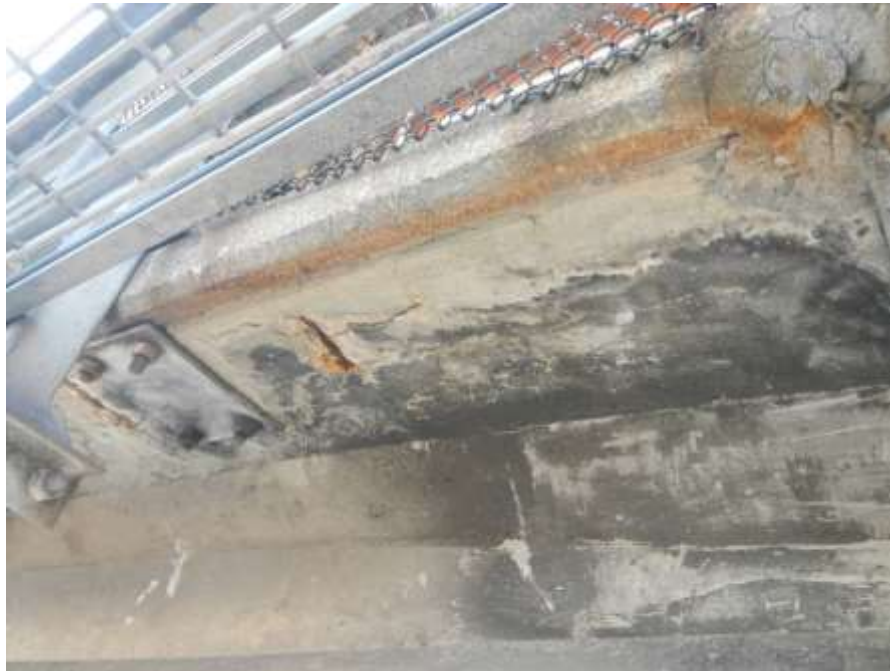
Photograph No. 22 – Area of Delaminated Concrete on North Deck Overhang Above Left Edge of Right Southbound Lane

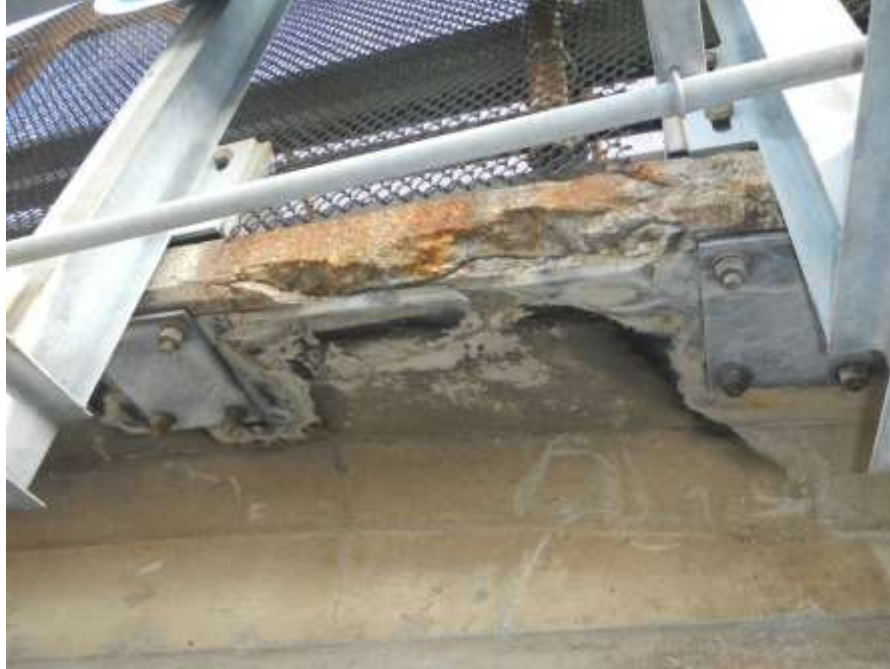
Photograph No. 23 – Area of Delaminated and Loose Concrete on South Deck Fascia/Overhang Above Lane Striping Between Right and Center Northbound Lanes of Kenilworth Avenue (Looking North)

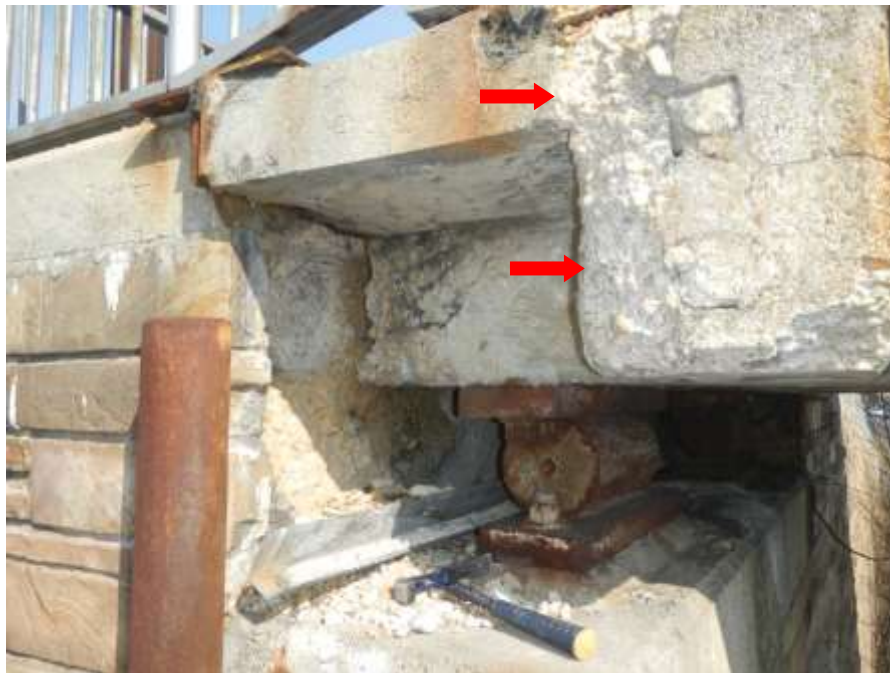
Photograph No. 24 – Spall with Exposed Corroded Reinforcing Steel in South Deck Fascia Near West Abutment (Looking Northwest)

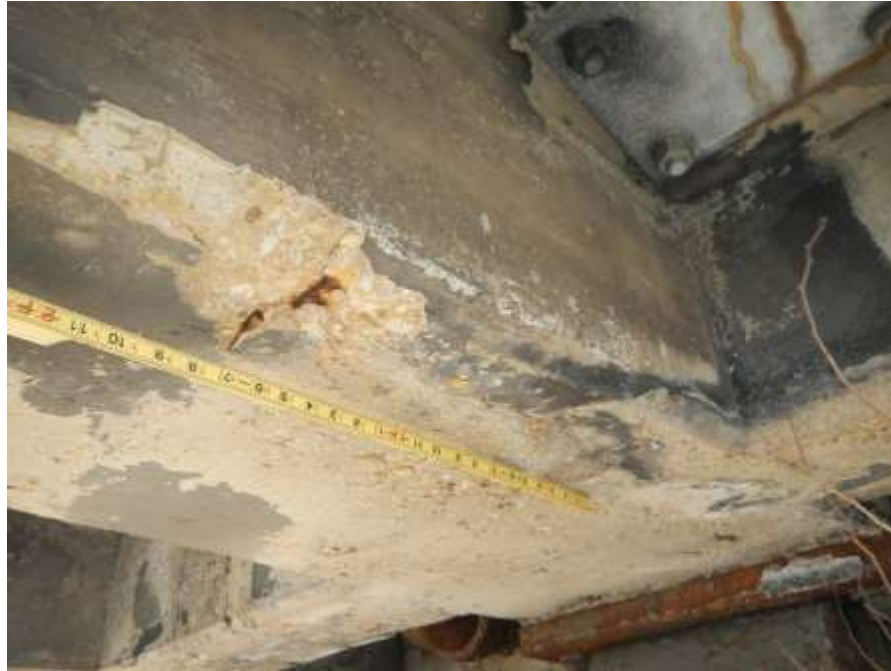
Photograph No. 25 – North T-Beam Underside Adjacent to End Diaphragm at West Abutment: Area of Delaminated Concrete and Spall with Exposed Corroded Reinforcing Steel (Looking Southwest)

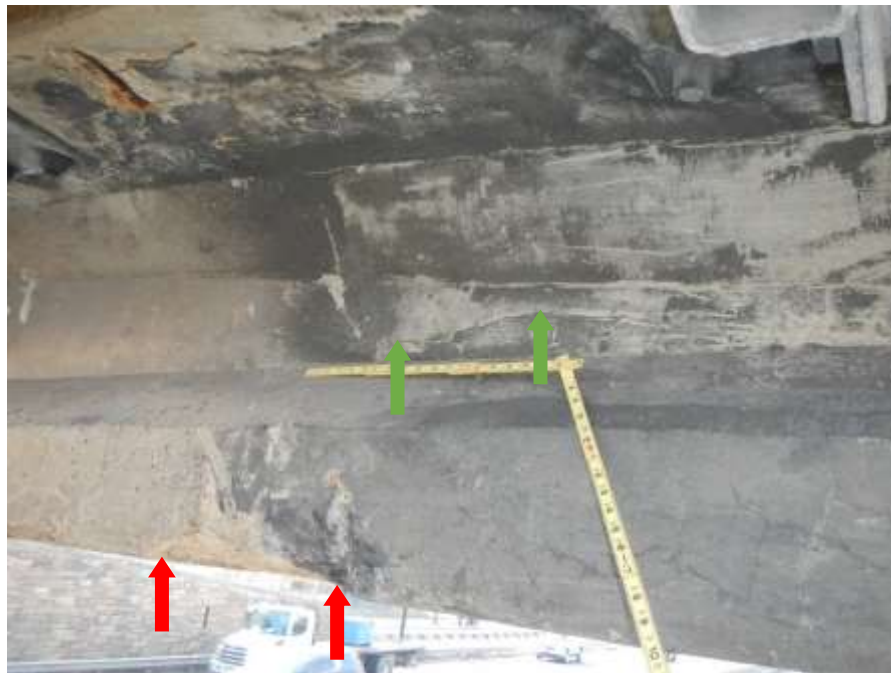
Photograph No. 26 – North T-beam Above Right Southbound Lane (Looking South): Spall on North Edge and Underside (Red Arrows); Horizontal Crack in North Face Web (Green Arrows)

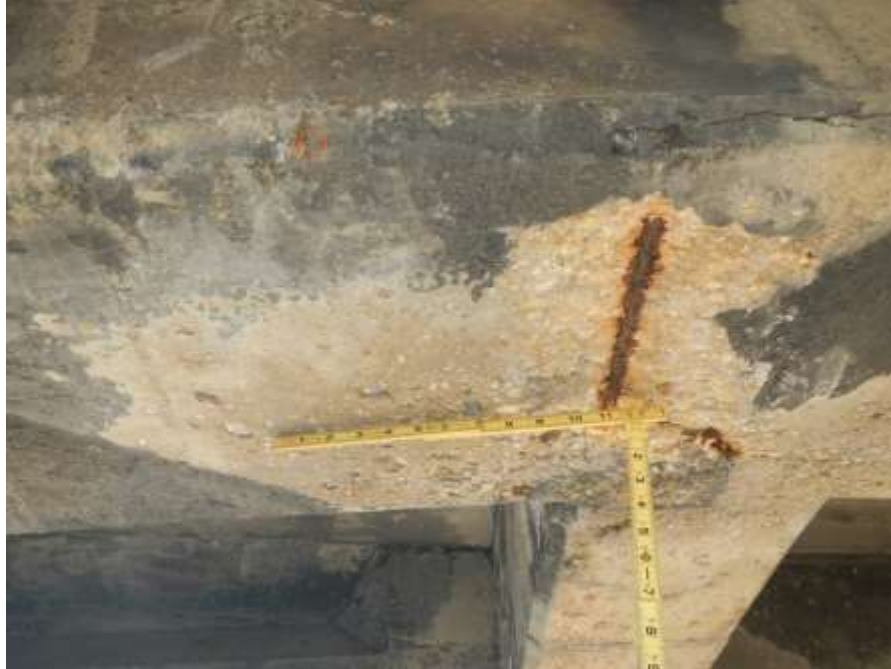
Photograph No. 27 – North T-Beam Underside at First Intermediate Diaphragm From West Abutment Above Right Southbound Lane: Spall with Exposed Corroded Reinforcing Steel (Looking South)

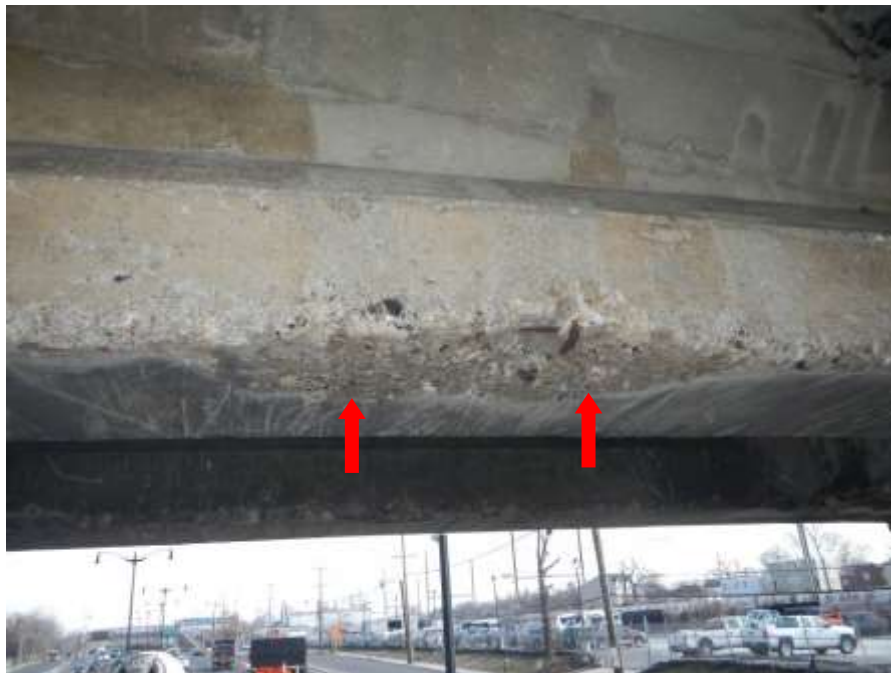
Photograph No. 28 – South T-beam Above Right Northbound Lane (Looking North): Spall with Exposed Corroded Reinforcing Steel on South Edge and Underside

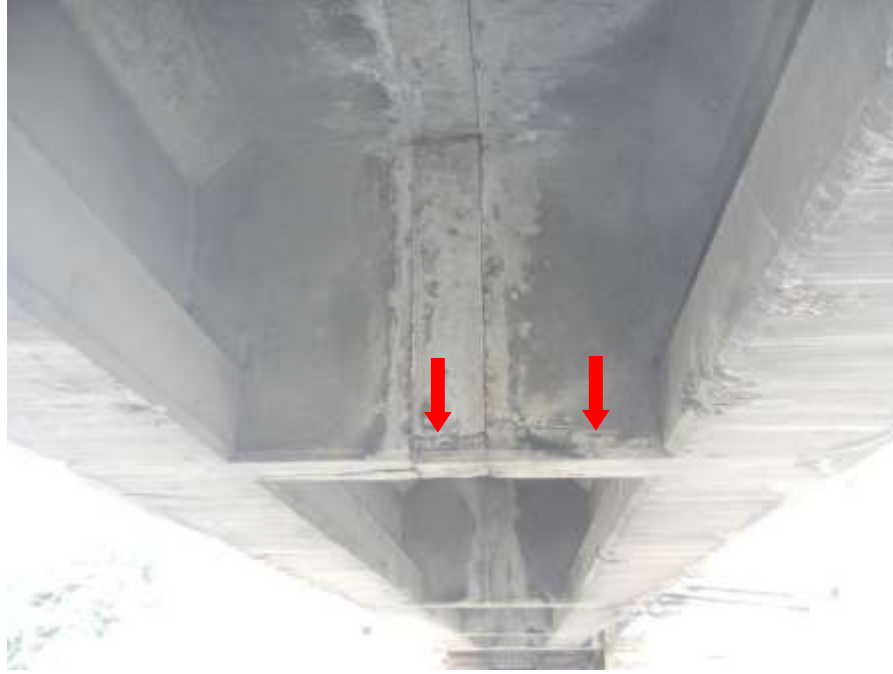
Photograph No. 29 – Crack in Underside of Third Diaphragm From East Abutment (Looking West)

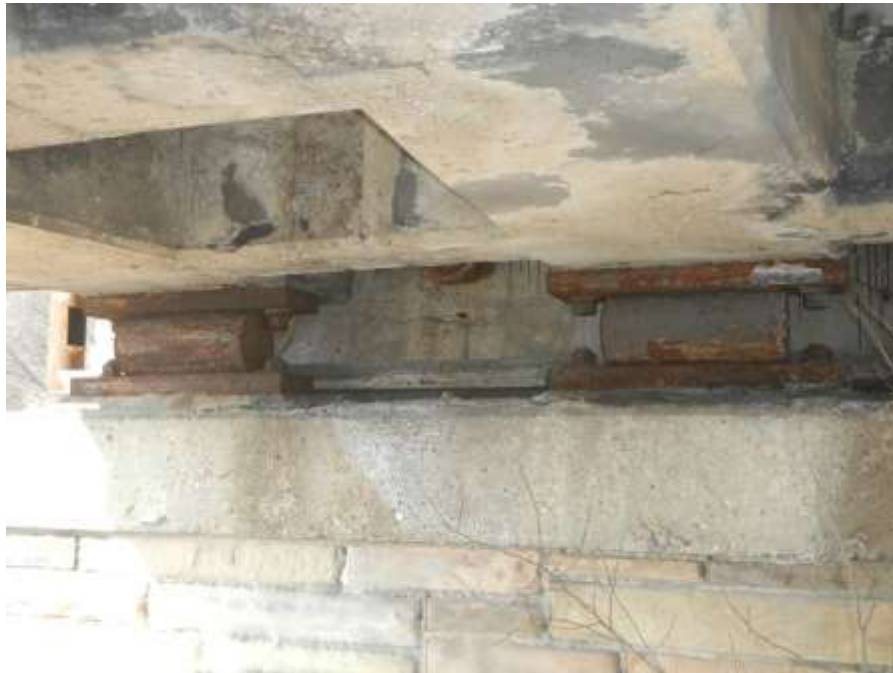
Photograph No. 30 – Steel Roller Expansion Bearings at West Abutment:
Note Minor to Moderate Corrosion on Bearings

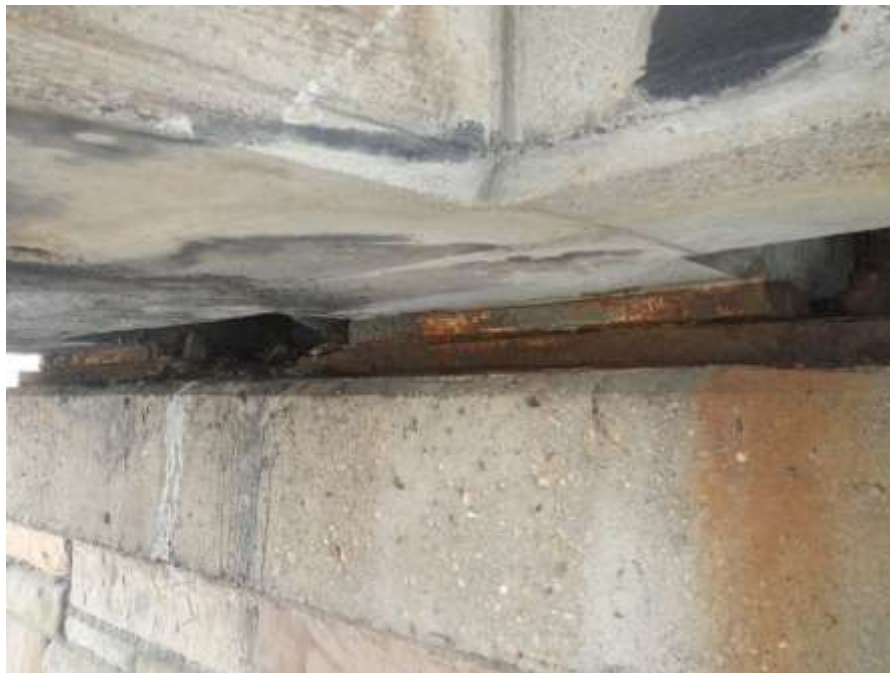
Photograph No. 32 – Steel Plate Fixed Bearings at East Abutment (Looking Northeast): Note Moderate Corrosion on Bearings

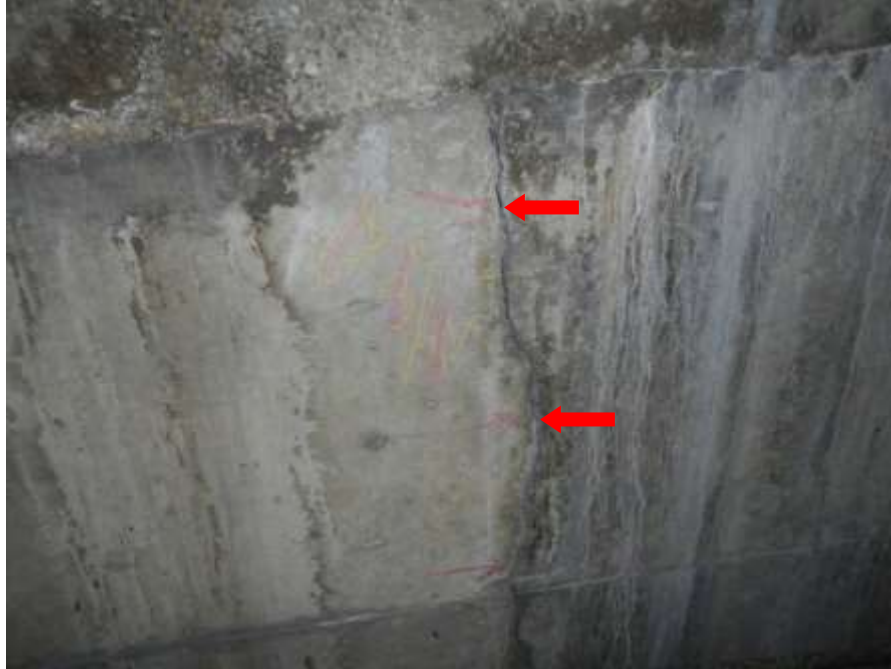
Photograph No. 35 – East Abutment Interior: Vertical Crack in East and West Faces of Concrete Interior Wall Between Approach Ramps at Approximately One-Third Point From South End (West Face Shown, Looking East)

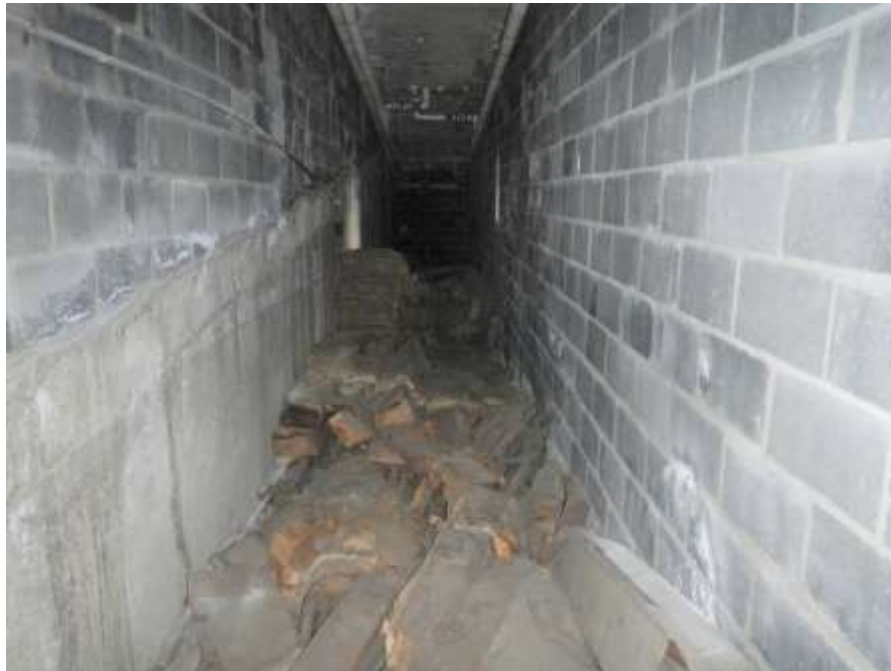
Photograph No. 36 – East Abutment Interior: Significant Accumulation of Debris on Concrete Floor Under Upper Pedestrian Approach Ramp From Just Beyond Utility Room Extending to South End of Ramp (Looking South)

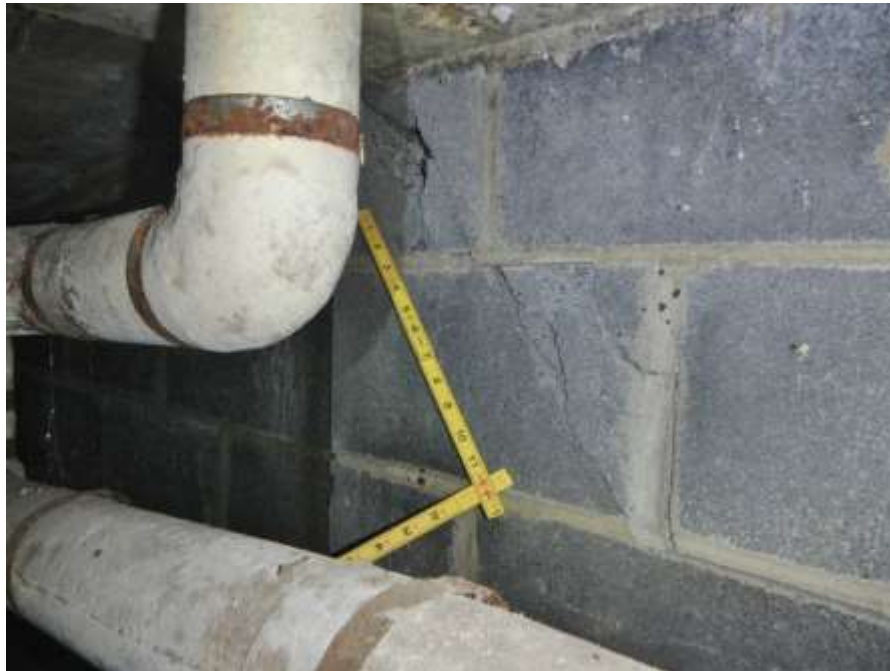
Photograph No. 38 – West Abutment Interior: Area of Cracked and Broken Cinderblocks at Top of East/Interior Face of Cinderblock Wall at Northwest Wingwall Near North End

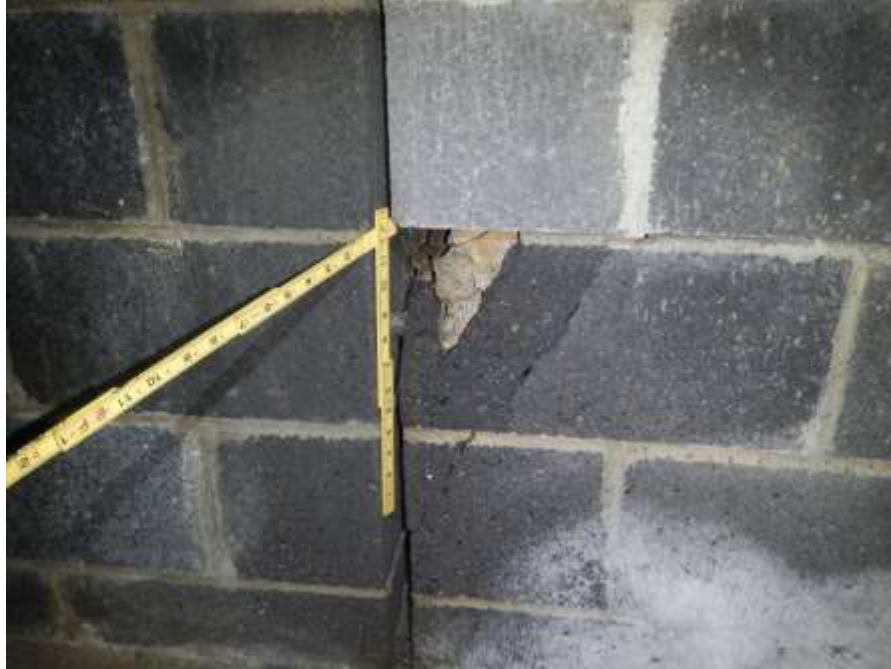
Photograph No. 39 – West Abutment Interior: Diagonal Crack with Adjacent Spall Near Base of East/Interior Face of Cinderblock Wall at Northwest Wingwall Near North End (Looking West)

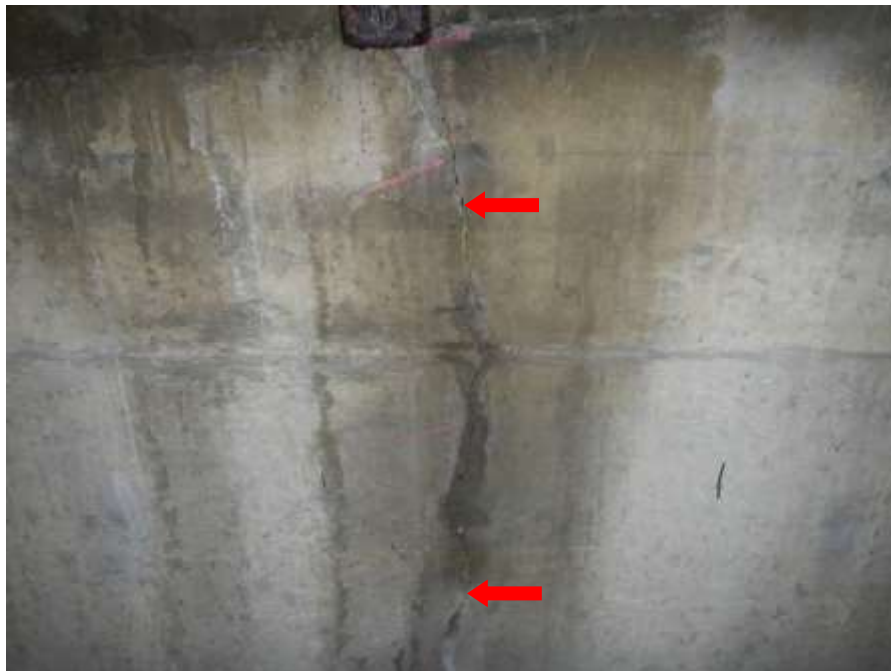
Photograph No. 40 – West Abutment Interior: Vertical Crack in East and West Faces of Concrete Interior Wall Between Upper and Lower Pedestrian Approach Ramps 18 Ft. From North End (East Face Shown)

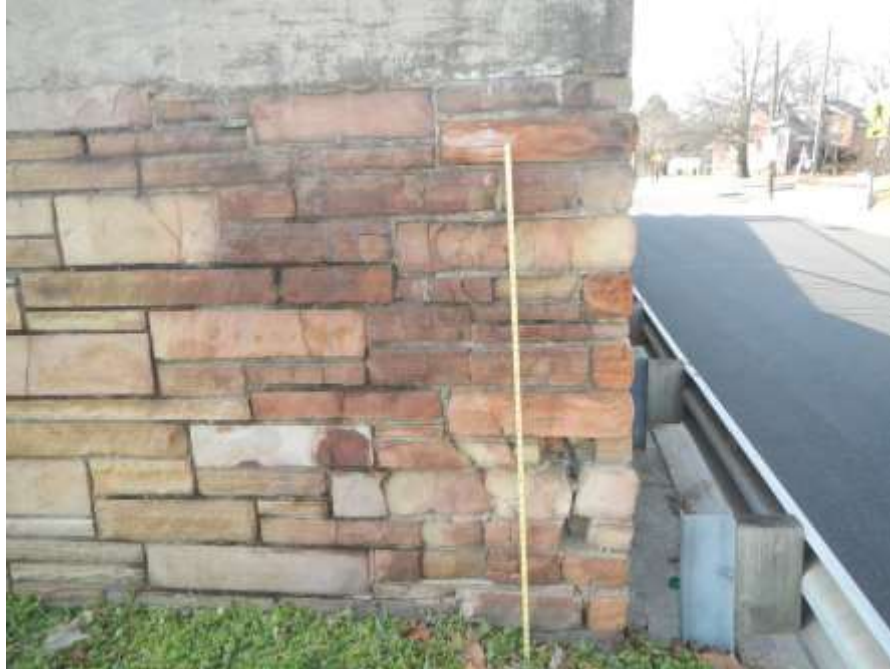
Photograph No. 41 – Area of Cracked and Missing Stones at Base of Wall Between North Ends of Northwest and Northeast Wingwalls (Looking South)

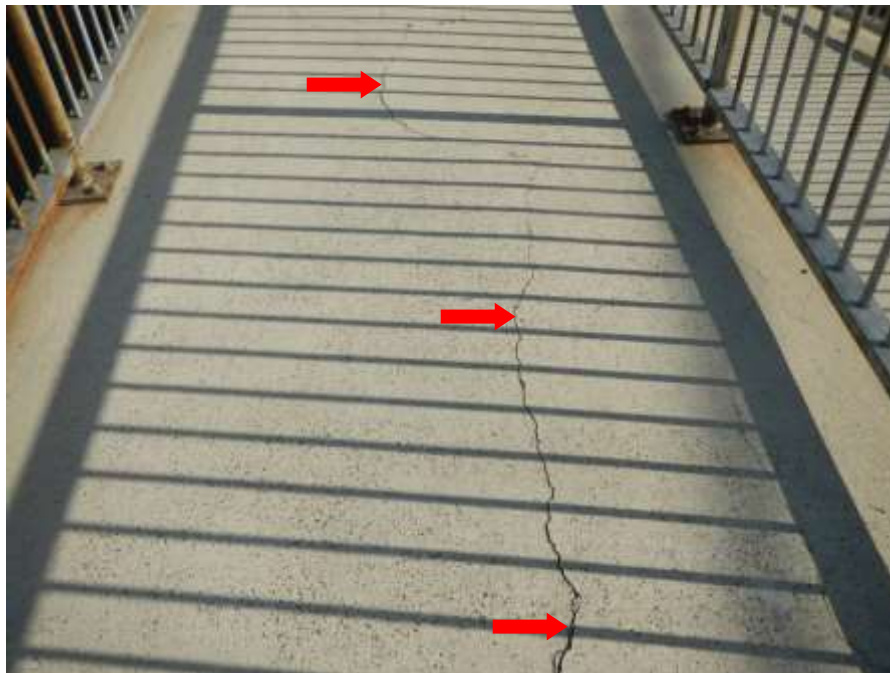
Photograph No. 42 – Full-Length Longitudinal Crack in Walking Surface of Upper Southeast Approach Pedestrian Ramp (Looking North)

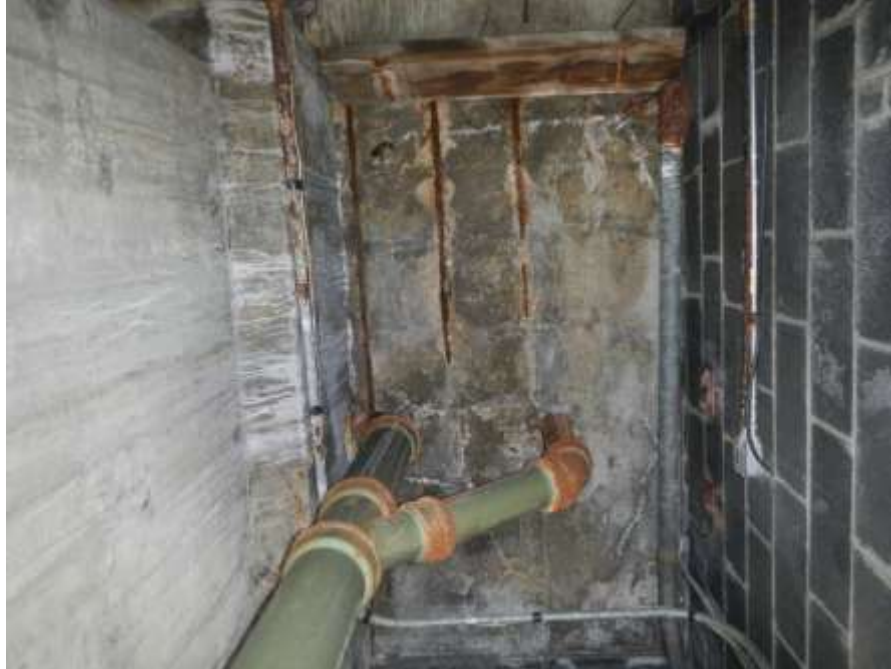
Photograph No. 43 – West Abutment Interior, Underside of Upper Northwest Approach Pedestrian Ramp: Intermittent Spalls with Exposed Corroded Reinforcing Steel Bars Near Access Door

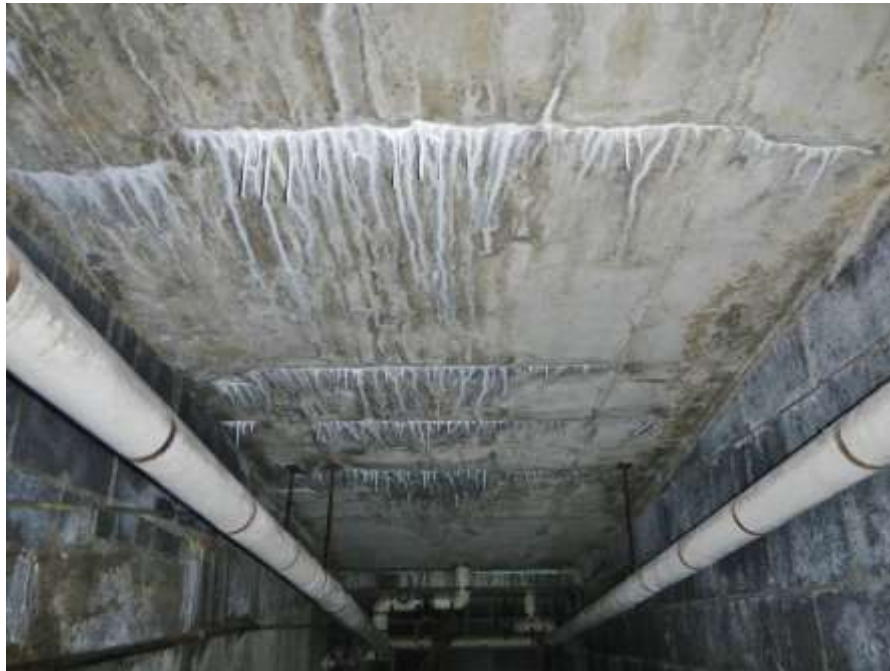
Photograph No. 44 – West Abutment Interior, Underside of Upper Northwest Approach Pedestrian Ramp: Water Stains with Moderate Efflorescence and Stalactites

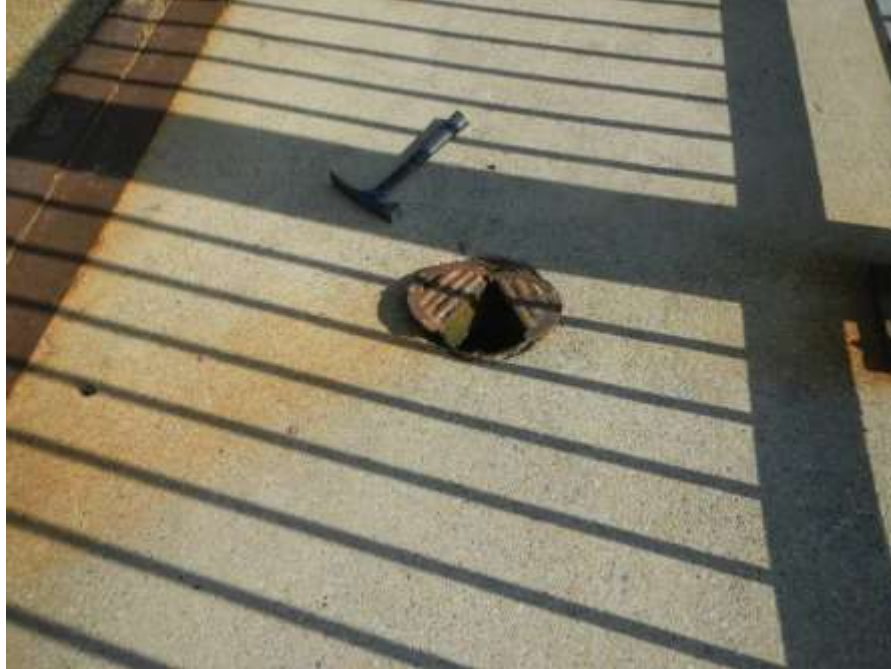
Photograph No. 45 – Cracked/Broken/Loose Drainage Grate at North End of Upper Southeast Approach Ramp: Note Concrete Debris Blocking Six of Eight Openings in Grate (Looking North)
