Bridge No.: 0066 D.O.I.: 02/10/2021
Name: Pedestrian Bridge over Kenilworth Avenue near Lane Place, N.E.

★ ★ ★ D.C. Department of Transportation
Transportation Operations Administration
Asset Management Division

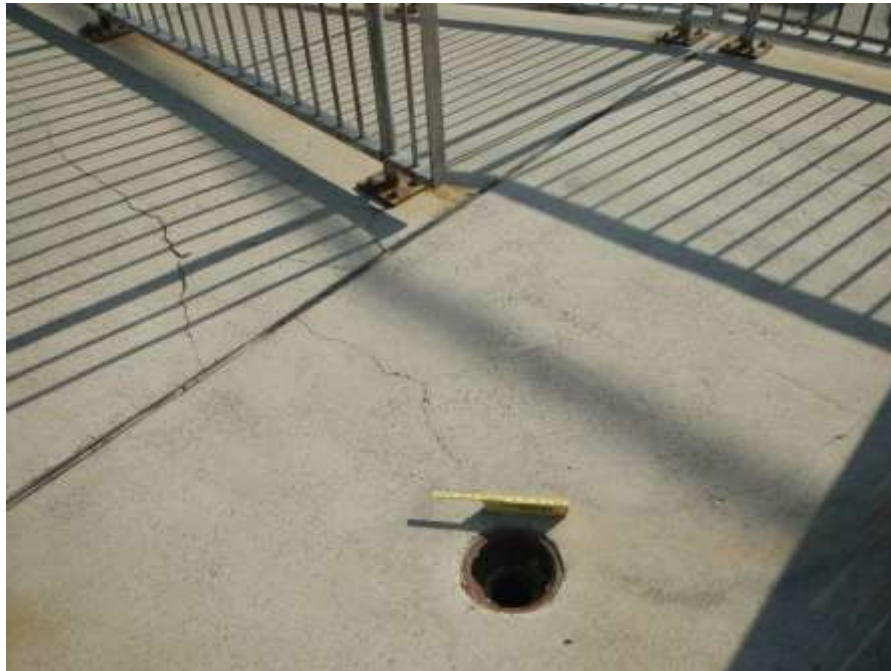
Photograph No. 46 – Missing Drainage Grate at South End of Upper Southeast Approach Ramp (Looking Northeast)

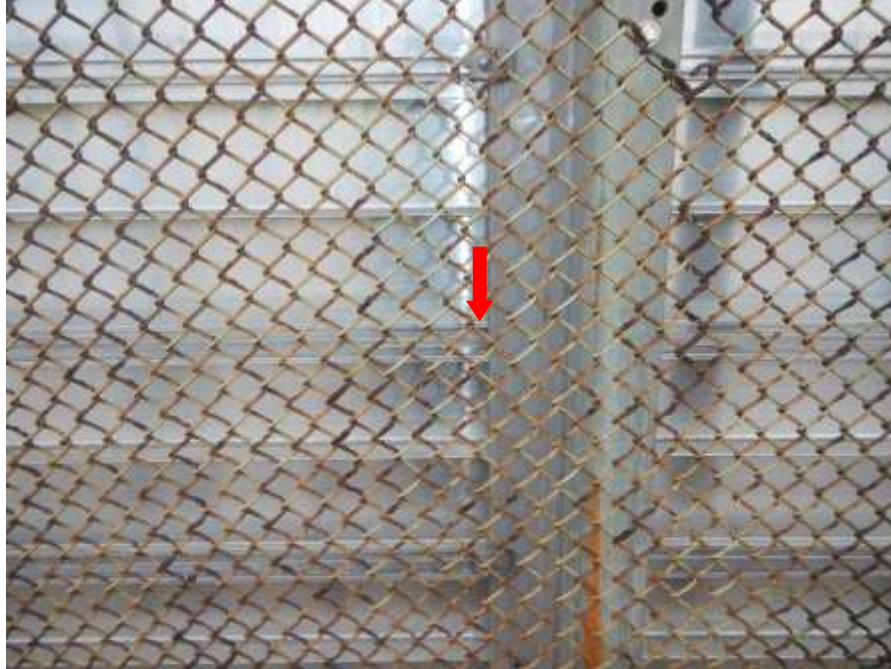
Photograph No. 47 – Right/West Overhead Directional Sign on North Side of Bridge: Third Sign Clip From Bottom Missing on Second Vertical Attachment Member From West (Looking North)

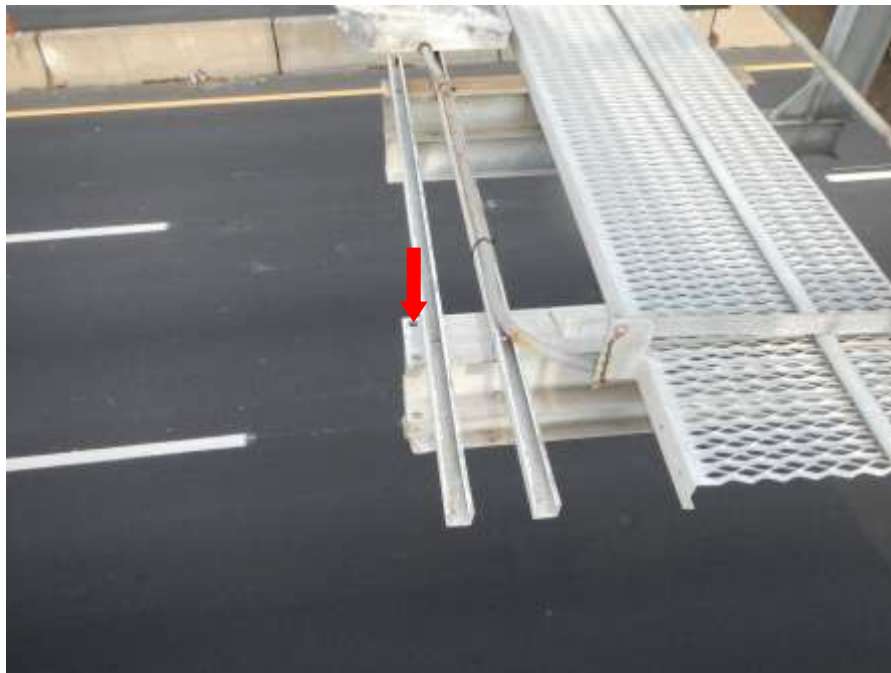
Photograph No. 48 – South and North Channels for Directional Sign Light Support on South Side of Bridge Disconnected at East End Due to Missing Bolts (Looking West)

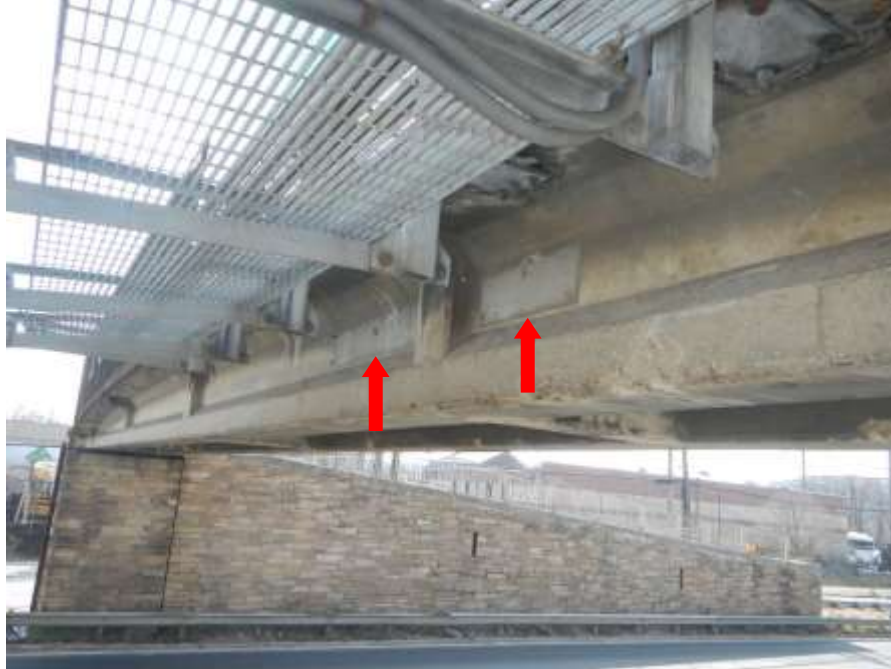
Photograph No. 49 – Both Sections of "Clearance 14 Ft." Sign Missing Above Southbound Lanes (Looking Southeast)

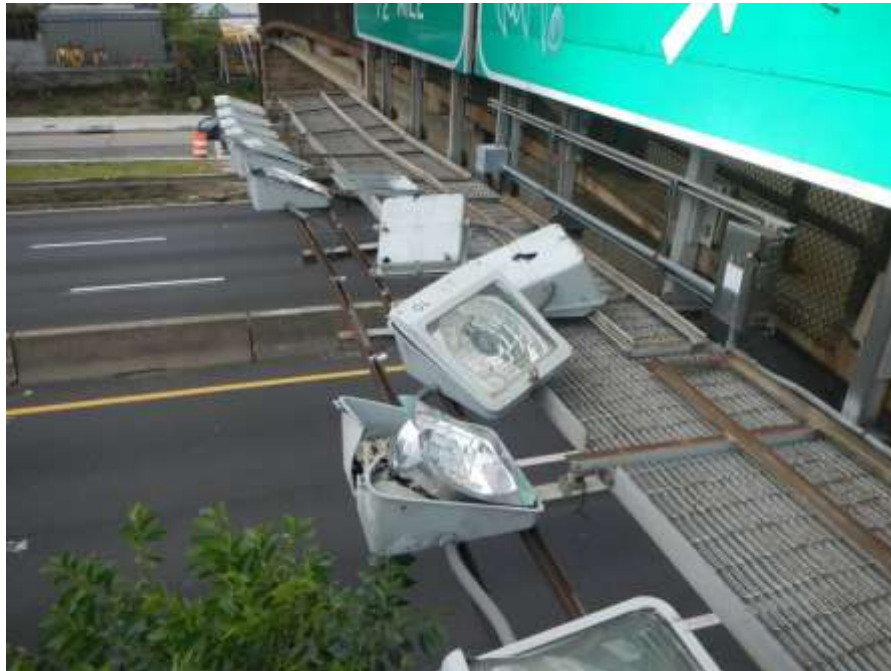
Photograph No. 50 – Damaged/Broken Lights for Directional Sign on North fascia Above Southbound Lanes of Kenilworth Avenue

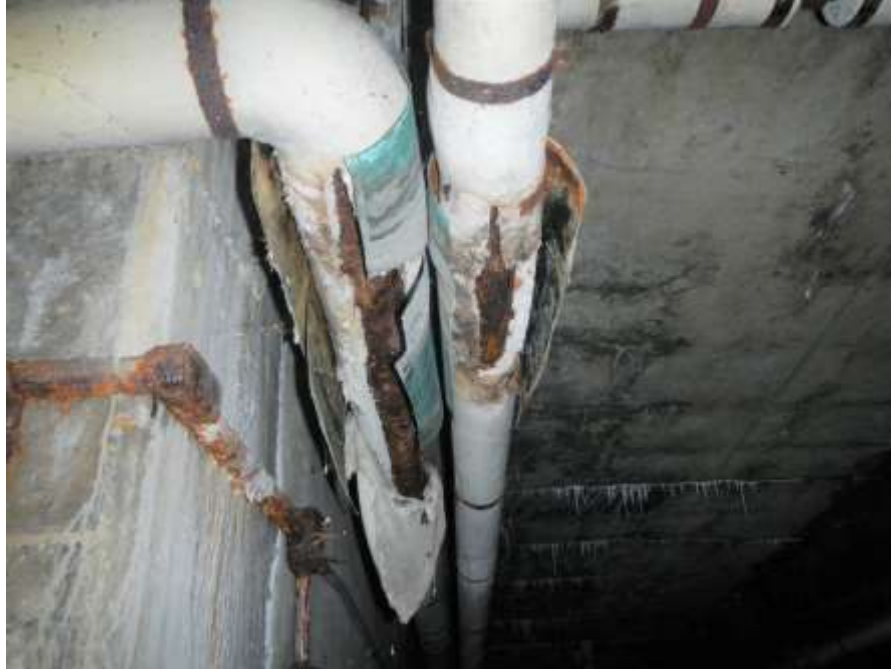
Photograph No. 51 – Severe Corrosion and Pipe Wrapping Unraveled on Two Pipes of Non-Functional Antifreeze System at South End of Lower Pedestrian Approach Ramp Inside East Abutment

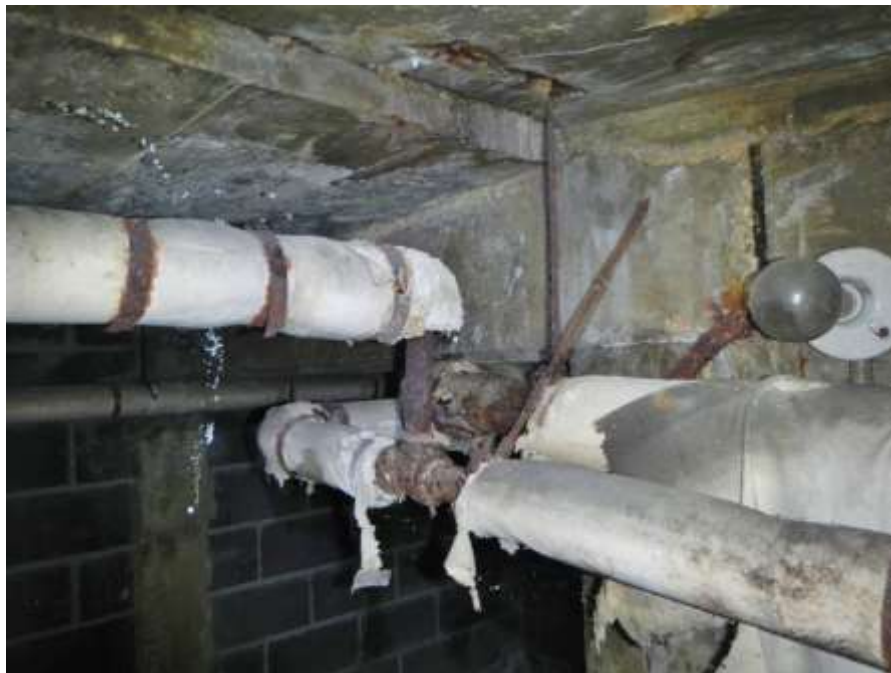
Photograph No. 52 – Two Broken Supports for Pipes of Non-Functional Antifreeze System at North End of Lower Pedestrian Approach Ramp Inside West Abutment
