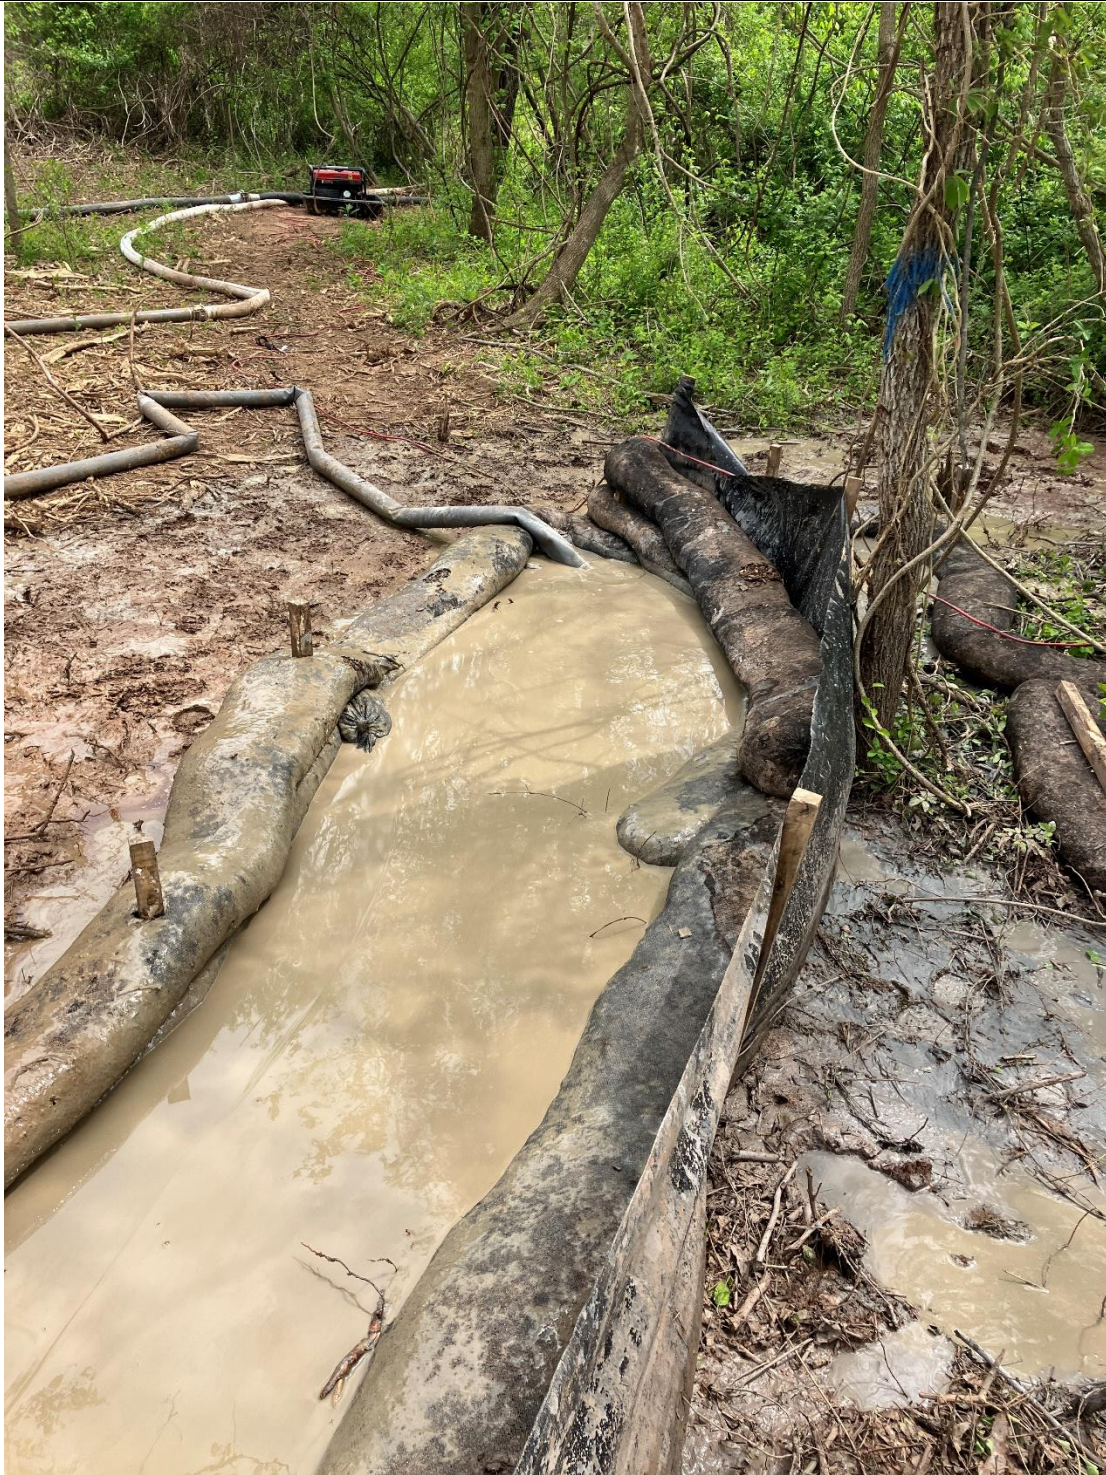
*Figure A: One of the undocumented frac-outs was found by the documented (in the 04/10/2024 MDE inspection report) frac-out on the western side of the waterway (UT to Monocacy River, use class I-P waters), on dry land. This frac-out is located at Segment 2. Sediment (bentonite) pollution is occurring in the Waters of the State but is contained at a downstream point.*

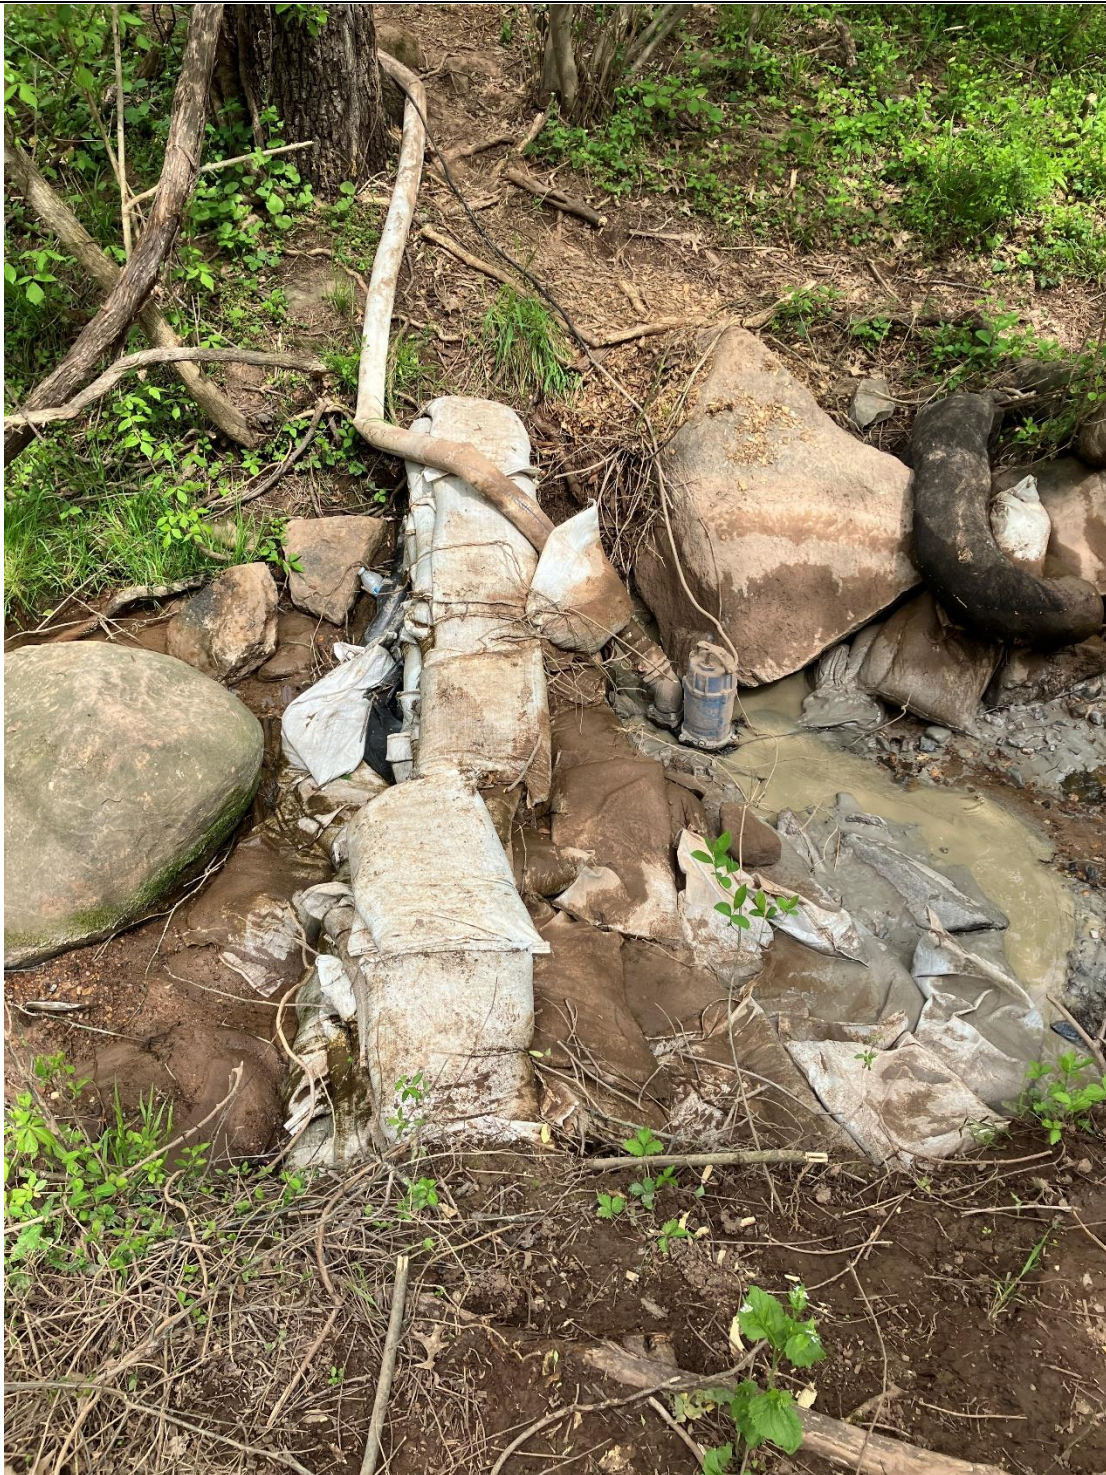
*Figure B: The furthest upstream (UT to Monocacy River, use class I-P waters) frac-out is contained and previously documented. This frac-out is located at Segment 2. Sediment (bentonite) pollution is occurring in the Waters of the State but is contained in a portion of the waterway.*

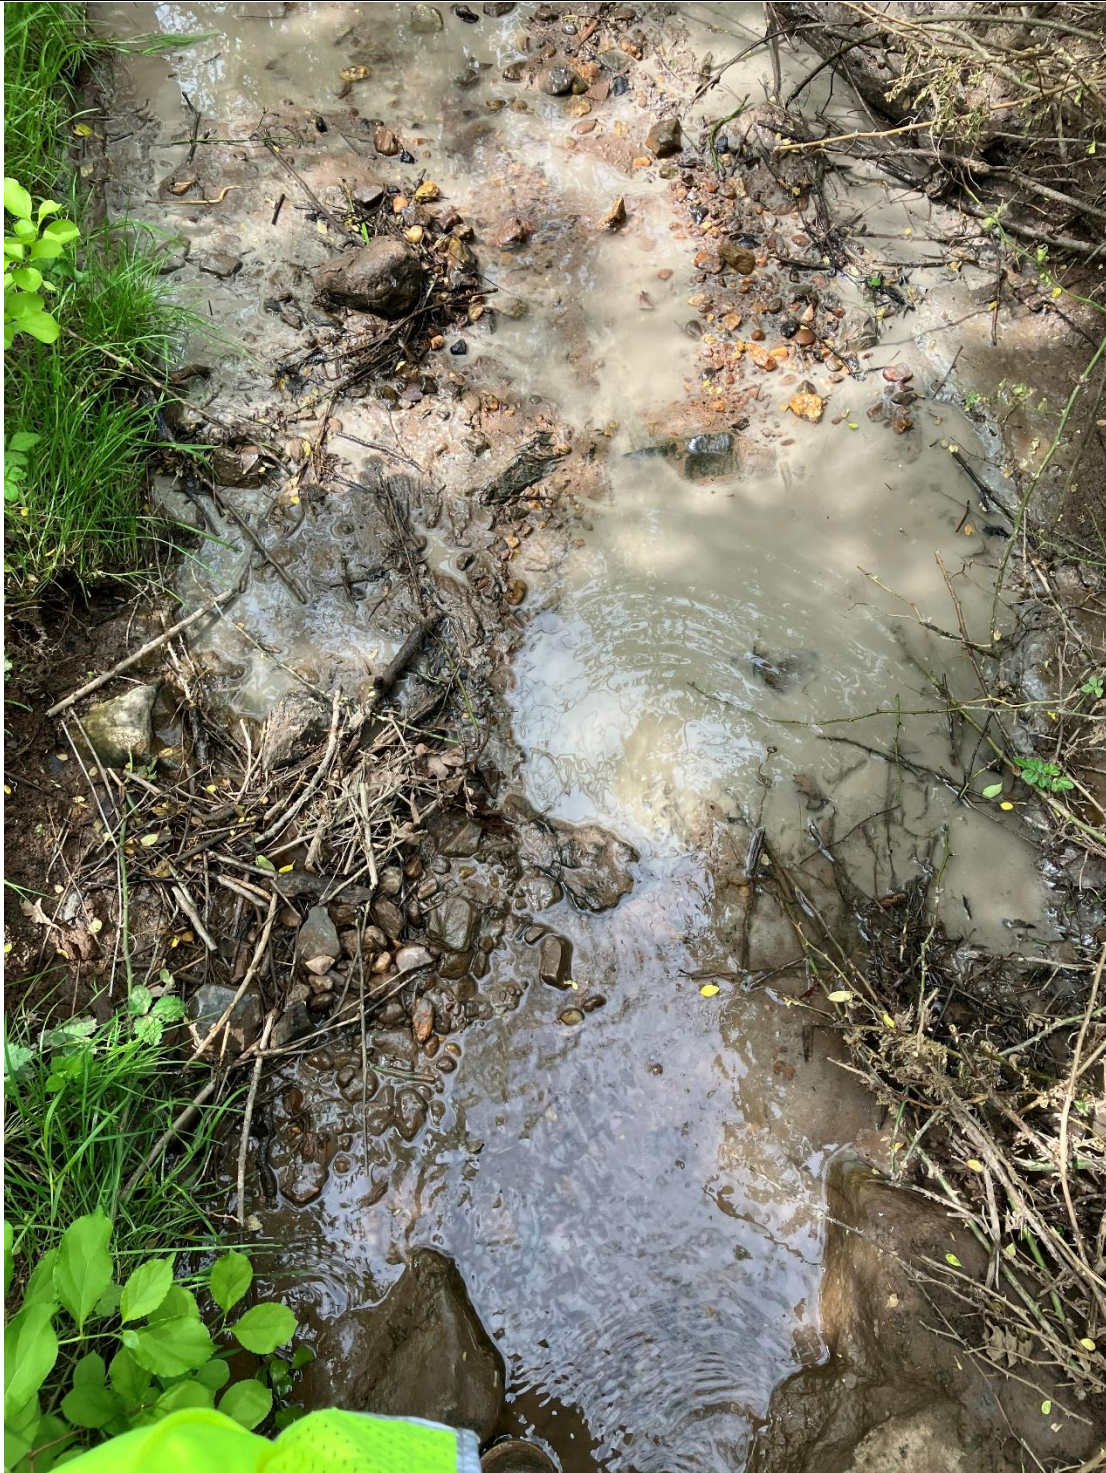
*Figure C: The other undocumented frac-out was within the stream (UT to Monocacy River, use class I-P waters) channel just downstream of the documented (in the 04/10/2024 MDE inspection report) frac-out (frac-out in Figure B) that was contained with sandbags around the discharge point. This frac-out is located at Segment 2. Sediment (bentonite) pollution is occurring in the Waters of the State but is contained at a downstream point.*

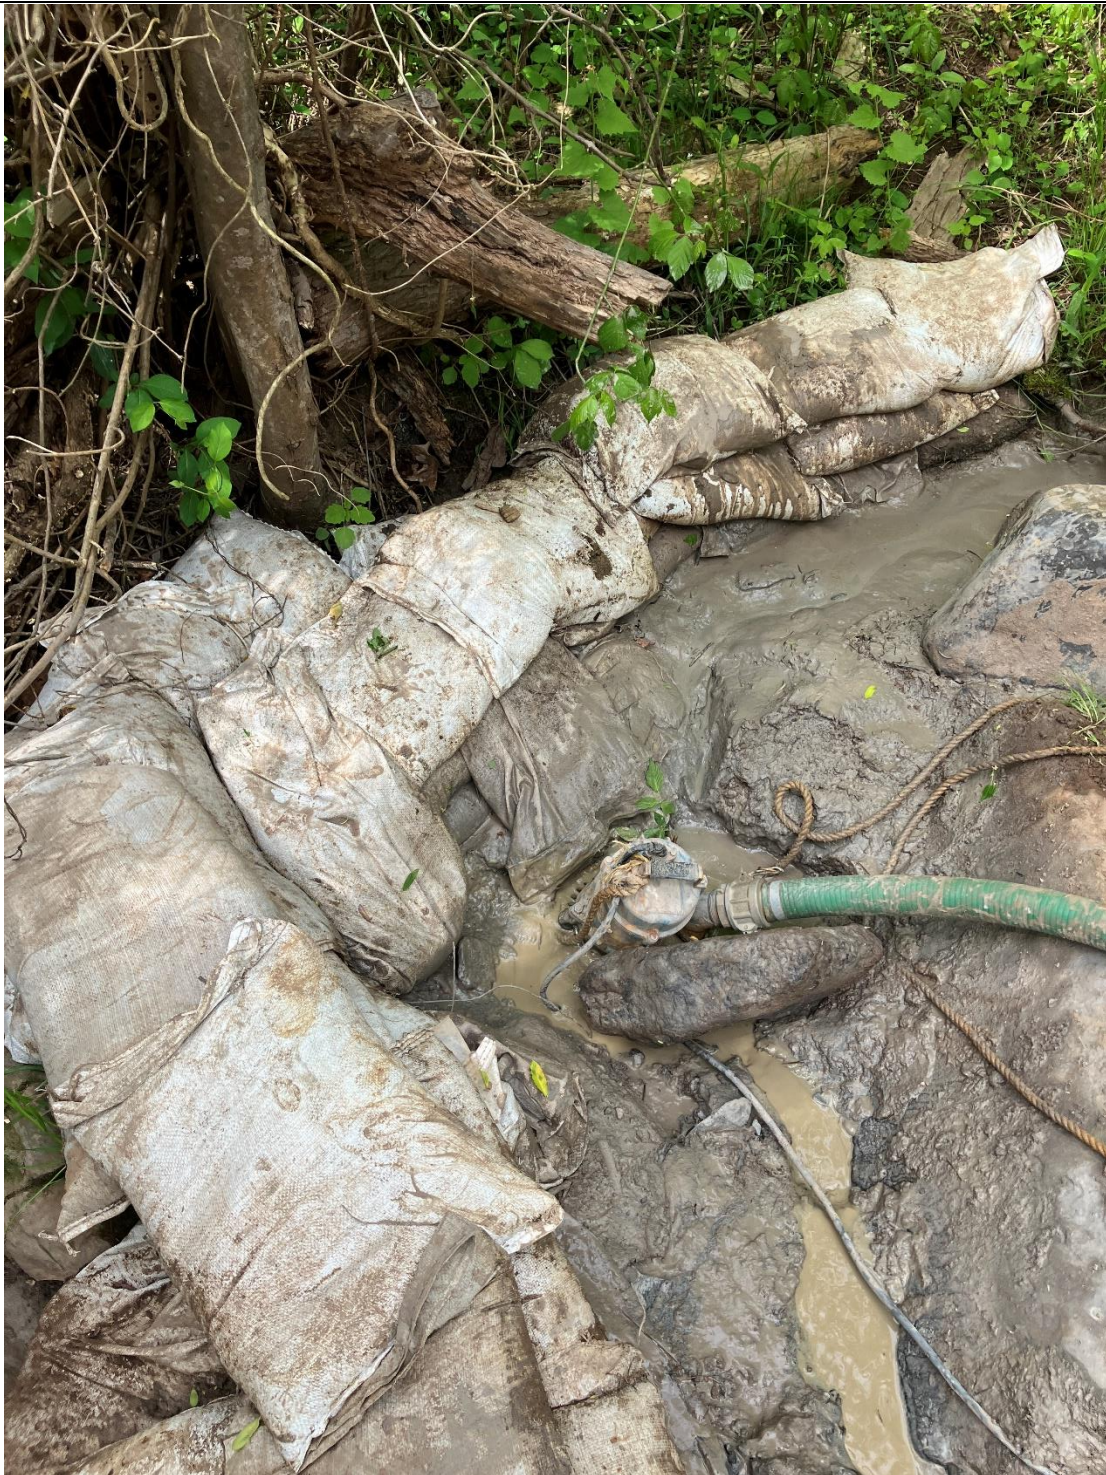
*Figure D: Another of the frac-outs within the channel of the waterway (UT to Monocacy River, use class I-P waters) just downstream where the farm stream crossing is located; there was sediment deposition deposited in the stream where the frac-out occurred. This frac-out is located at Segment 2. Sediment (bentonite) pollution is occurring in the Waters of the State but is contained in a portion of the waterway.*

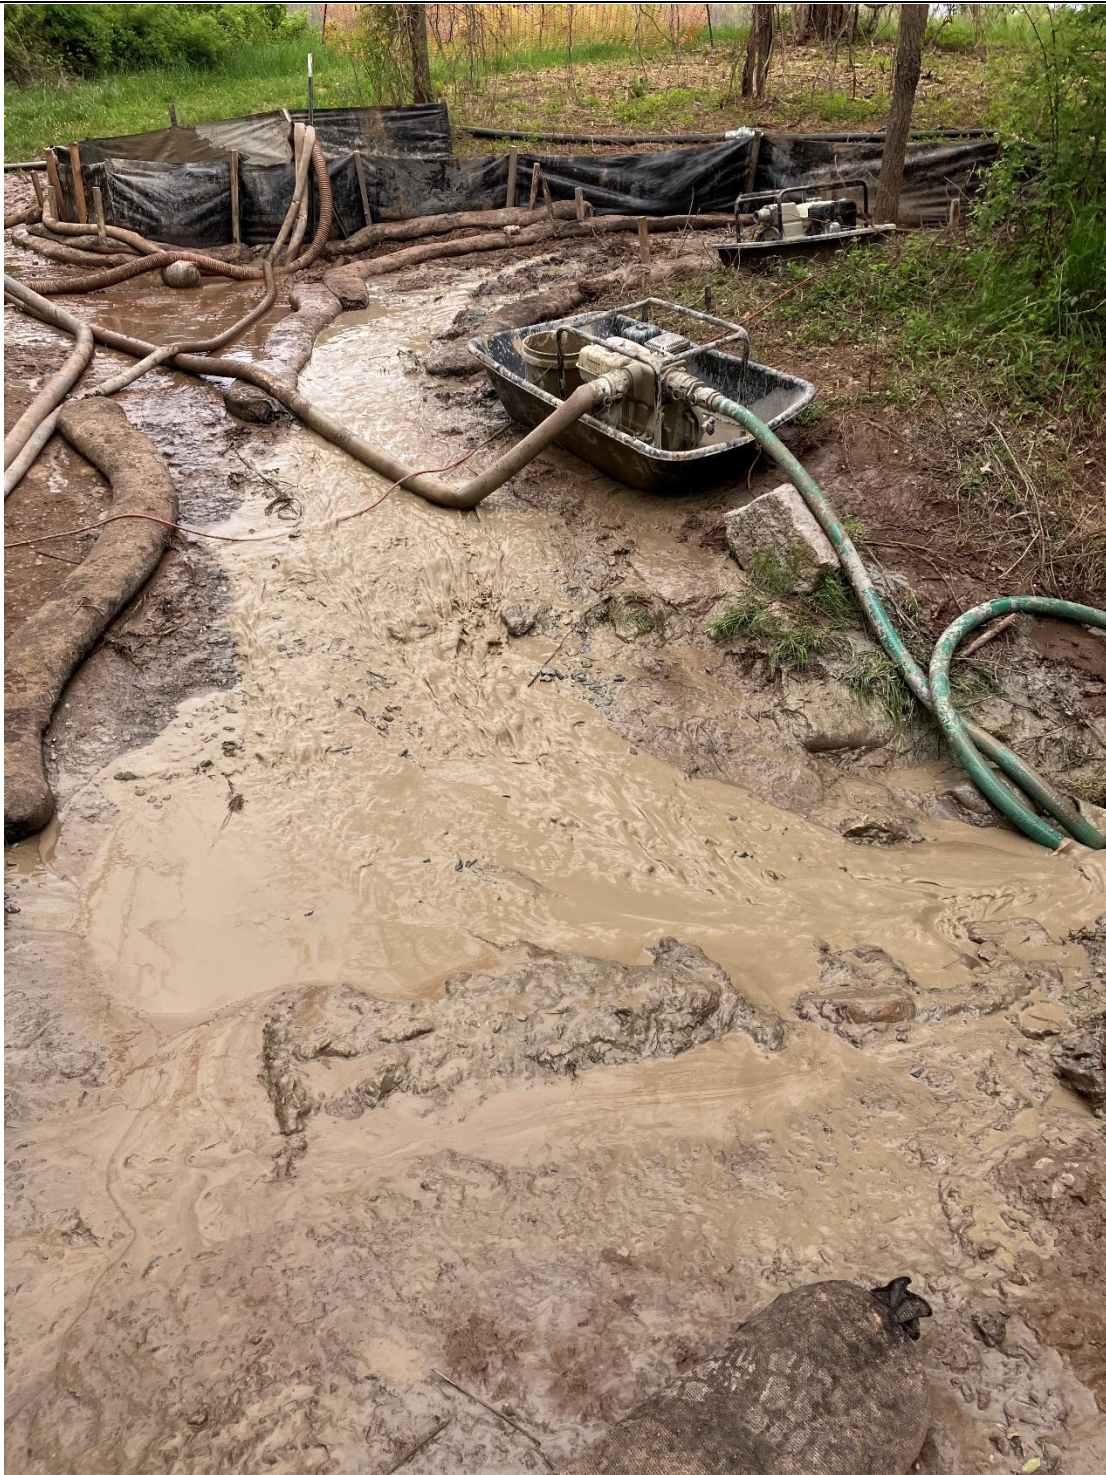
*Figure E: The two frac-outs on the western bank of UT to Monocacy River are discharging into the waterway and are not individually contained. These frac-outs are located at Segment 2. The one frac-out is the same one documented in Figure A. Sediment (bentonite) pollution is occurring in the Waters of the State but is contained at a downstream point.*

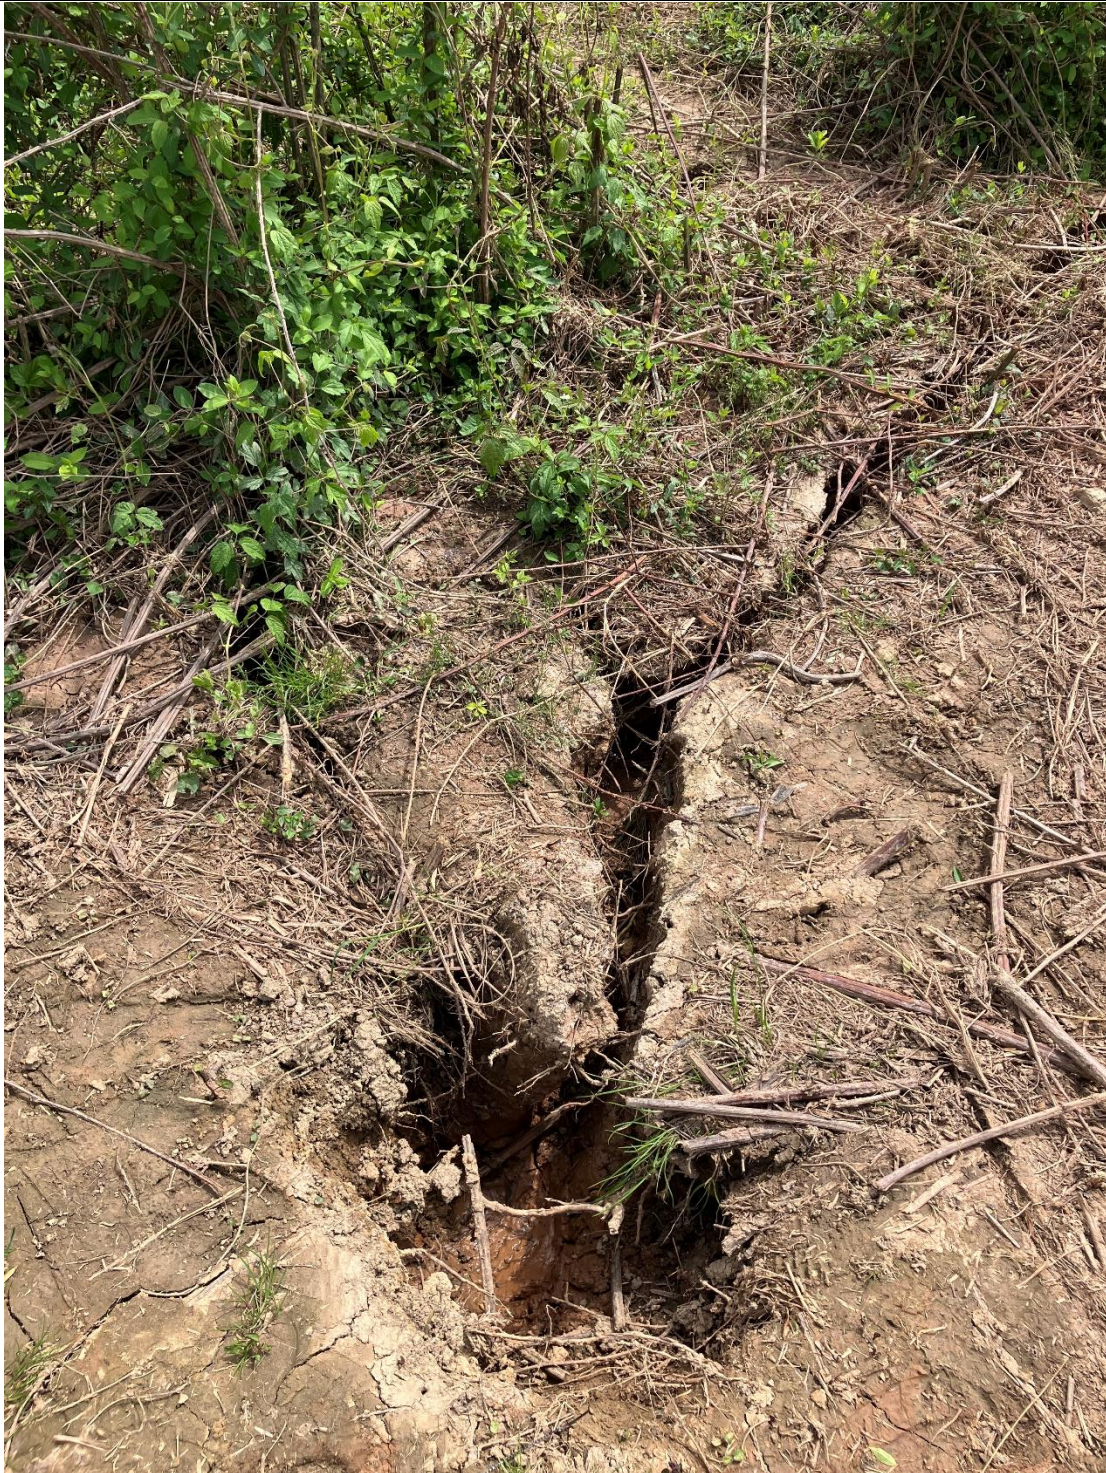
*Figure F: There were cracks/fractures in the ground, noticed at the frac-out location in Segment 16 (located at roughly 39.3158900, -77.4996900). Sediment (bentonite) pollution has occurred in the Waters of the State but was contained during the time of the inspection.*

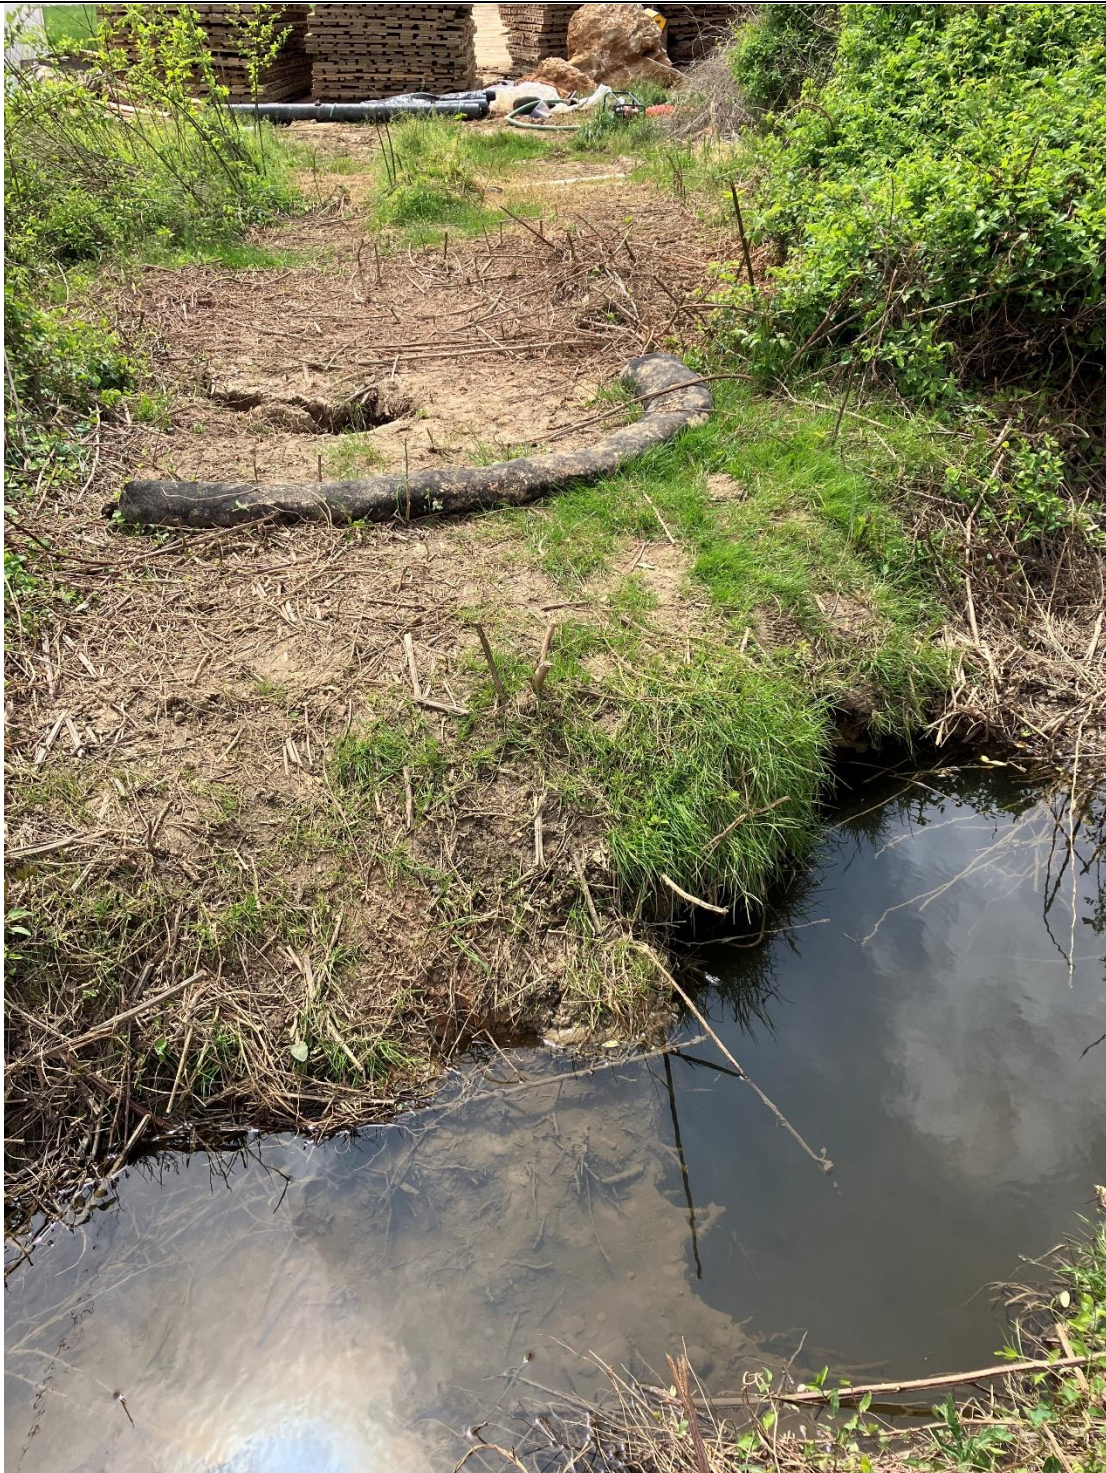
*Figure G: There were cracks/fractures in the ground, noticed at the frac-out location in Segment 16 (located at roughly 39.3158900, -77.4996900). This frac-out has been cleaned up but the cracks/fractures have not been stabilized. Sediment (bentonite) pollution has occurred in the Waters of the State but was contained during the time of the inspection.*
