Maryland Department of Environment
Water and Science Administration
Compliance Program
1800 Washington Blvd, Suite 420
Baltimore, MD 21230-1719
410- 537-3510, 1-800-633-6101

Inspector: Jacob Haglund
AI ID: 172623
Site Name: QLoop LLC - Sage Fiber (Segment 4)
Facility Address: Potomac Edison Row, 39.249374 -77.483653, Fisher Avenue, Poolesville, MD 20842
County: Montgomery County
Start Date/Time: April 04, 2024 11:30 AM
End Date /Time: April 04, 2024 04:00 PM
Media Type(s): NPDES Construction Activity, Nontidal Wetlands, Waterway Construction
Contact(s):

Inspection Date: April 04, 2024
Site Name: QLoop LLC - Sage Fiber
Facility Address: Potomac Edison Row, 39.249374 -77.483653, Fisher Avenue, Poolesville, MD 20842

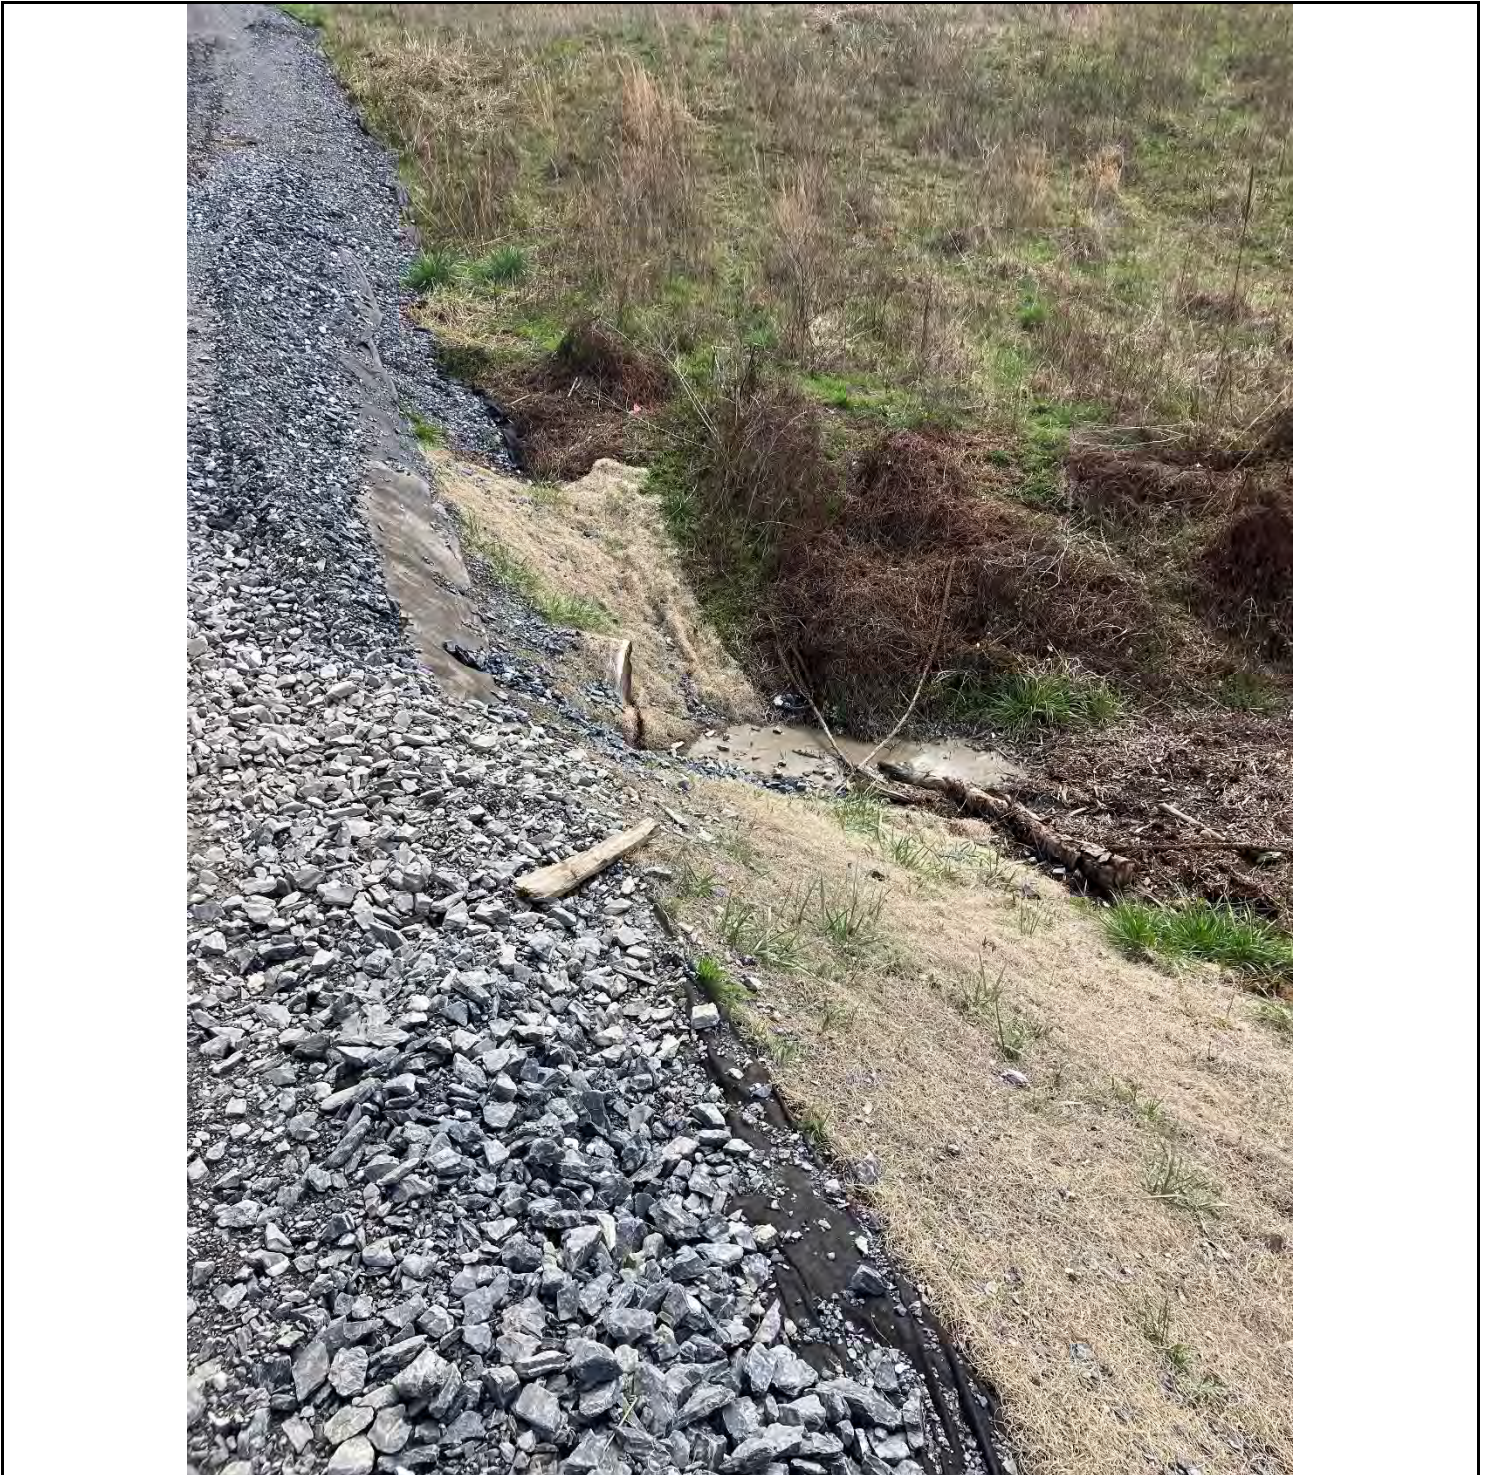
Figure A: There were issues found with a lack of sediment and erosion controls on the edge of the access road off of the Mouth of the Monocacy Road. Sediment pollution was noticed in the waterways (Waters of the State) that are crossed by the access road leading to the boring operation. Sediment pollution remains in a position likely to pollute the Waters of the State.

- 4) There were issues found with the sediment and erosion controls on the access road off of the Mouth of the Monocacy Road. The matting was crushed in some locations and/or sinking. Waterways and wetlands that were crossed lacked adequate controls at the edge of the matting and road. Sediment pollution was noticed in the waterways (Waters of the State) that are crossed by the access road leading to the boring operation. Sediment pollution remains in a position likely to pollute the Waters of the State. // Where the matting crosses over-regulated wetland and/or waterway areas should have controls along the edge of the matting. Replace matting that is breaking and/or crushed from vehicle traffic. Double up matting when one segment of matting is sinking. Add sediment and erosion control along the edge of the access road (Segment 2) where regulated wetlands and waterways are crossed. Ensure all controls are installed as per the 2011 Maryland Standards and Specifications for Soil Erosion and Sediment Control.

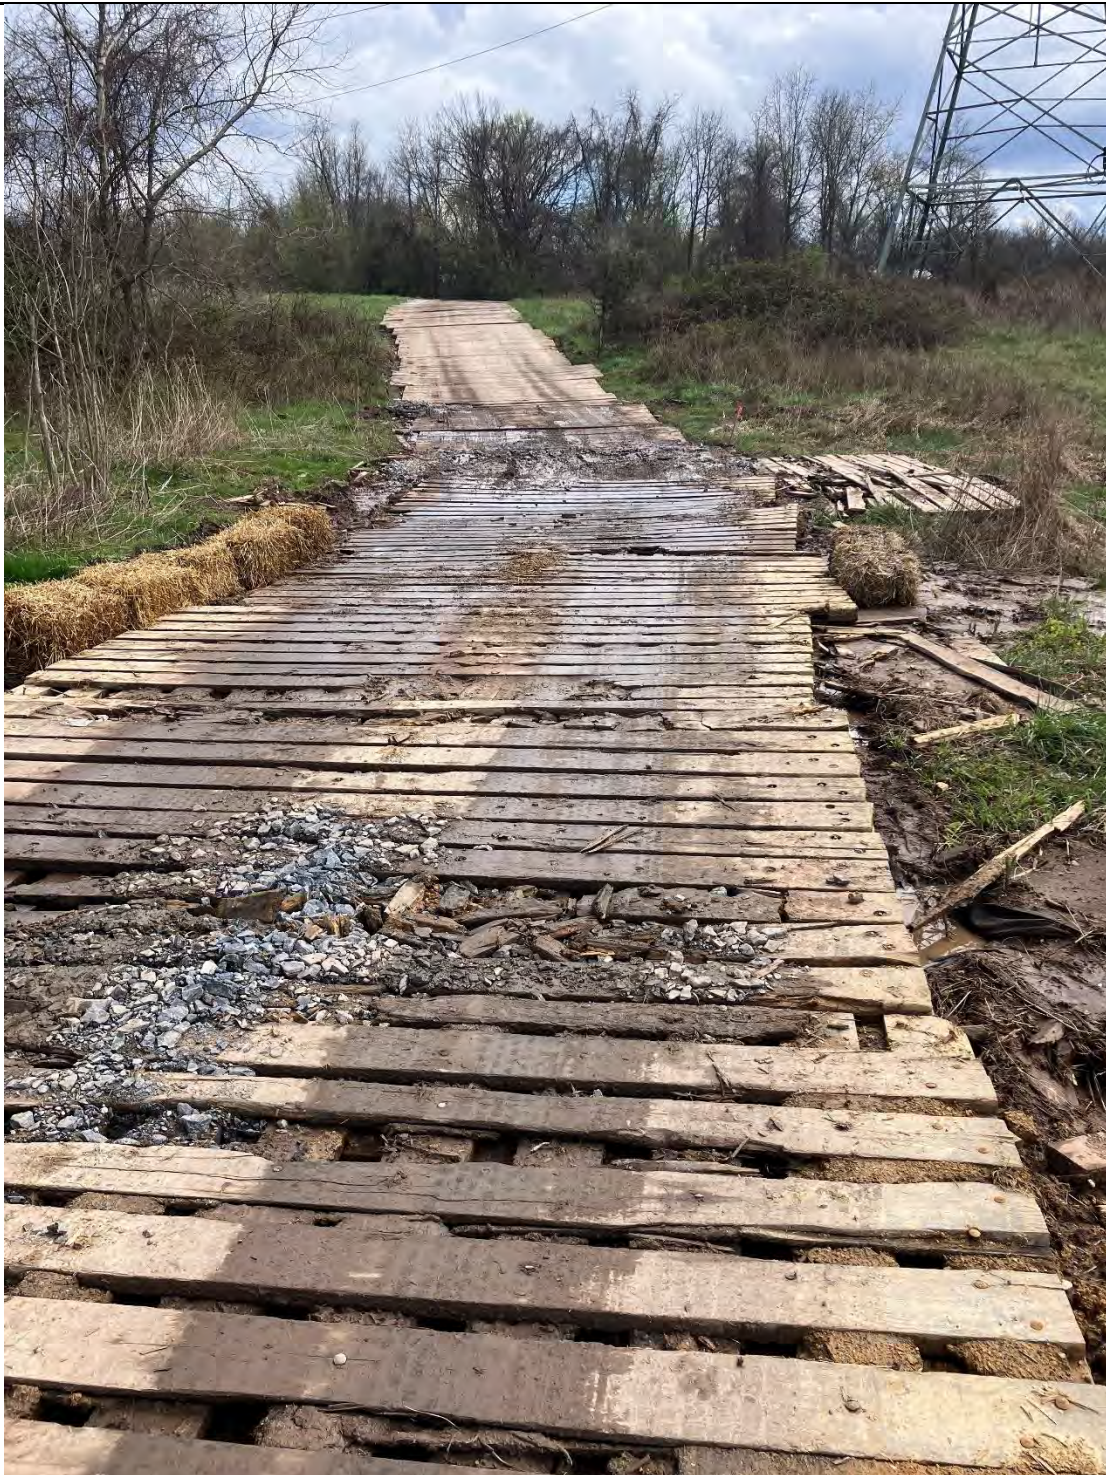
Figure B: There were issues found with the sediment and erosion controls on the access road off of the Mouth of the Monocacy Road. The matting was crushed in some locations and/or sinking. Crossed waterways and wetlands lacked adequate controls at the edge of the matting. Sediment pollution was noticed in the waterways (Waters of the State) that are crossed by the access road leading to the boring operation. Sediment pollution remains in a position likely to pollute the Waters of the State.

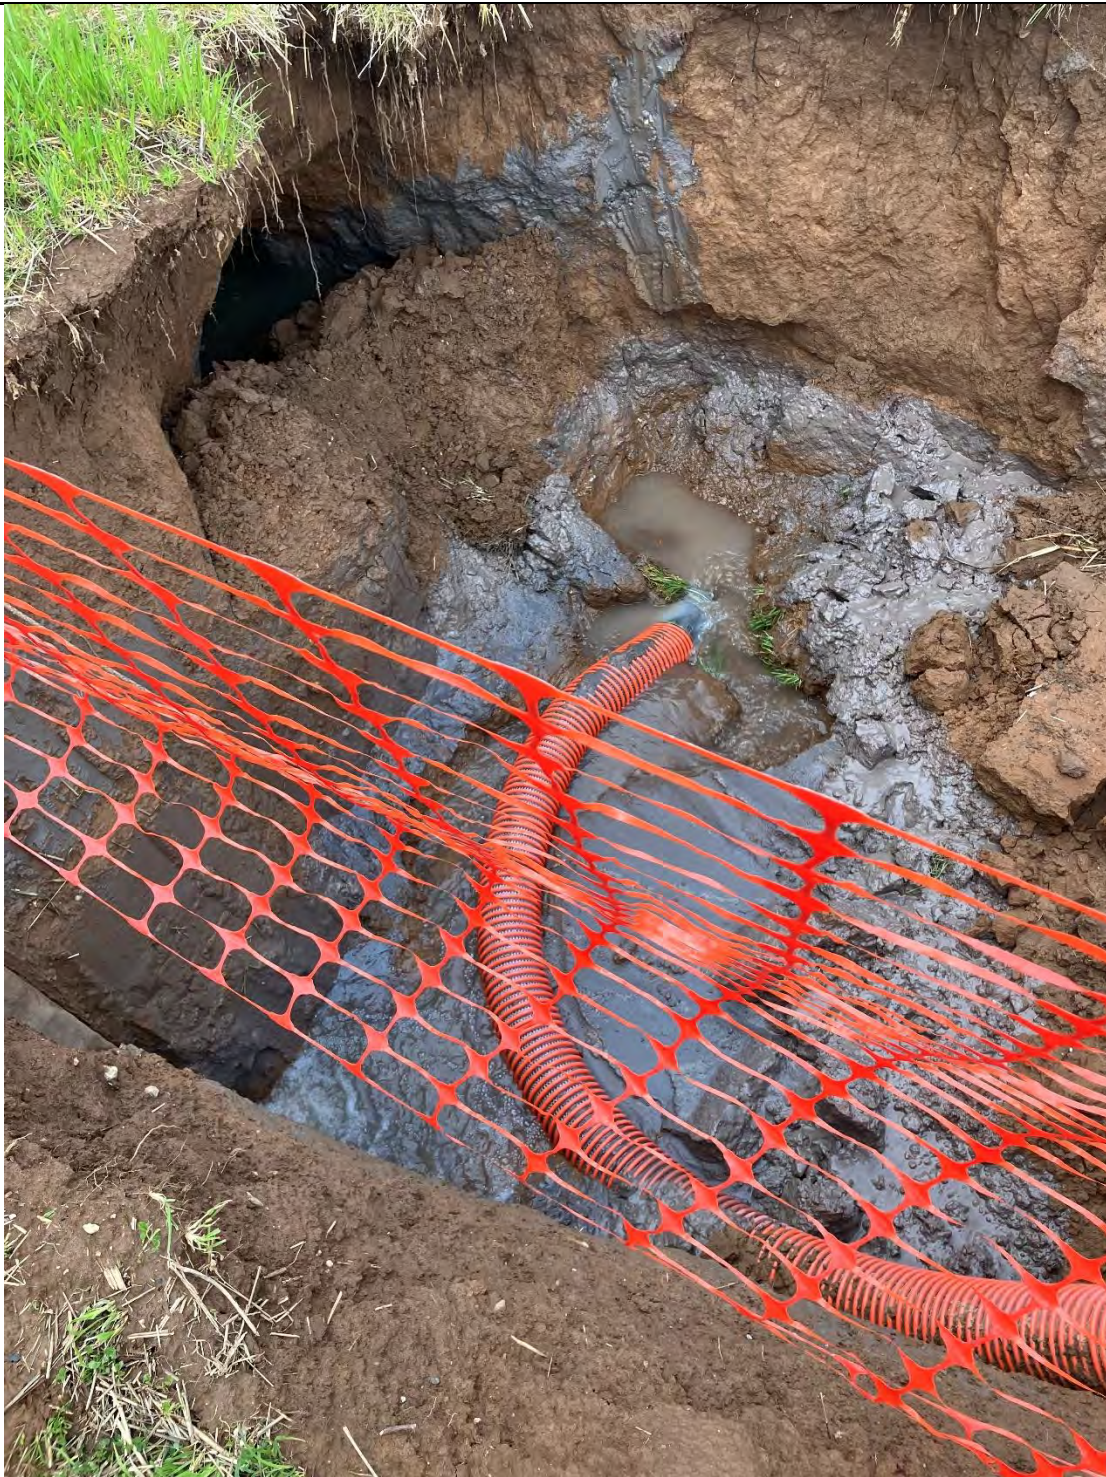
Figure C: There was a frac-out within a previously bored hole that was later abandoned. This location was outside the LOD. Also, sediment-laden water is being pumped out of the other frac-out locations to this abandoned bored hole. Sediment (bentonite) pollution was found in the Waters of the State and remains in a condition likely to continue to pollute.

- 5) There were two frac-outs found outside of the LOD and it was evident that sediment (bentonite) pollution was entering the Waters of the State. Sediment (bentonite) pollution also remains in a position likely to pollute the Waters of the State. A 24-hour notification was not given to MDE about the frac-out events. These events occurred on 03/20/2024. The Frac-out Contingency Plan was not followed: drilling did not cease when the frac-out was found and 24-hour notification was not given to MDE. // The Frac-out Contingency Plan should be utilized and followed in the event of a frac-out and/or a pressure decrease when drilling. Ensure the Contingency Plan is followed when remediating the issues of a frac-out and when notifying MDE. MDE should be notified in 24 hours when a frac-out has been found.

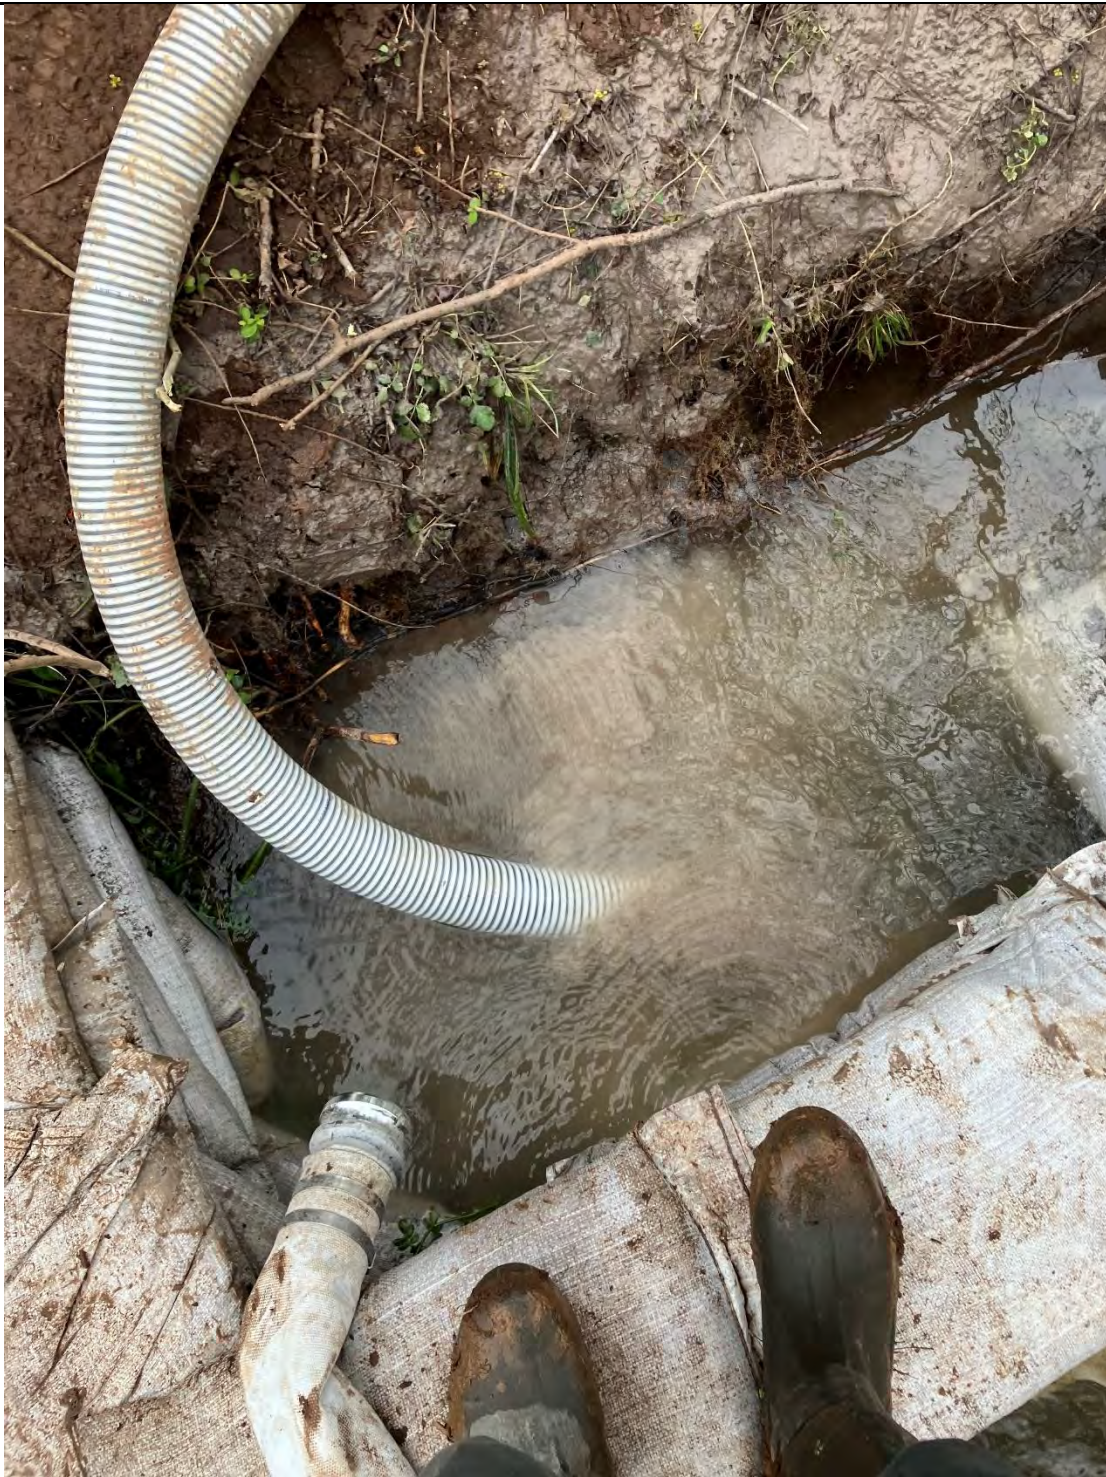
Figure D: Another frac-out was within the channel of a waterway (UT to Monocacy River, use class I-P waters), and the discharge point was located underwater; it was evident that there was sediment-laden water discharging into the waterway. A sandbag containment was set up within the waterway to contain the sediment-laden discharge and to pump out the discharge water to the abandoned borehole (where there was also frac-out discharge). Sediment (bentonite) pollution was found in the Waters of the State and remains in a condition likely to continue to pollute.

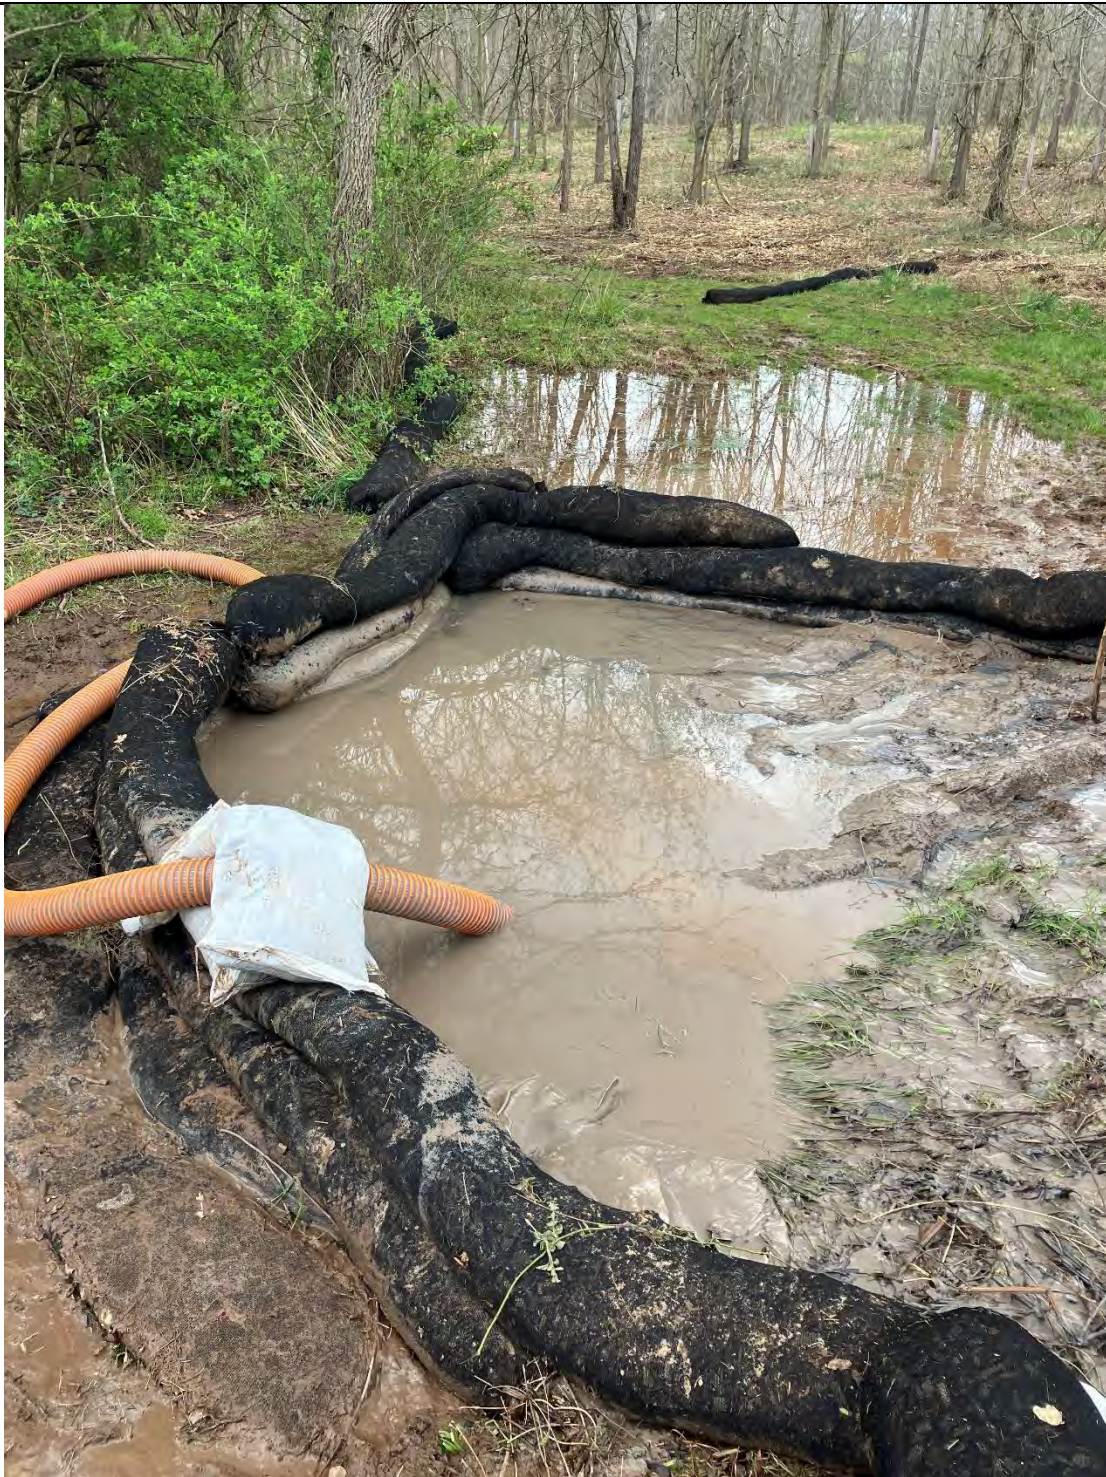
Figure E: The other frac-out was on the western side of the same waterway but the frac-out was on dry land and contained with filter logs; this frac-out was being pumped out. Sediment (bentonite) pollution was found in the Waters of the State and remains in a condition likely to continue to pollute.

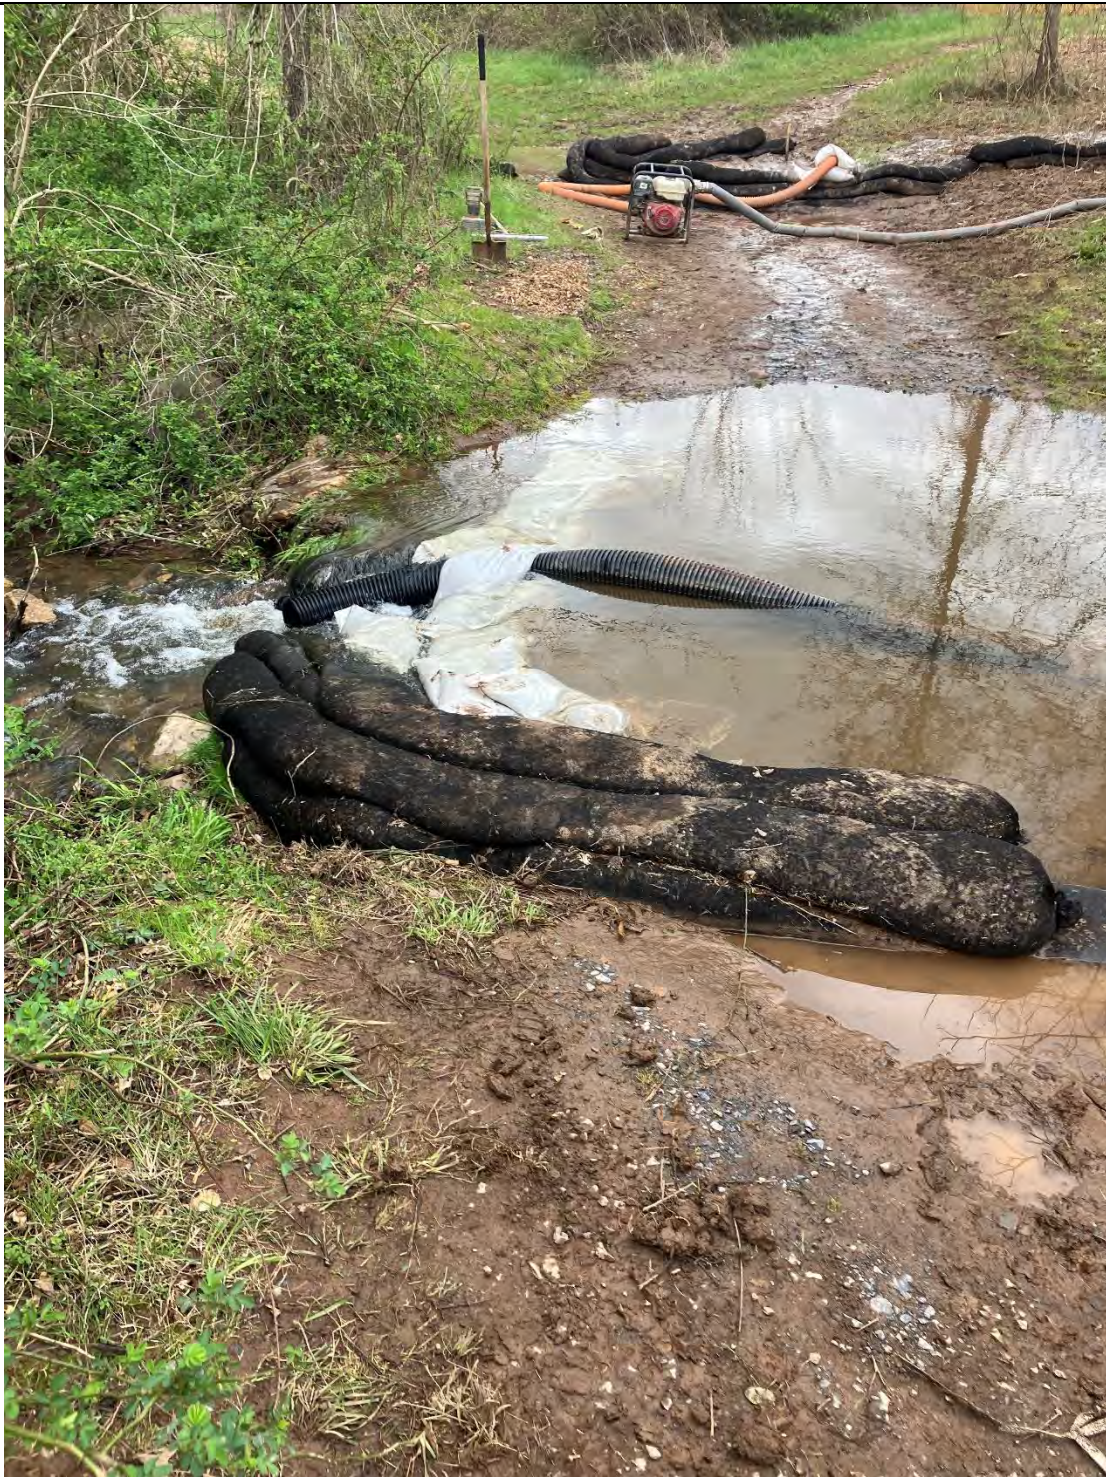
Figure F: The clear water diversion appeared to be discharging clear water and down stream of the frac-out locations were found to be clear during the time of the inspection.

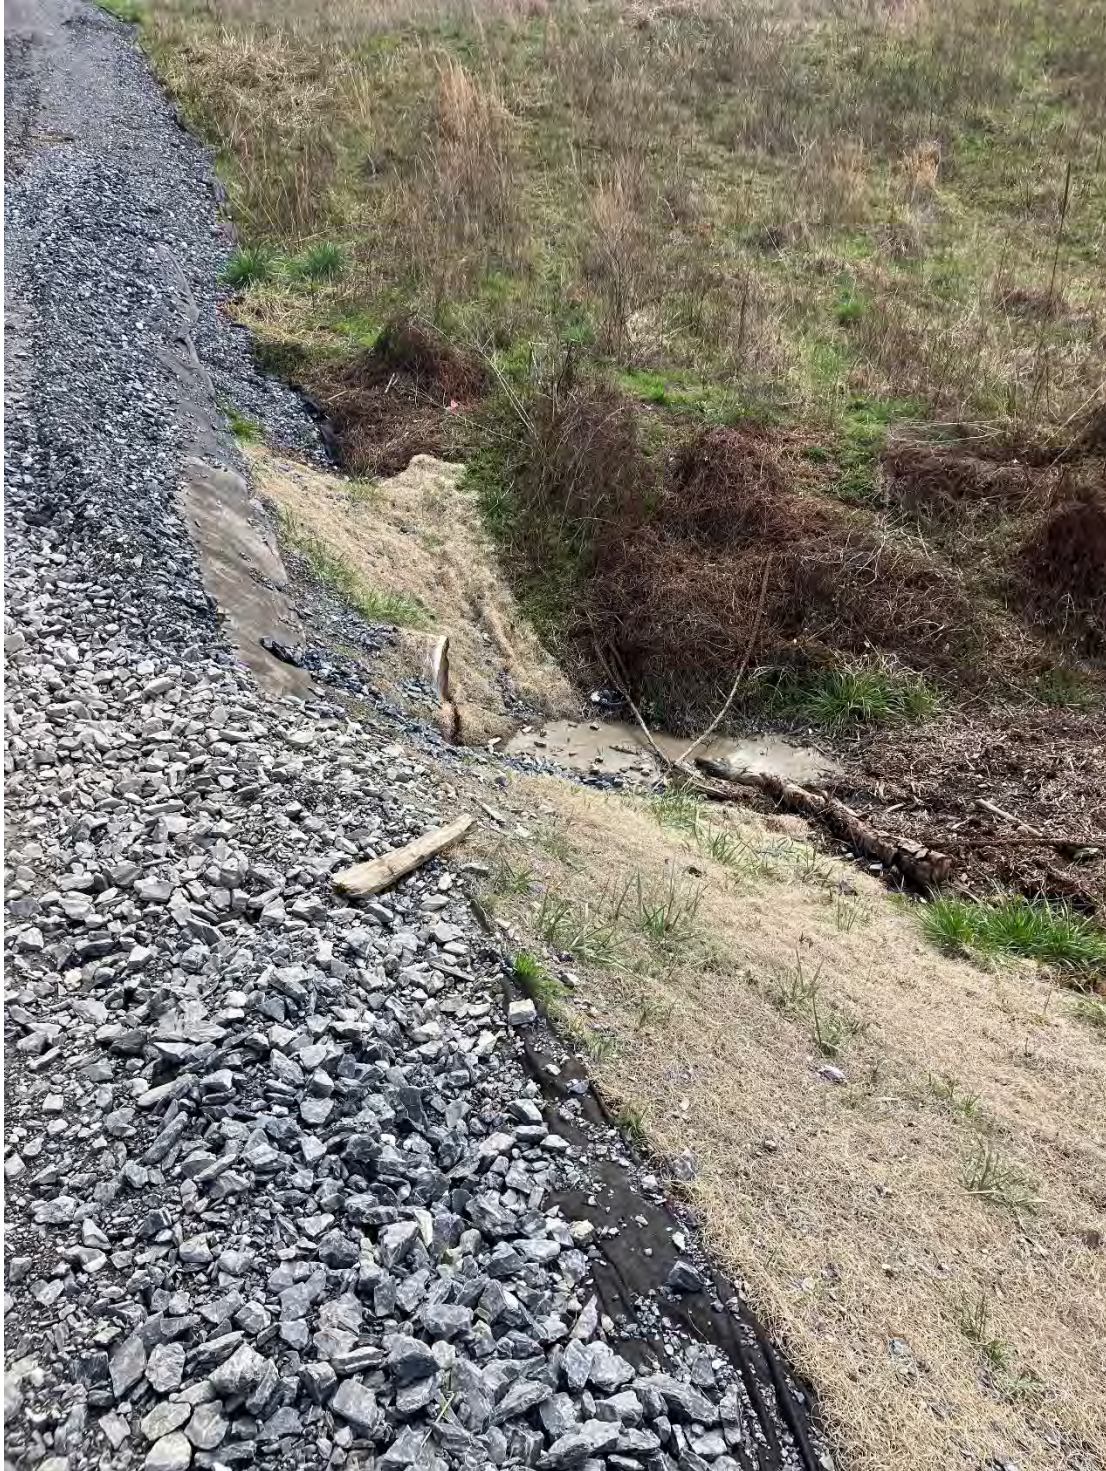
Figure A: There were issues found with a lack of sediment and erosion controls on the edge of the access road off of the Mouth of the Monocacy Road. Sediment pollution was noticed in the waterways (Waters of the State) that are crossed by the access road leading to the boring operation. Sediment pollution remains in a position likely to pollute the Waters of the State.

- 1) Matting was crushed in some locations and/or sinking. Waterways and wetlands that were crossed lacked adequate controls at the edge of the matting and road. Sediment pollution was observed and remains in a position likely to pollute the Waters of the State. // Where the matting crosses over-regulated wetland and/or waterway areas should have controls along the edge of the matting. Replace matting that is breaking and/or crushed from vehicle traffic. Double up matting when one segment of matting is sinking. Add sediment and erosion control along the edge of the access road (Segment 2) where regulated wetlands and waterways are crossed. Ensure all controls are installed as per the 2011 Maryland Standards and Specifications for Soil Erosion and Sediment Control.

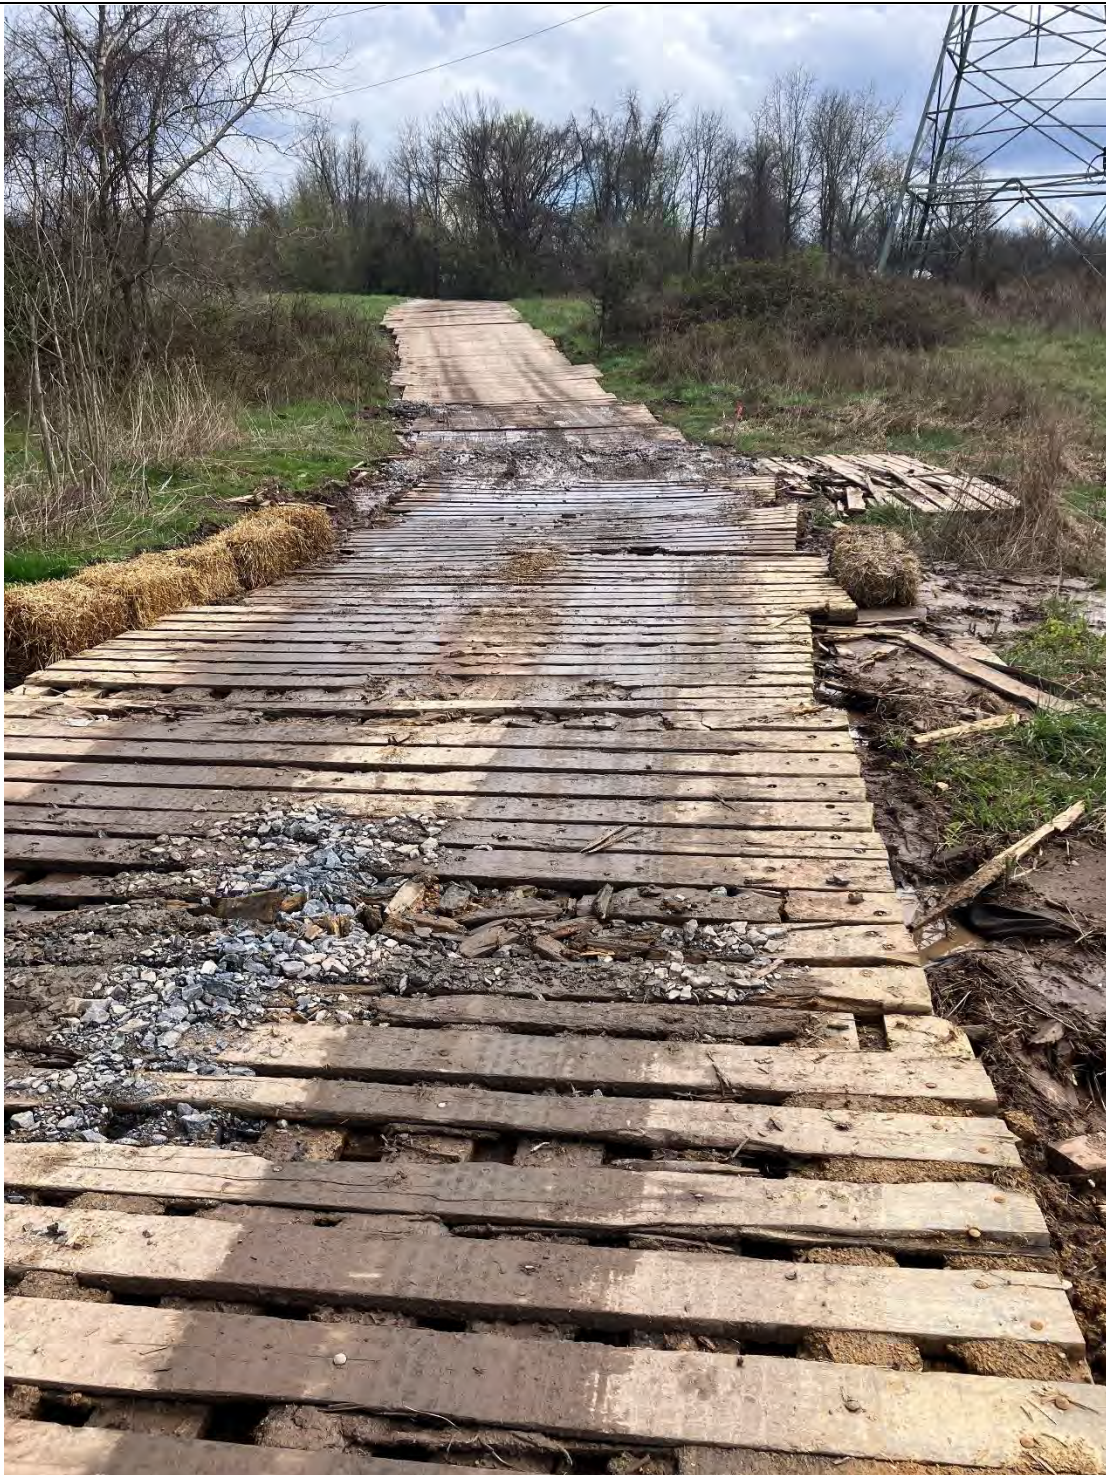
Figure B: There were issues found with the sediment and erosion controls on the access road off of the Mouth of the Monocacy Road. The matting was crushed in some locations and/or sinking. Crossed waterways and wetlands lacked adequate controls at the edge of the matting. Sediment pollution was noticed in the waterways (Waters of the State) that are crossed by the access road leading to the boring operation. Sediment pollution remains in a position likely to pollute the Waters of the State.

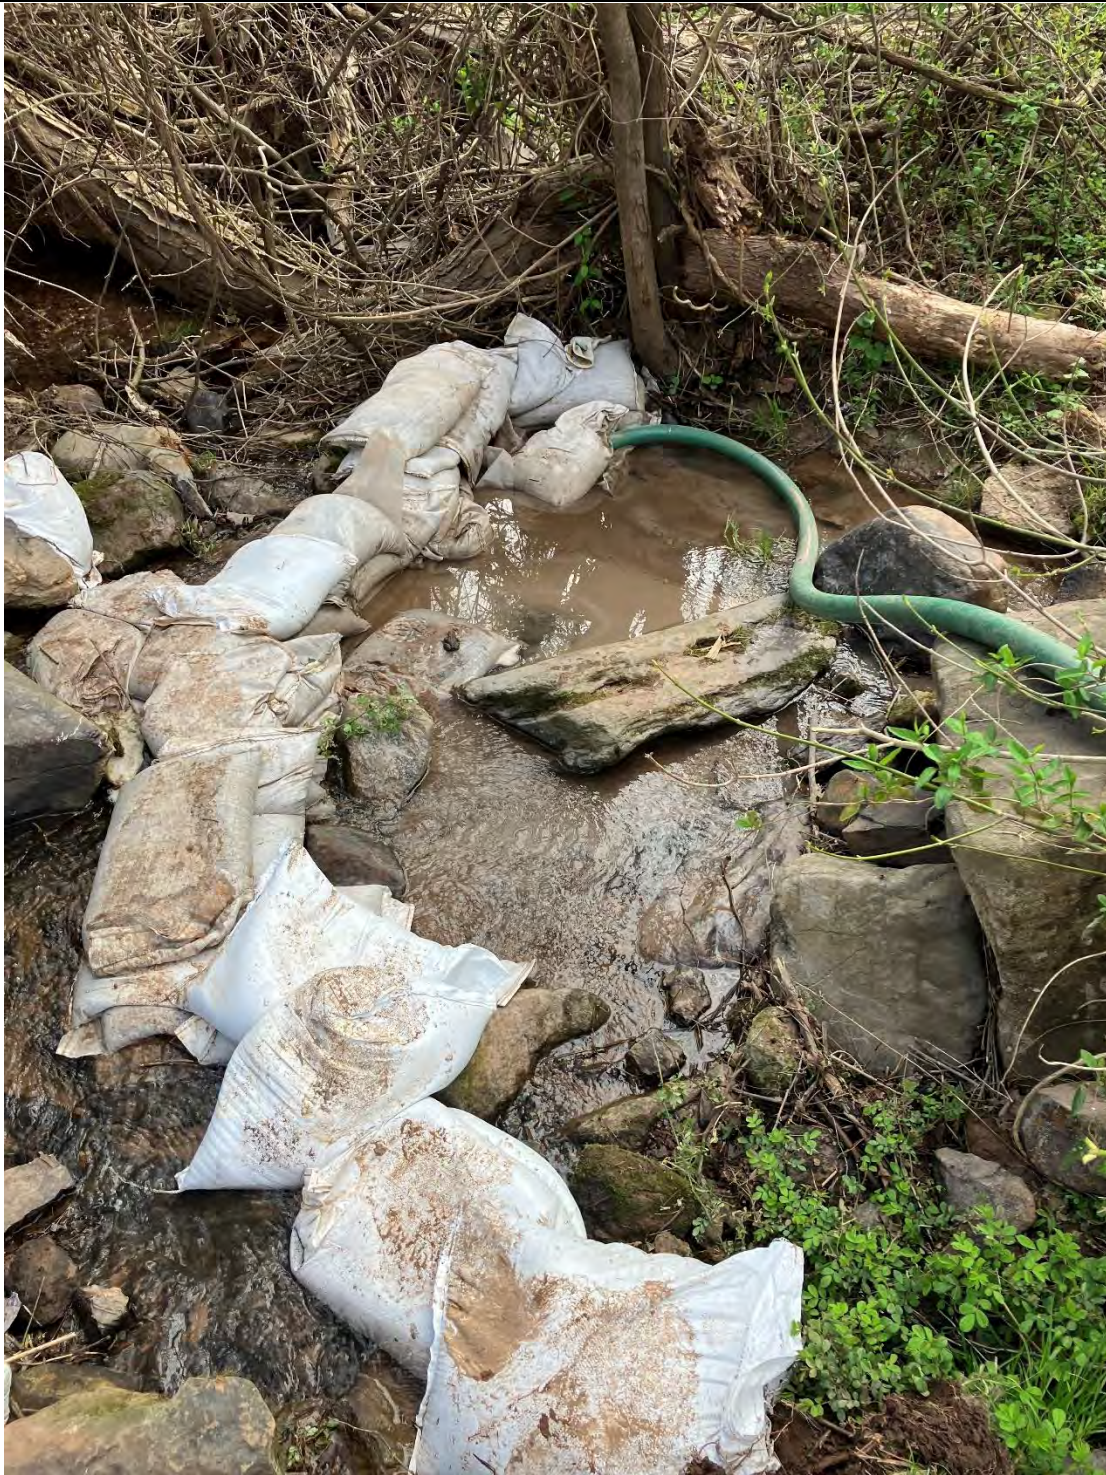
Figure C: There was another frac-out found within the channel of the waterway (UT to Monocacy River, use class I-P waters) just downstream where the farm stream crossing is located; there was sediment deposition deposited in the stream where the frac-out occurred. All of the frac-outs that occurred in the waterway (UT to Monocacy River, use class I-P waters) had sandbag containments around the discharge points. Sediment (bentonite) pollution was found in the Waters of the State and remains in a condition likely to continue to pollute.

- 2) There were several documented frac-outs found outside of the LOD and it was evident that sediment (bentonite) pollution had entered the Waters of the State. Sediment (bentonite) pollution also remains in a position likely to pollute the Waters of the State. // Deposited sediment (bentonite) should be pumped out where it is deposited behind sandbags or filter logs. Stabilize the stream bank with seed (native floodplain mix) and straw once all emergency work has been completed around the impacted waterway and floodplain. Ensure

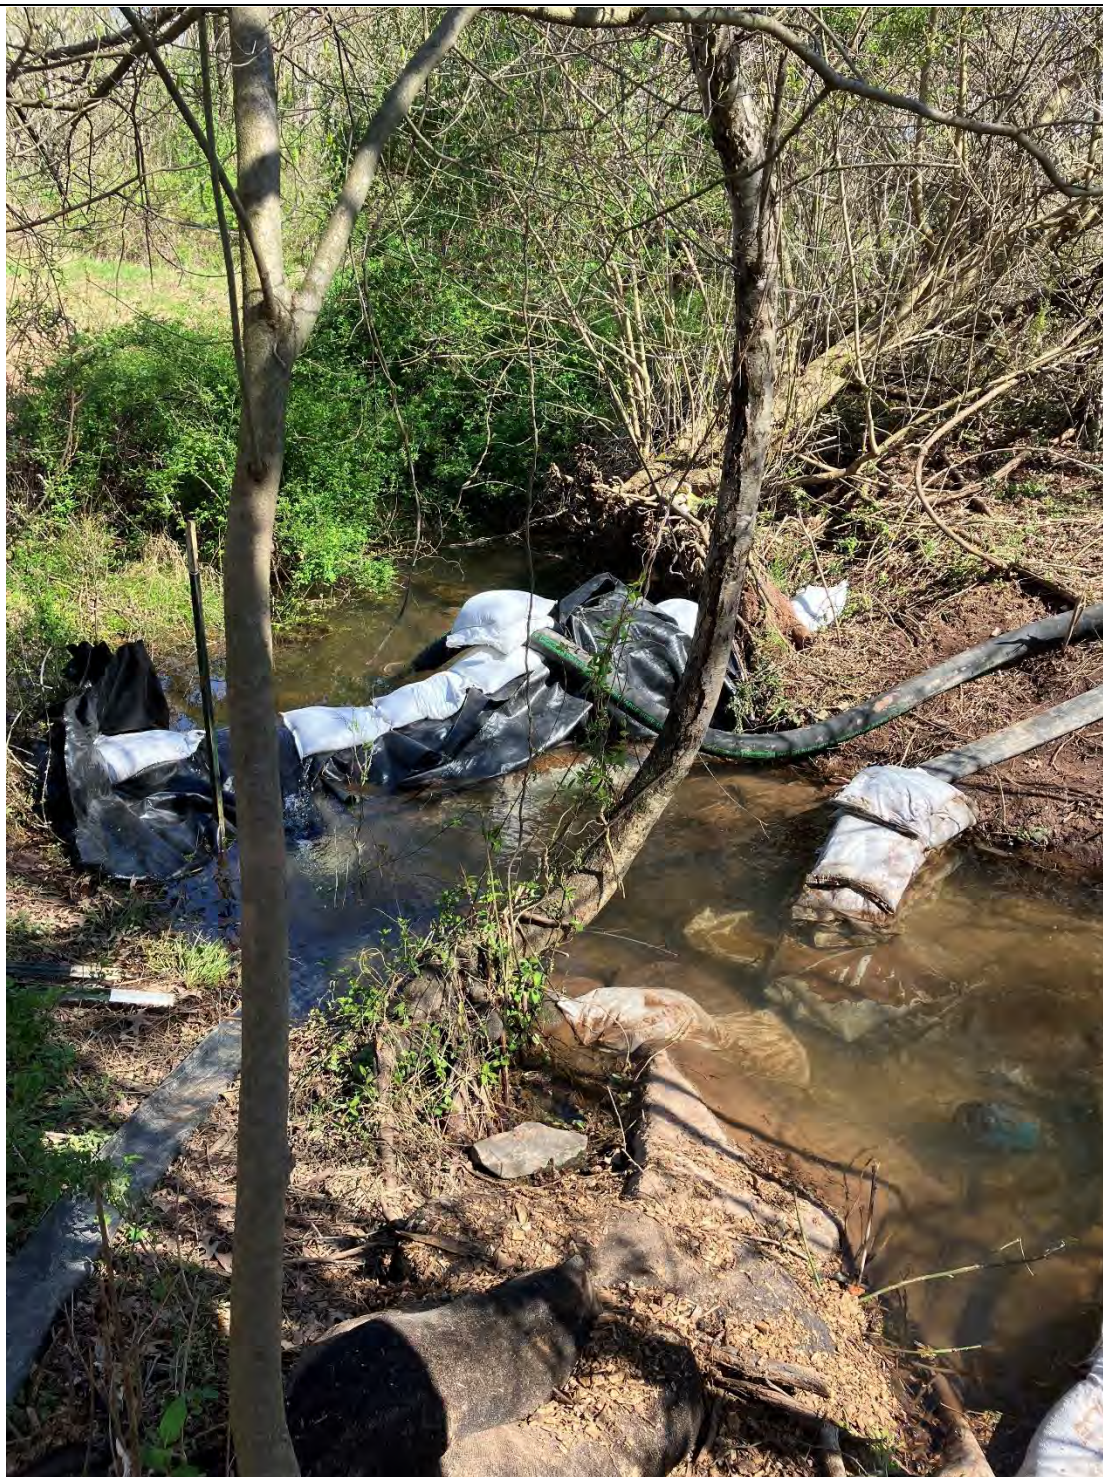
Figure D: Another frac-out was within the channel of a waterway (UT to Monocacy River, use class I-P waters), and the discharge point was located underwater on the stream bank. All of the frac-outs that occurred in the waterway (UT to Monocacy River, use class I-P waters) had sandbag containments around the discharge points; the containment was utilized to help to isolate and pump out the sediment-laden discharge water. Sediment (bentonite) pollution was found in the Waters of the State and remains in a condition likely to continue to pollute.

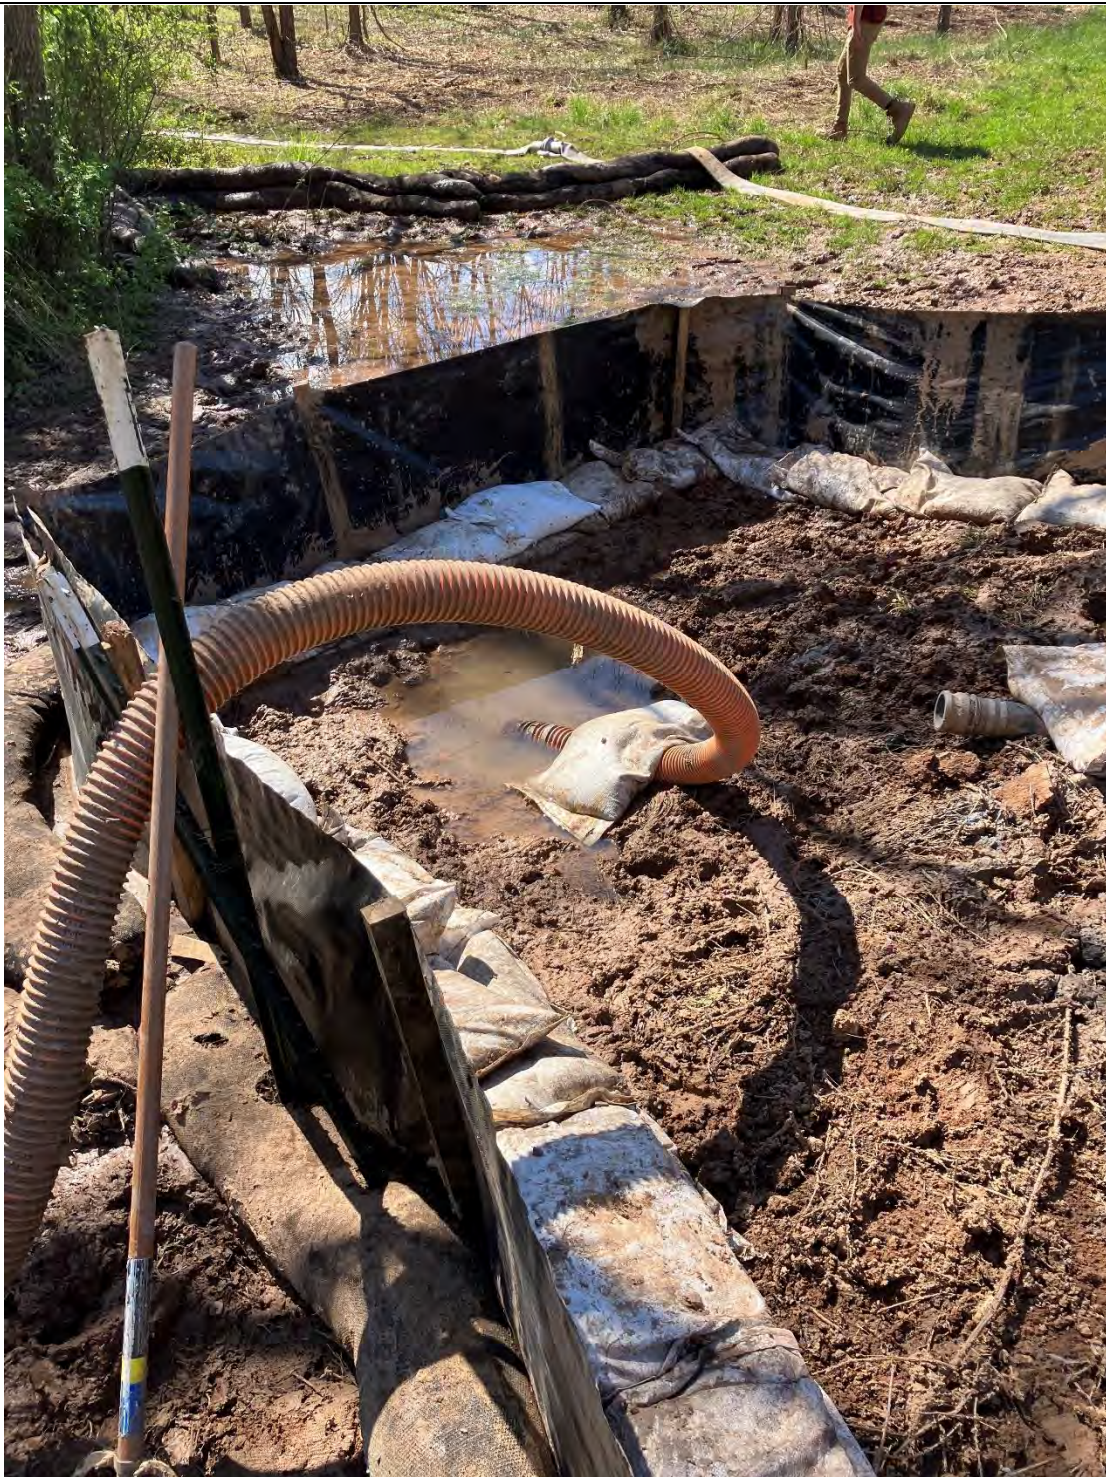
Figure E: There was a frac-out on the western side of the waterway (UT to Monocacy River, use class I-P waters), this frac-out was on dry land and contained with filter logs, sandbags, and silt fence. Sediment (bentonite) pollution was found in the Waters of the State and remains in a condition likely to continue to pollute. There was substantial sediment (bentonite) pollution downstream of where the frac-outs were located.

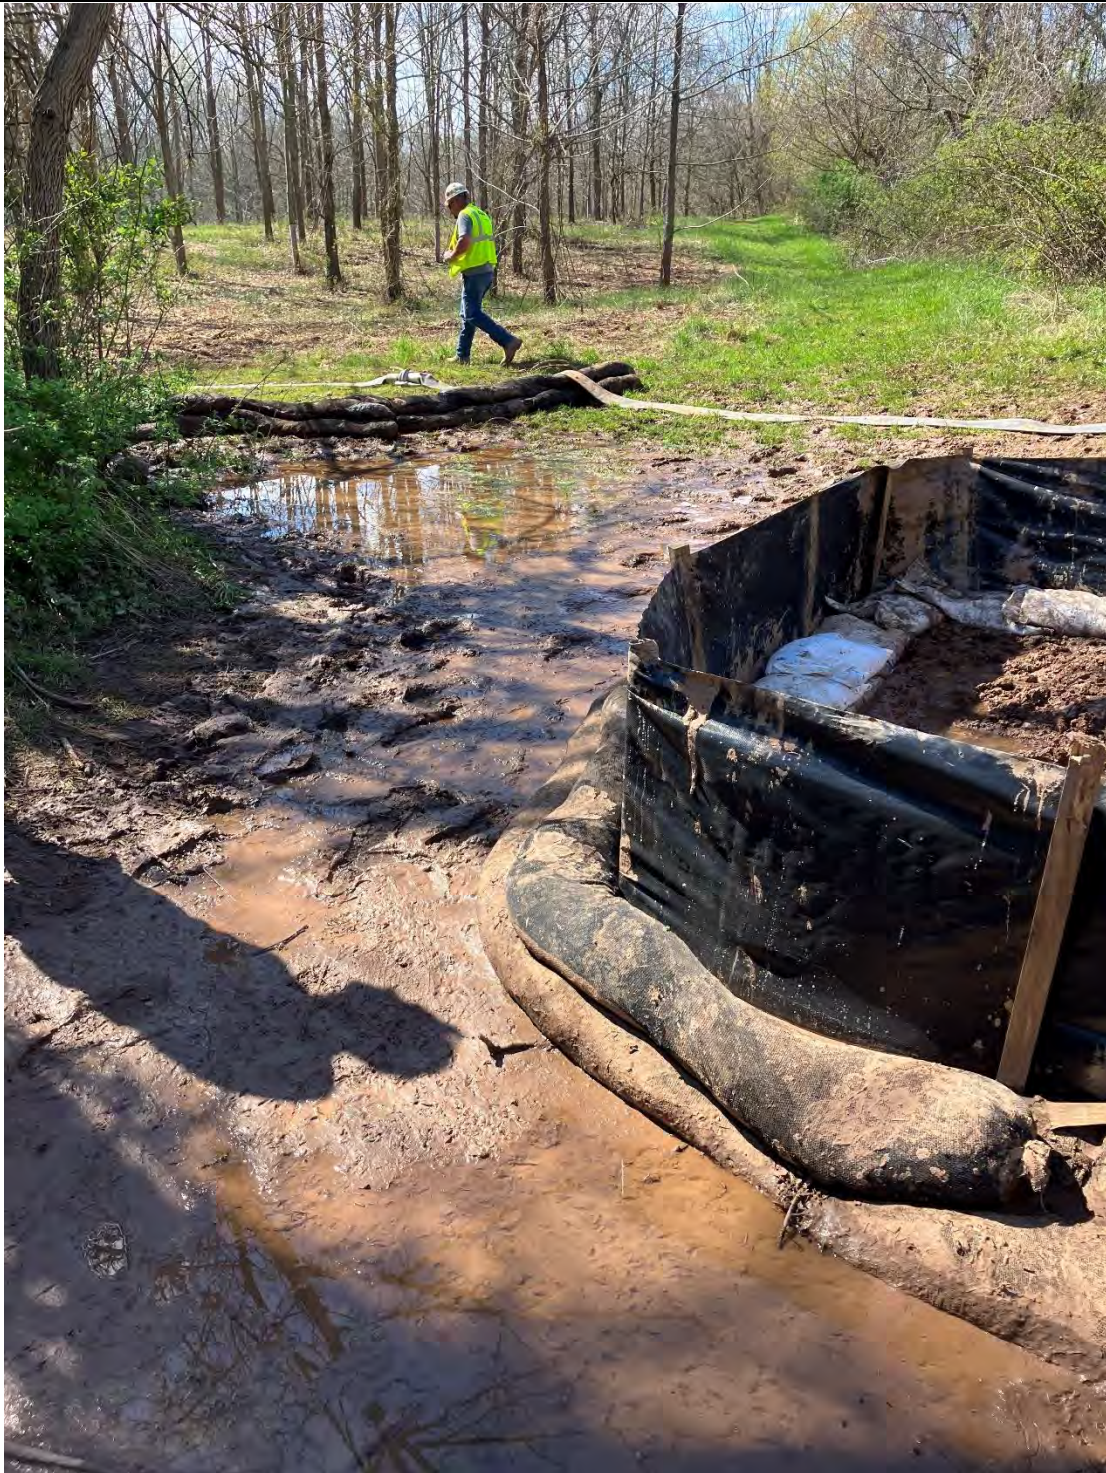
Figure F: Outside of the frac-out documented in Figure E there was sediment (bentonite) deposition. Sediment pollution was found in the Waters of the State and remains in a condition likely to continue to pollute. There was substantial sediment (bentonite) pollution downstream of where the frac-outs were located.
