Maryland Department of Environment
Water and Science Administration
Compliance Program
1800 Washington Blvd, Suite 420
Baltimore, MD 21230-1719
410- 537-3510, 1-800-633-6101

Inspector: Jacob Haglund
AI ID: 172623
Site Name: QLoop LLC - Sage Fiber (Segment 4)
Facility Address: Potomac Edison Row, 39.249374 -77.483653, Fisher Avenue, Poolesville, MD 20842
County: Montgomery County
Start Date/Time: April 04, 2024 11:30 AM
End Date /Time: April 04, 2024 04:00 PM
Media Type(s): NPDES Construction Activity, Nontidal Wetlands, Waterway Construction
Contact(s):

Inspection Date: April 04, 2024
Site Name: QLoop LLC - Sage Fiber
Facility Address: Potomac Edison Row, 39.249374 -77.483653, Fisher Avenue, Poolesville, MD 20842

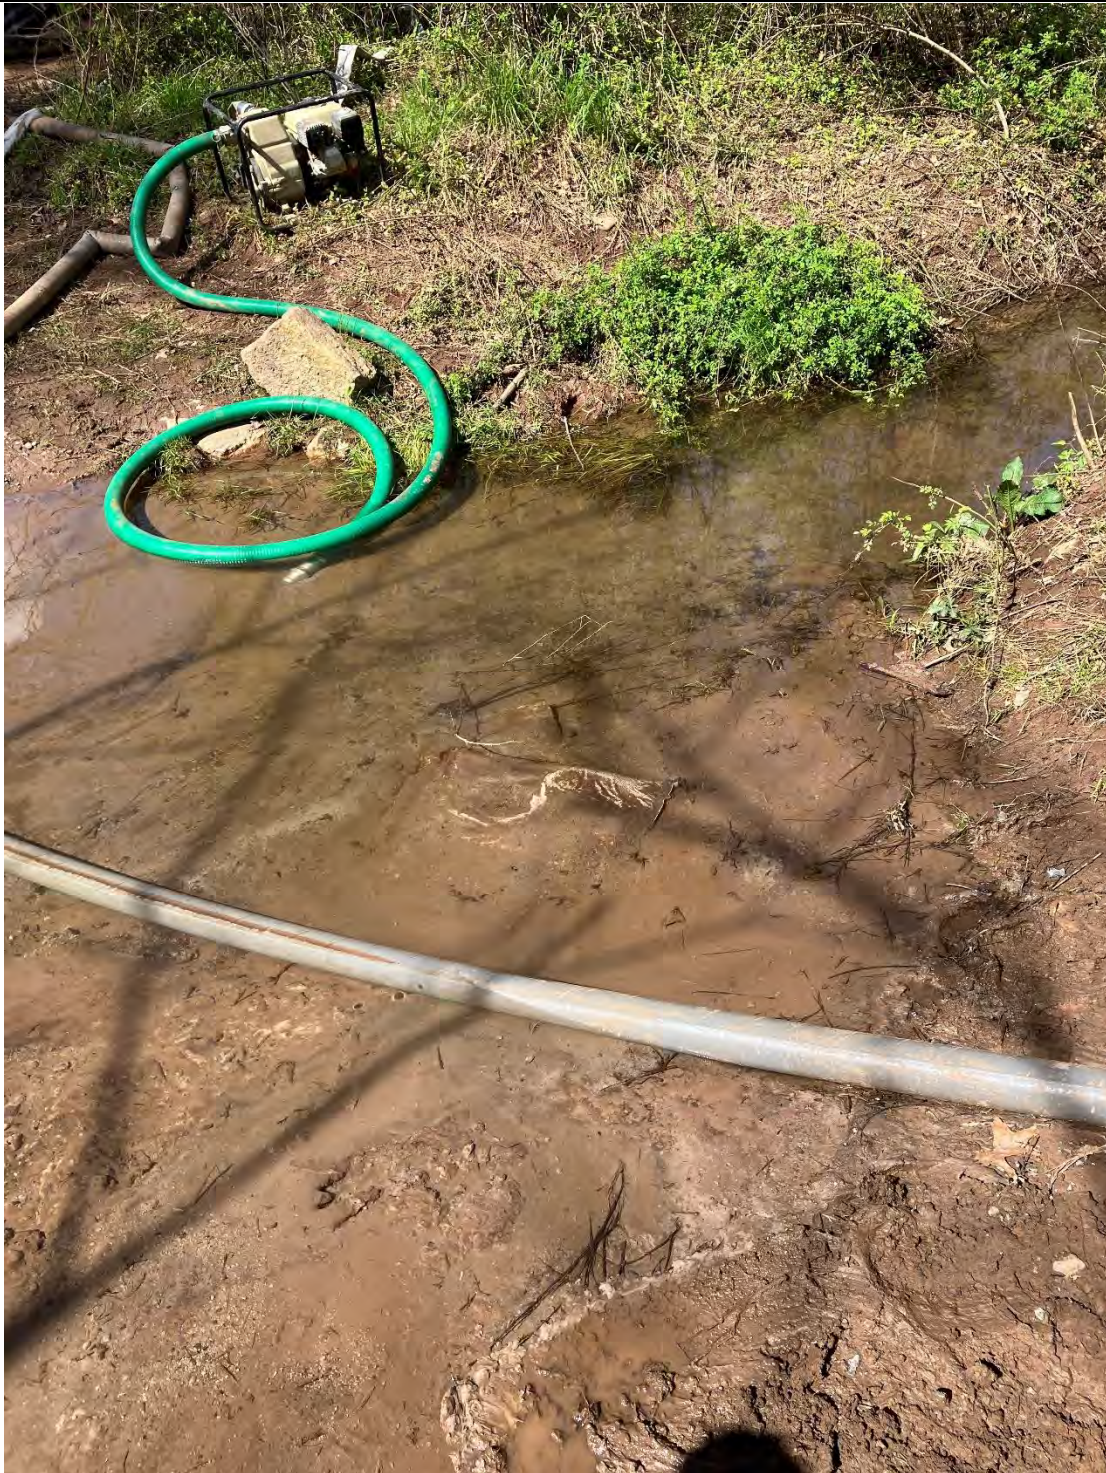
Figure G: Sediment pollution was found in the Waters of the State where the farm waterway crossing is located. There was substantial sediment (bentonite) pollution downstream of where the frac-outs were located.

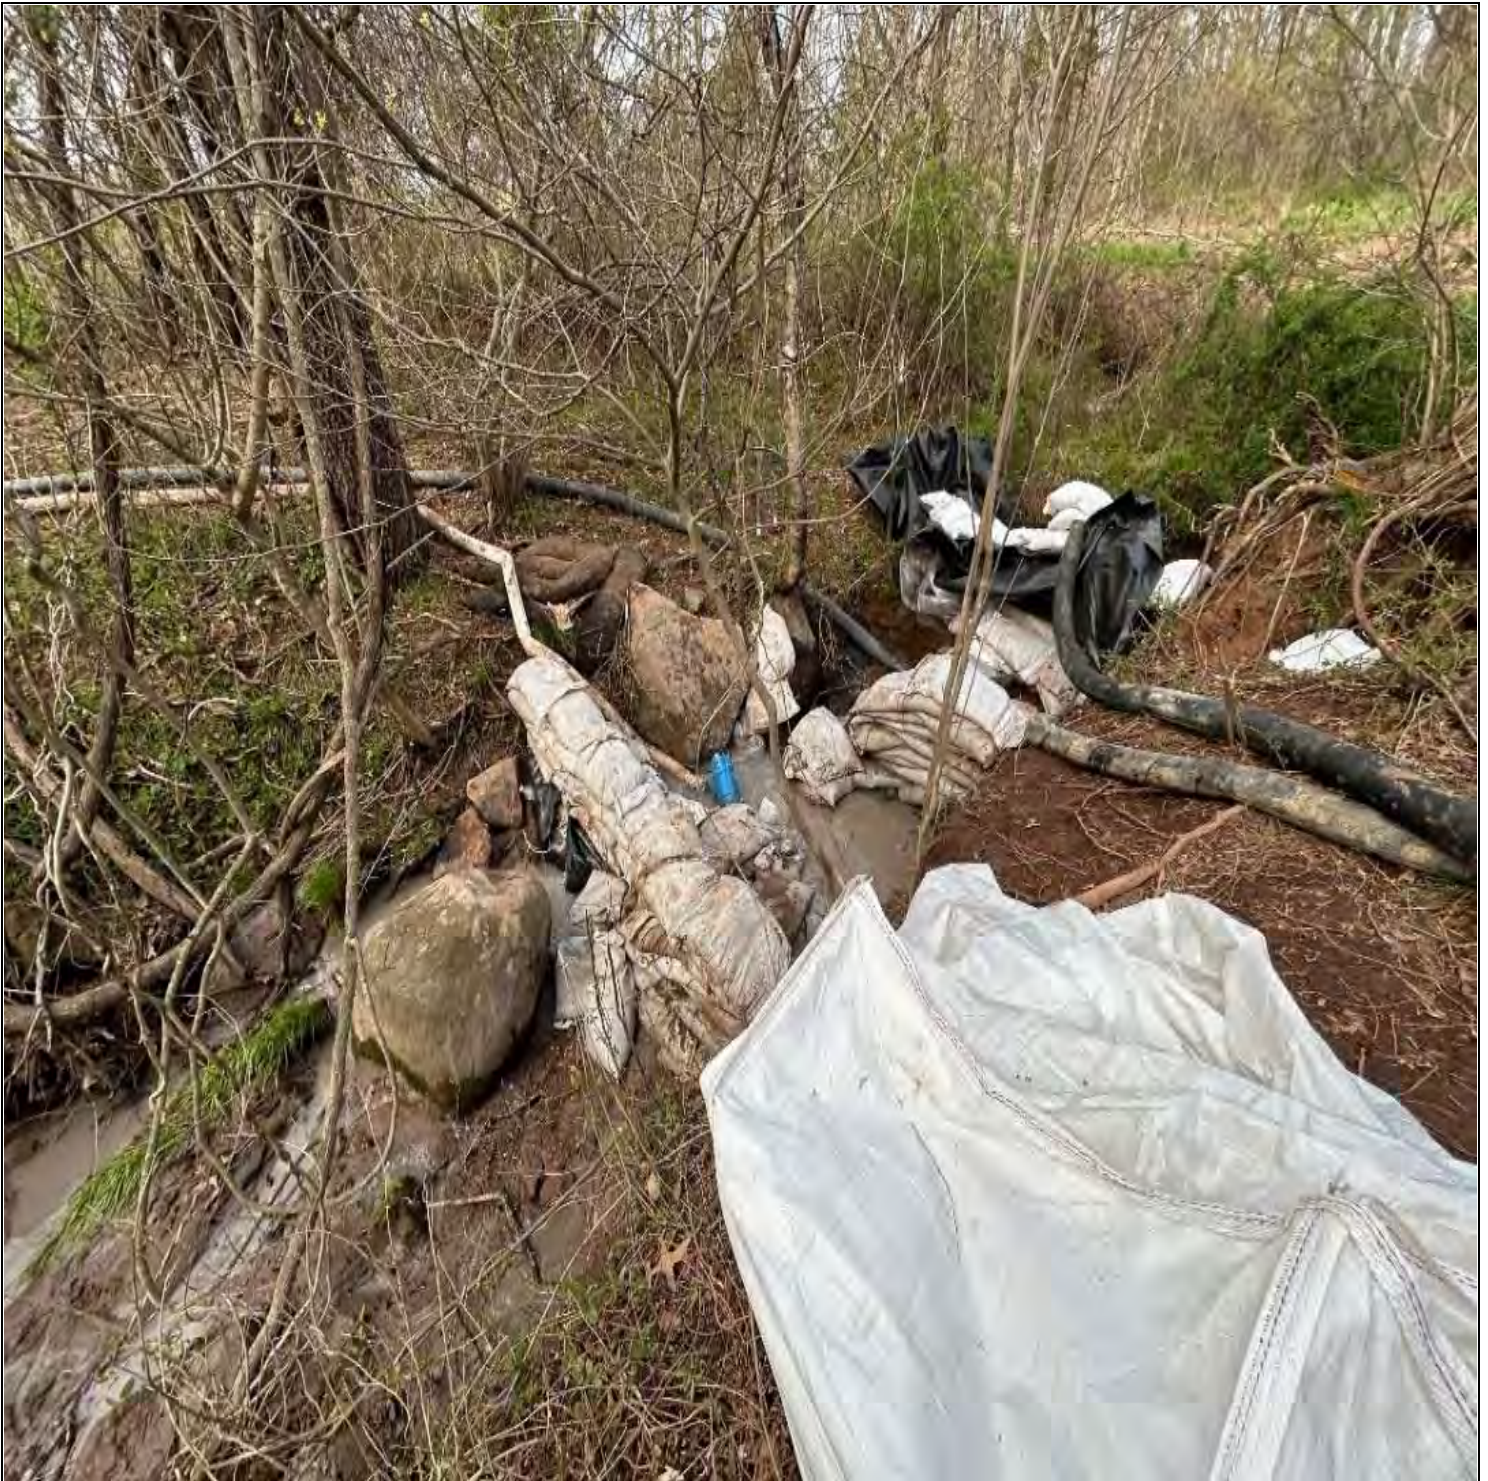
Figure H: "Origin/pumping area of tributary and the site of the bentonite discharge. Upstream is clearwater flow." The photo was taken on 04/08/2024 by Douglas Cochran with Frederick County Government.

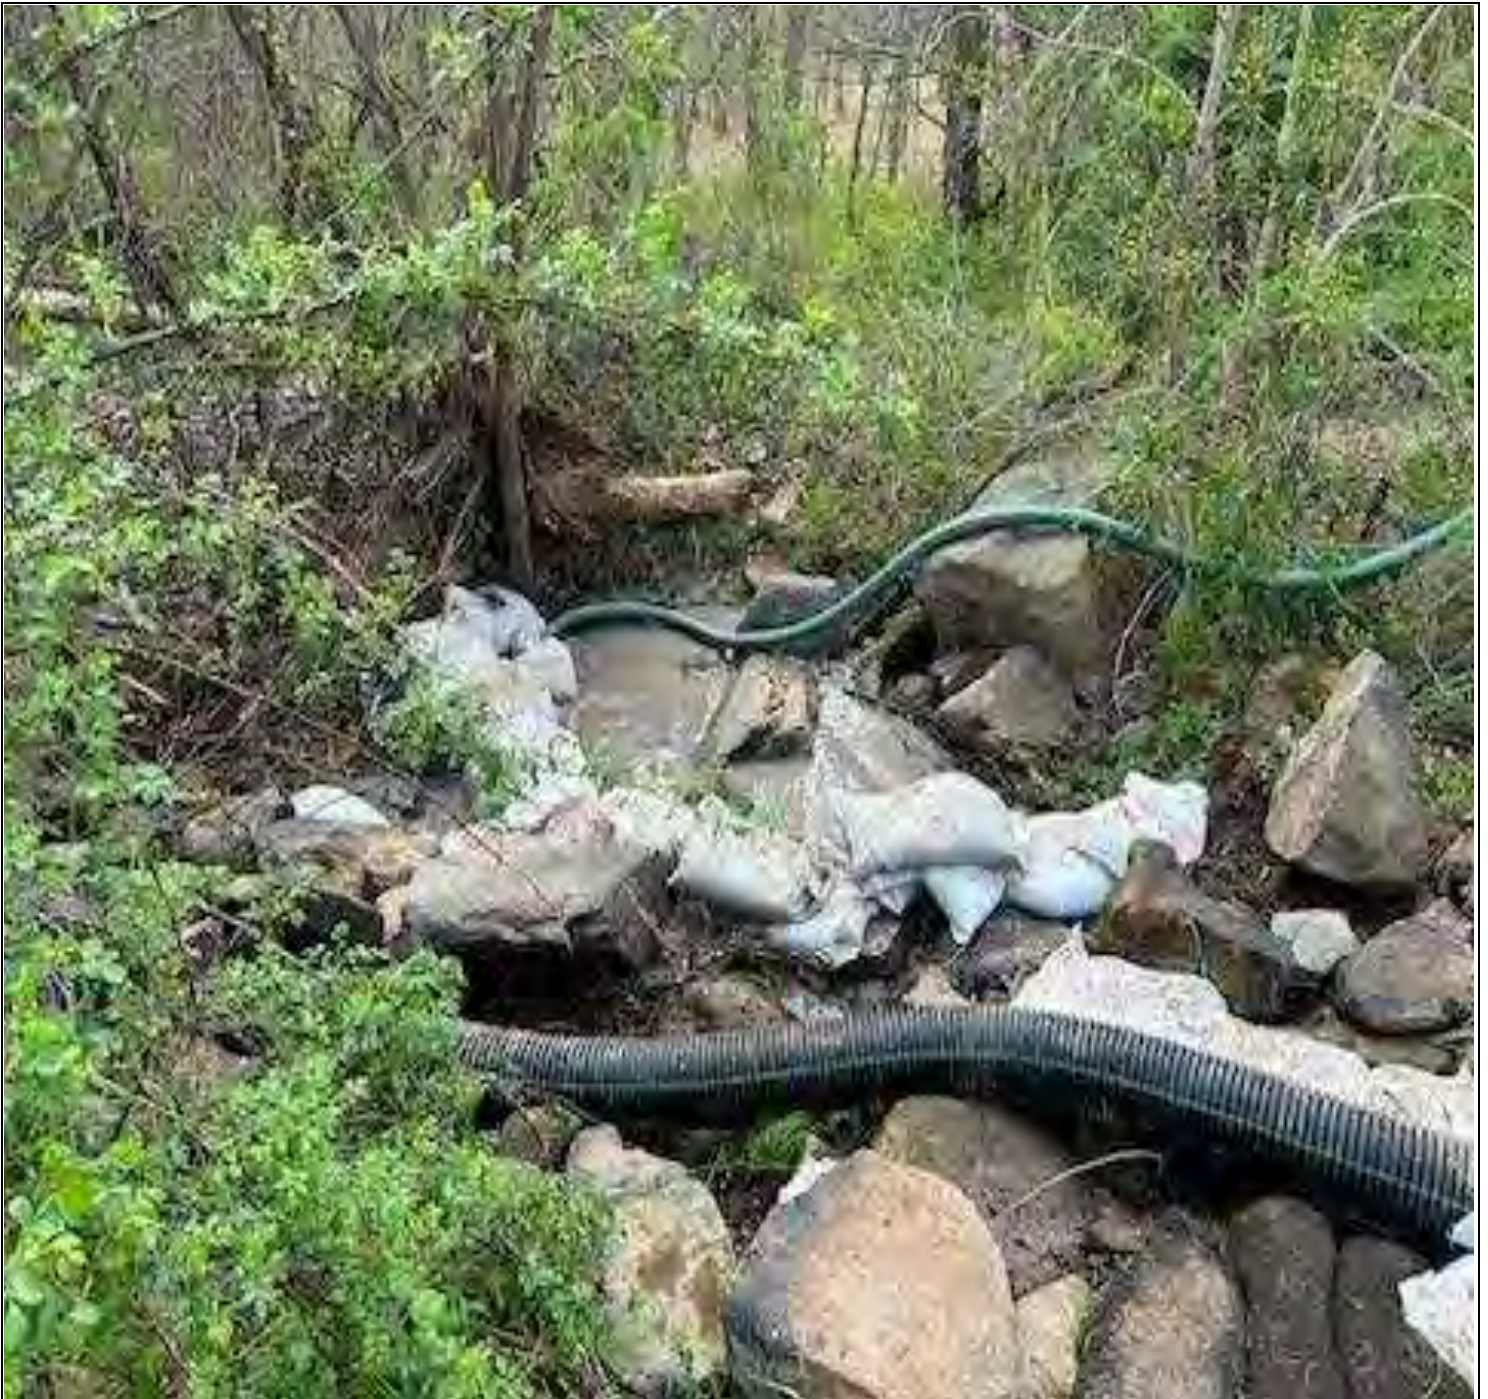
Figure 1: "Bentonite mud and drilling fluid present further downstream." The photo was taken on 04/08/2024 by Douglas Cochran with Frederick County Government.

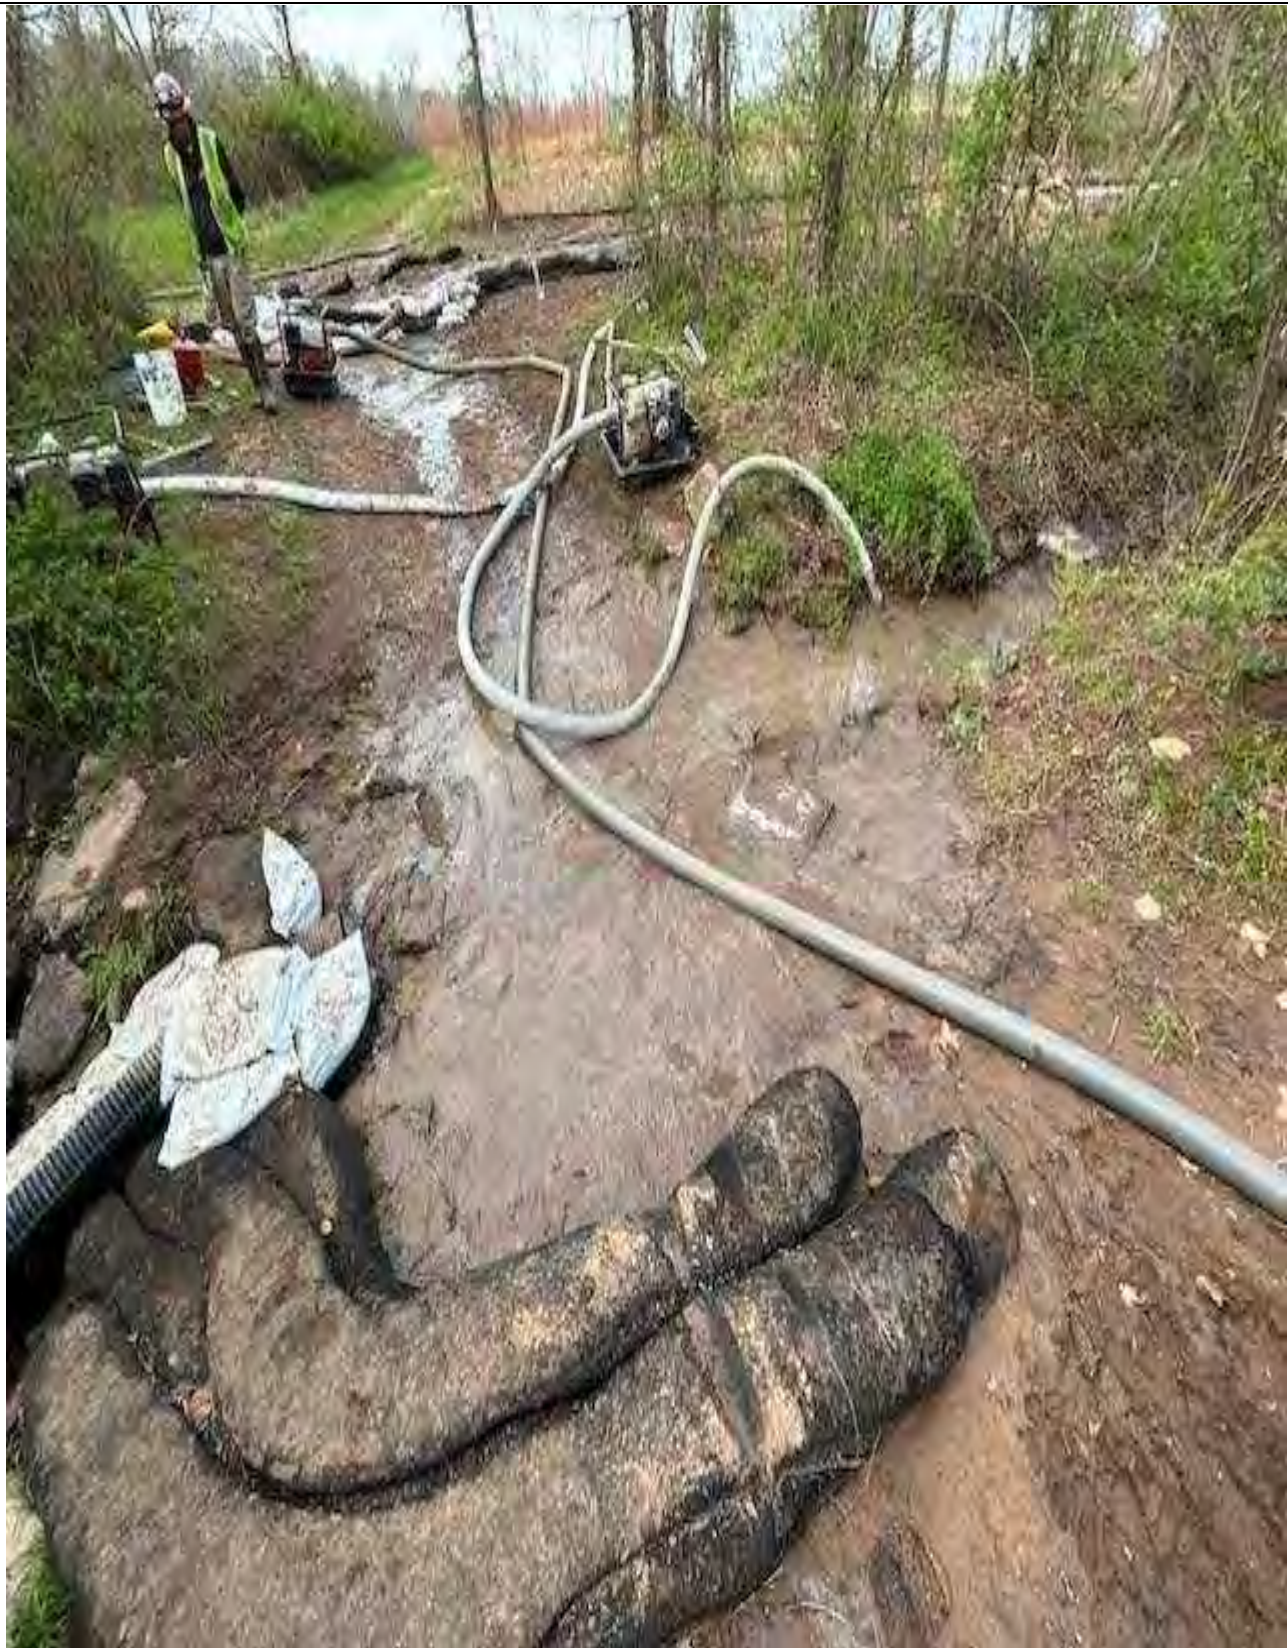
Figure J: "Pumping and dam area downstream. Dewatering pools present in the distance." The photo was taken on 04/08/2024 by Douglas Cochran with Frederick County Government.

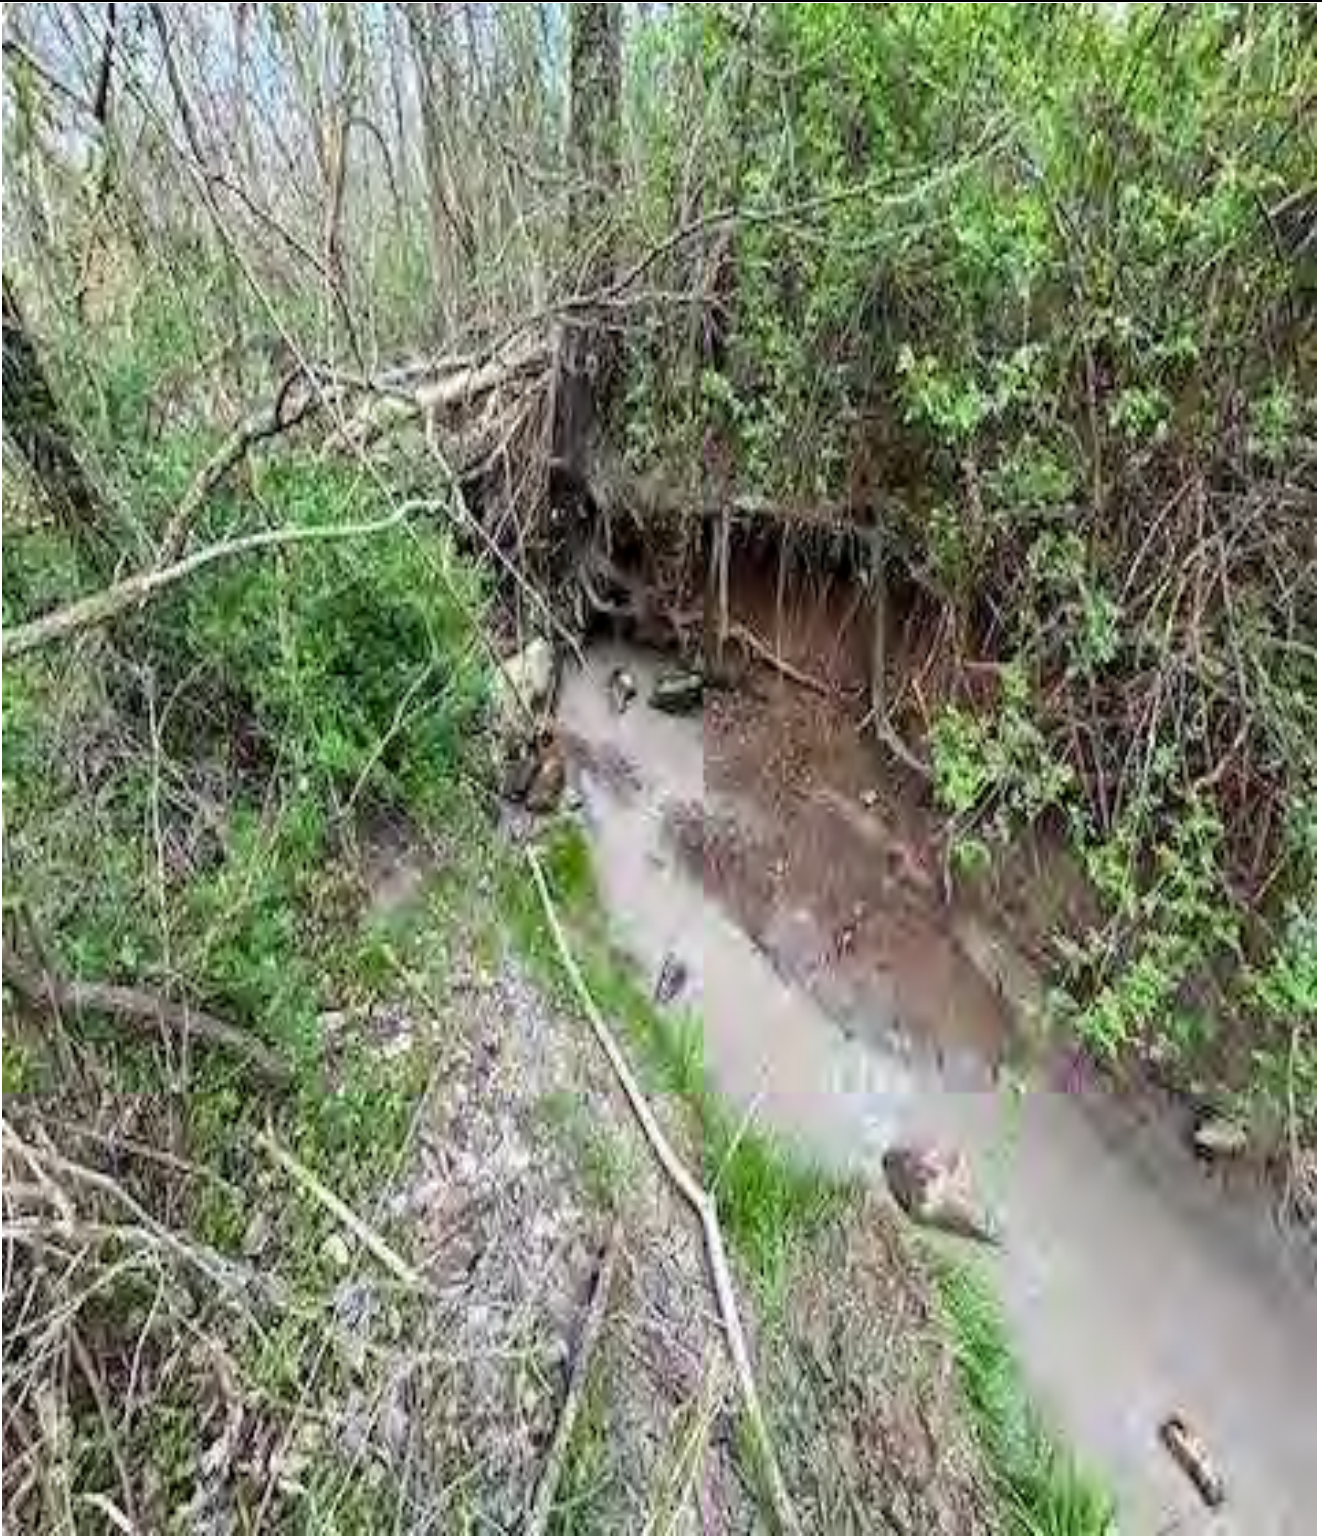
Figure K: "Bentonite mud and drilling fluid downstream of the initial discharge area." The photo was taken on 04/08/2024 by Douglas Cochran with Frederick County Government.

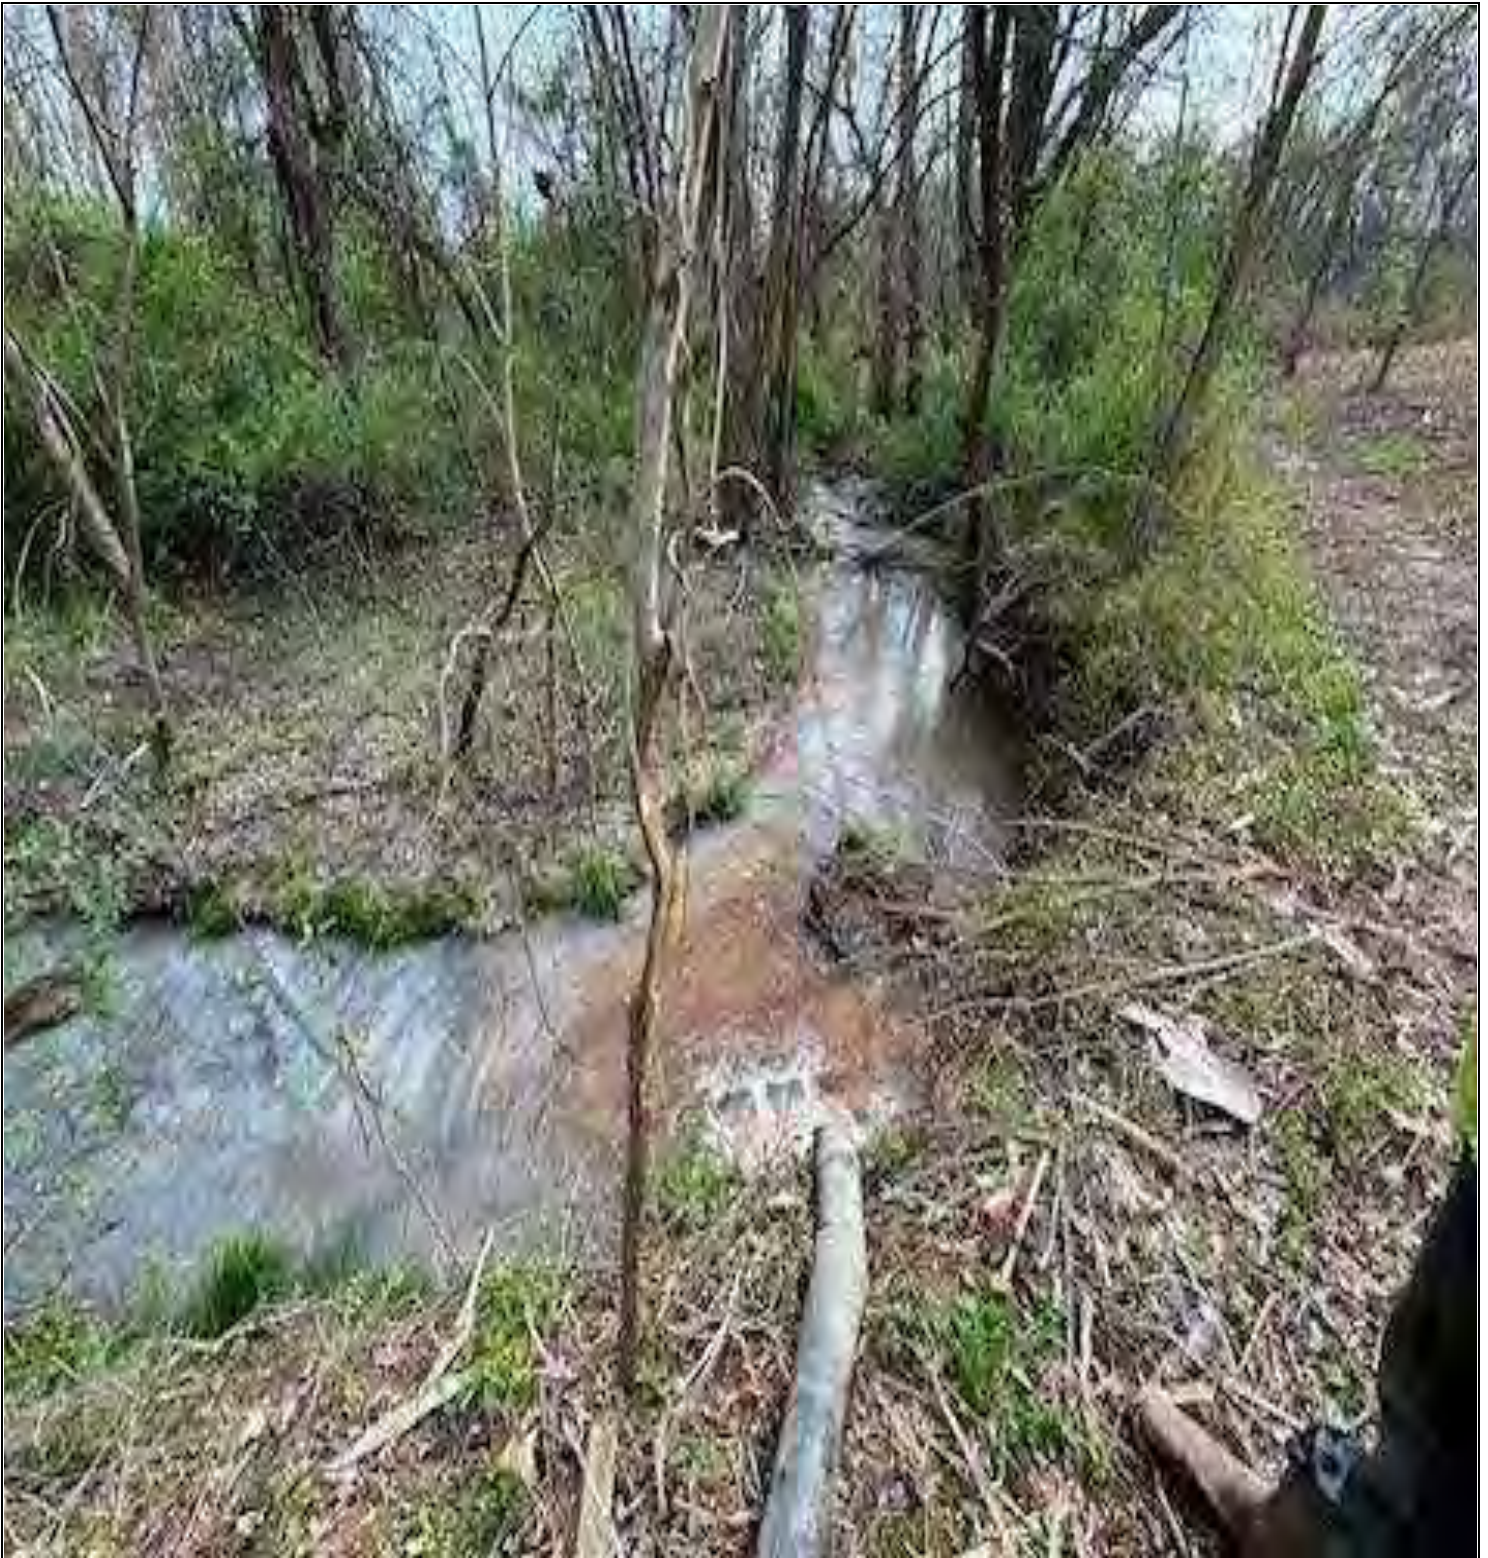
Figure L: "Clearwater pump around discharge to turbid streamflow downstream of containment area." The photo was taken on 04/08/2024 by Douglas Cochran with Frederick County Government.

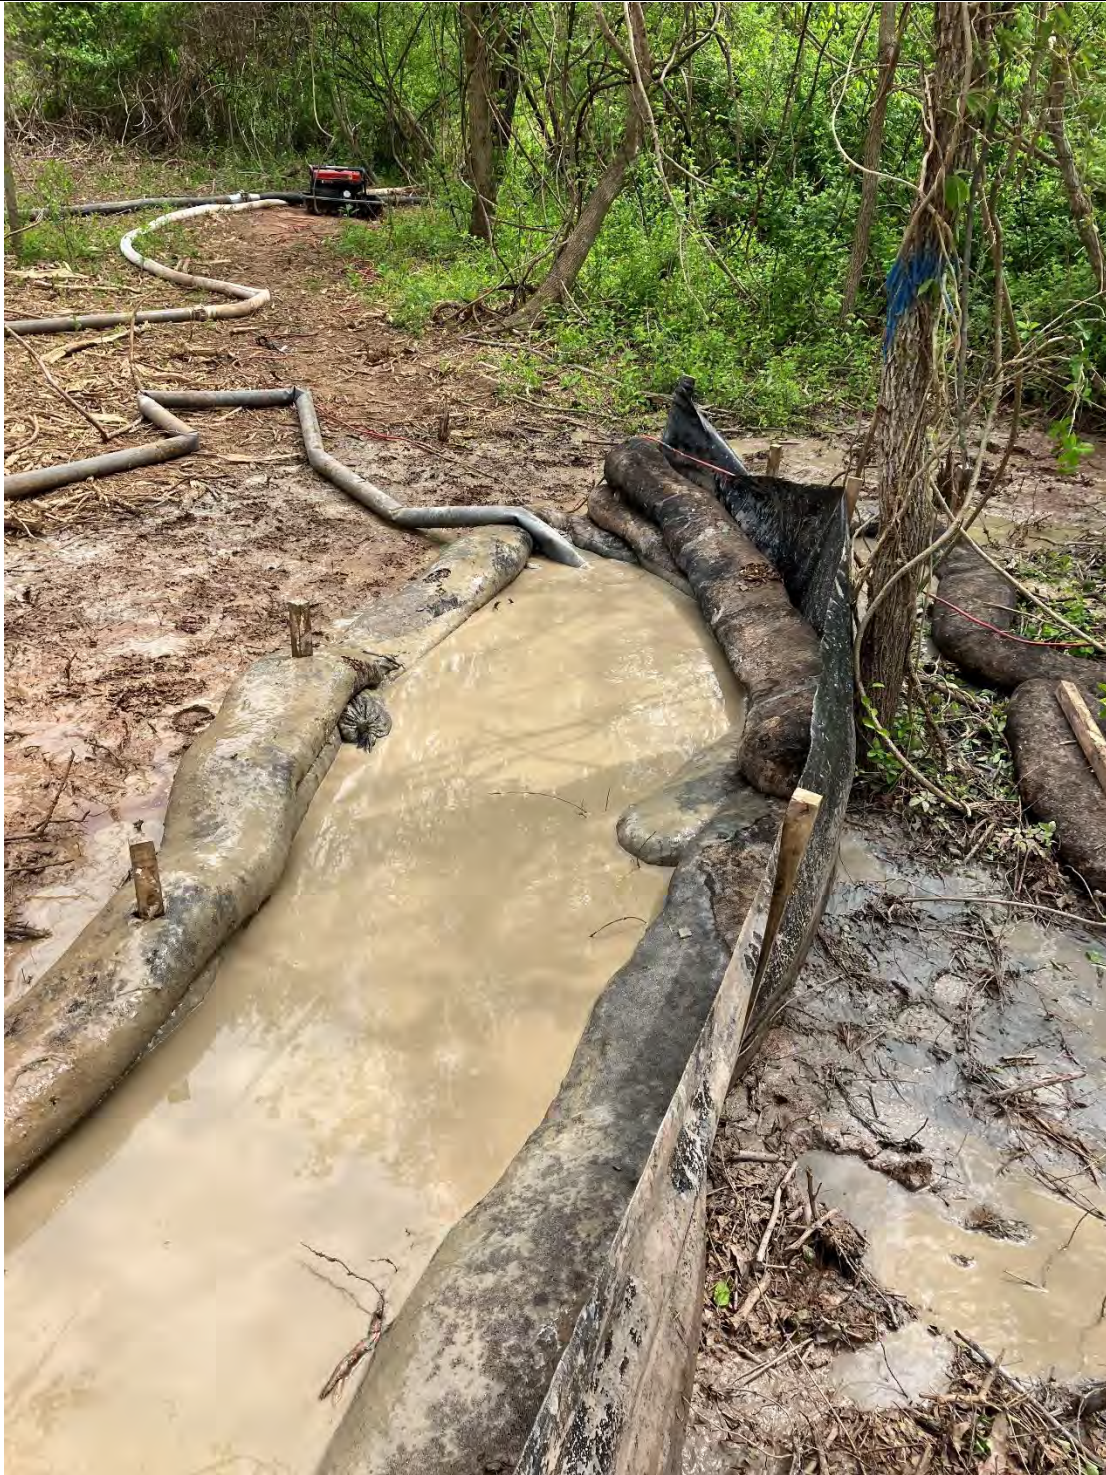
Figure A: One of the undocumented frac-outs was found by the documented (in the 04/10/2024 MDE inspection report) frac-out on the western side of the waterway (UT to Monocacy River, use class I-P waters), on dry land. This frac-out is located at Segment 2. Sediment (bentonite) pollution is occurring in the Waters of the State but is contained at a downstream point.

- 1) There were several frac-outs found outside of the LOD and it was evident that sediment (bentonite) pollution had entered the Waters of the State. Two of these frac-outs have not been reported to MDE by a representative for QLoop but rather discovered on this date of inspection. One of the undocumented frac-outs was found by the documented (in the 04/10/2024 MDE inspection report) frac-out on the western side of the waterway (UT to Monocacy River, use class I-P waters), on dry land. The other undocumented frac-out was within the stream (UT to Monocacy River, use class I-P waters) channel just downstream of the documented (in the 04/10/2024 MDE inspection report) frac-out that was contained with sandbags around the discharge point. Sediment (bentonite) pollution also remains in a position likely to pollute the Waters of the State. // Deposited sediment (bentonite) should be pumped out where it is deposited behind sandbags or filter logs. Each frac-out location should be separately contained, isolated with controls, and pumped out. All deposited sediment (bentonite) downstream of the frac-out locations should be pumped out the of waterway (UT to Monocacy River, use class I-P waters). Stabilize the stream bank with seed (native floodplain mix) and straw once all emergency work has been completed around the impacted waterway and floodplain. Ensure that the outfall pipe for the pump around is secured so that the pipe end will not vibrate and cause disturbance on the stream bank.

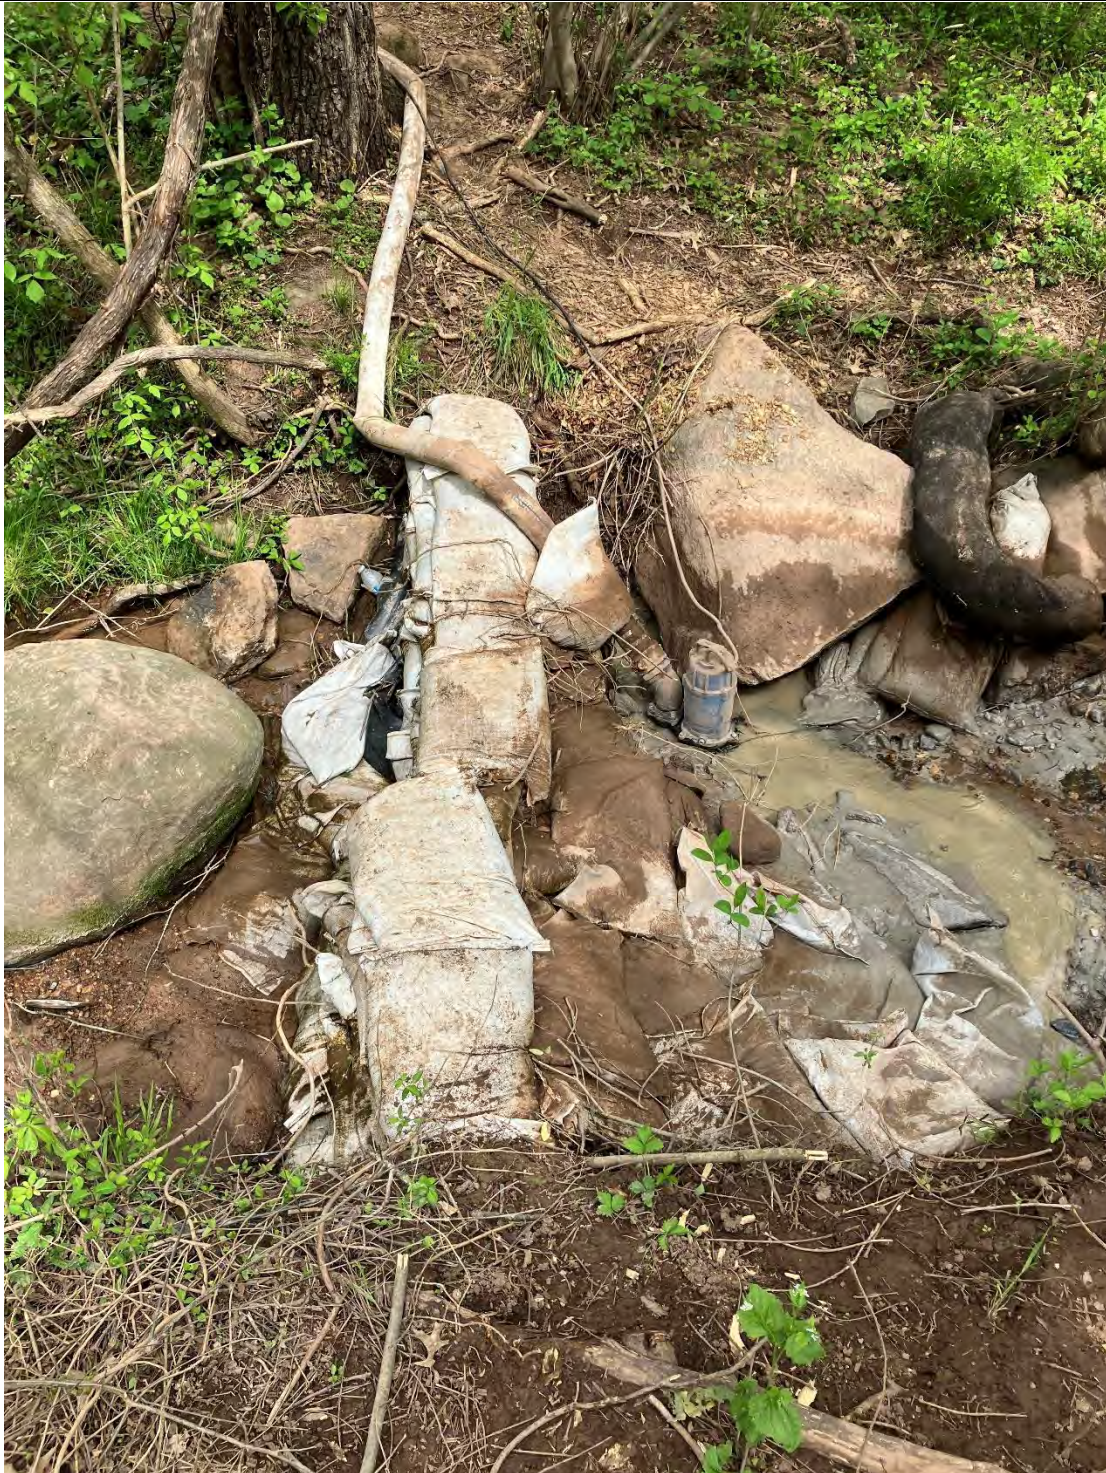
Figure B: The furthest upstream (UT to Monocacy River, use class I-P waters) frac-out is contained and previously documented. This frac-out is located at Segment 2. Sediment (bentonite) pollution is occurring in the Waters of the State but is contained in a portion of the waterway.

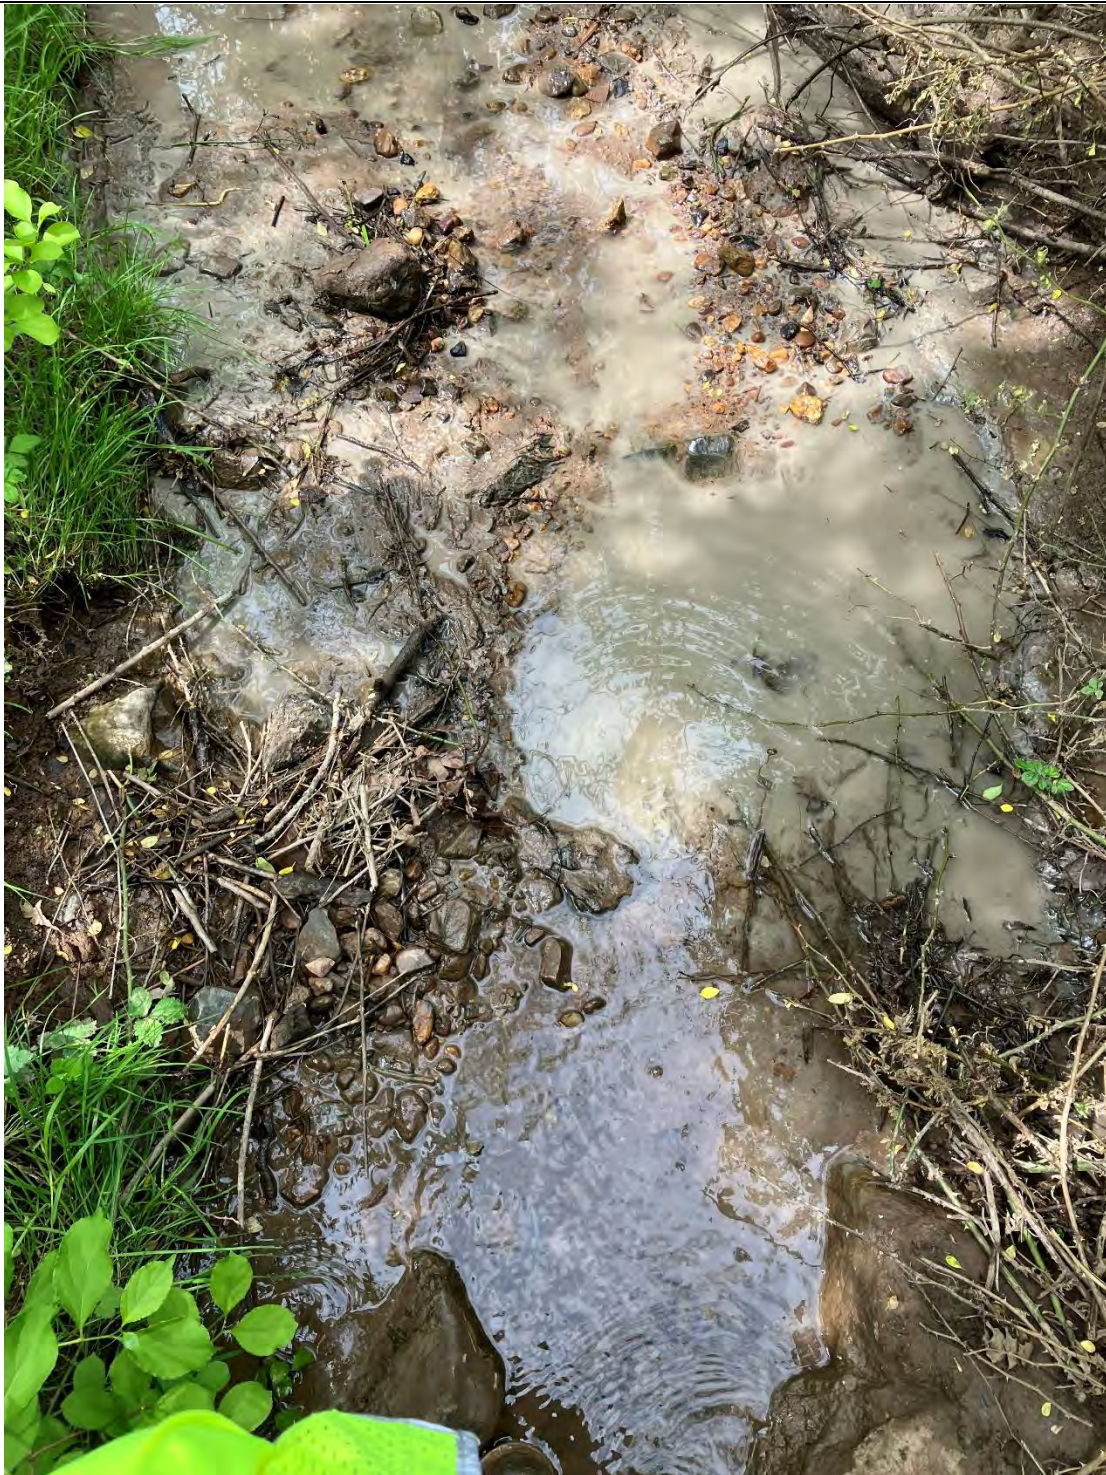
Figure C: The other undocumented frac-out was within the stream (UT to Monocacy River, use class I-P waters) channel just downstream of the documented (in the 04/10/2024 MDE inspection report) frac-out (frac-out in Figure B) that was contained with sandbags around the discharge point. This frac-out is located at Segment 2. Sediment (bentonite) pollution is occurring in the Waters of the State but is contained at a downstream point.

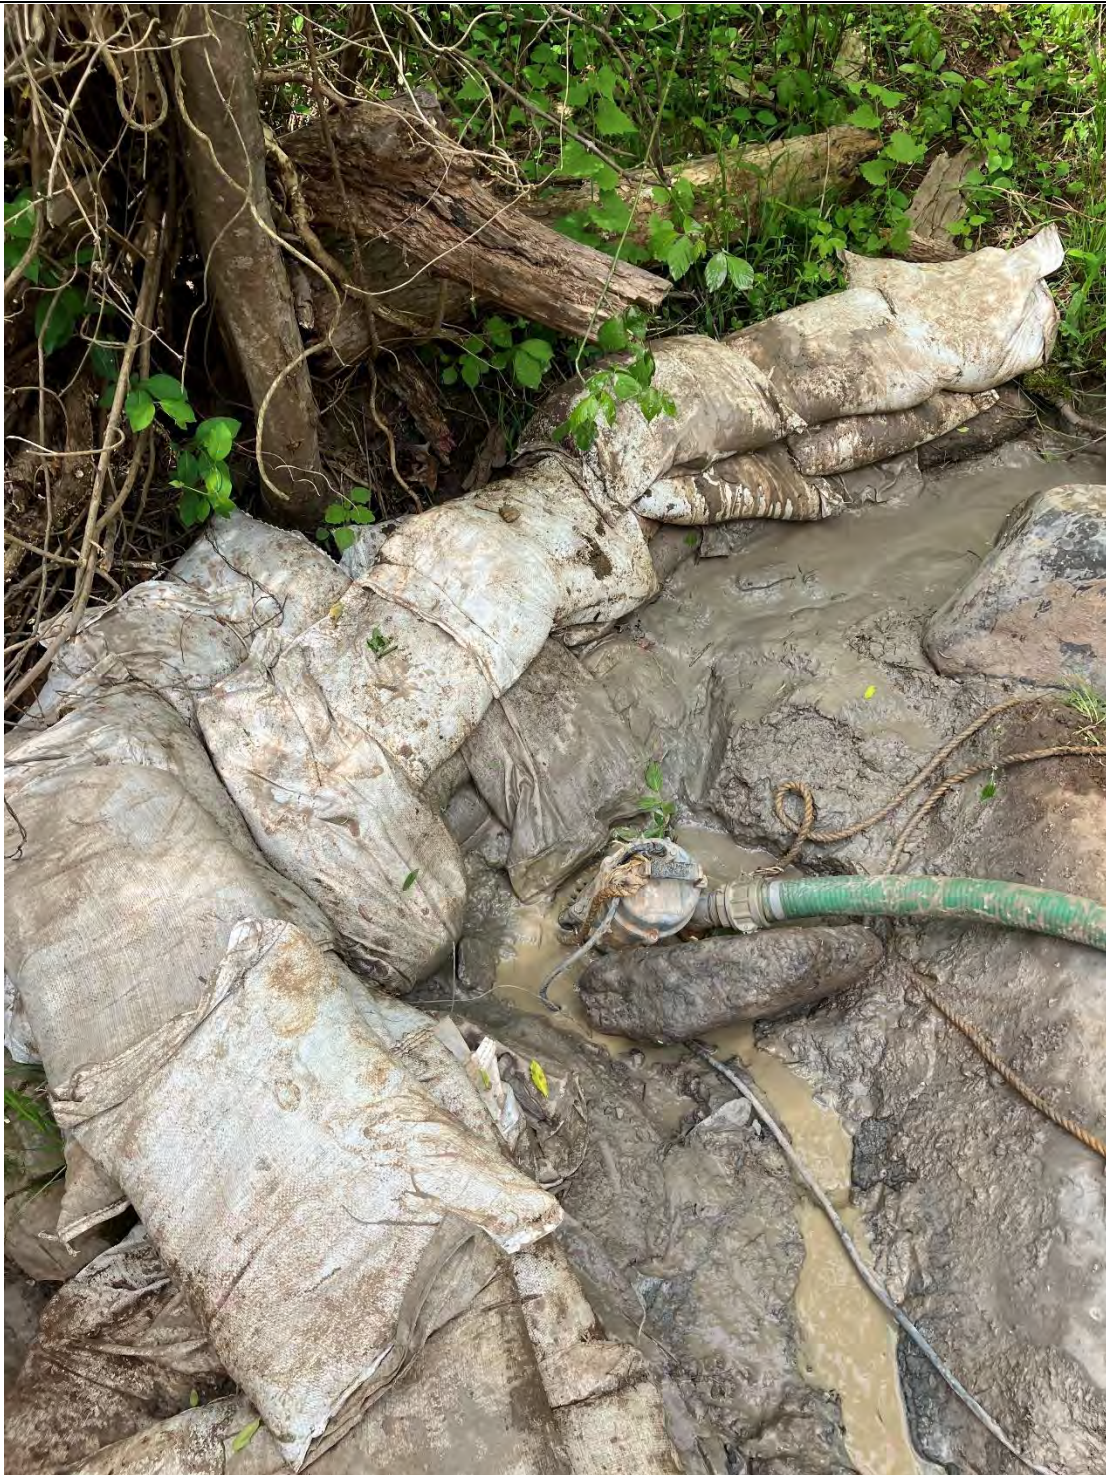
Figure D: Another of the frac-outs within the channel of the waterway (UT to Monocacy River, use class I-P waters) just downstream where the farm stream crossing is located; there was sediment deposited in the stream where the frac-out occurred. This frac-out is located at Segment 2. Sediment (bentonite) pollution is occurring in the Waters of the State but is contained in a portion of the waterway.

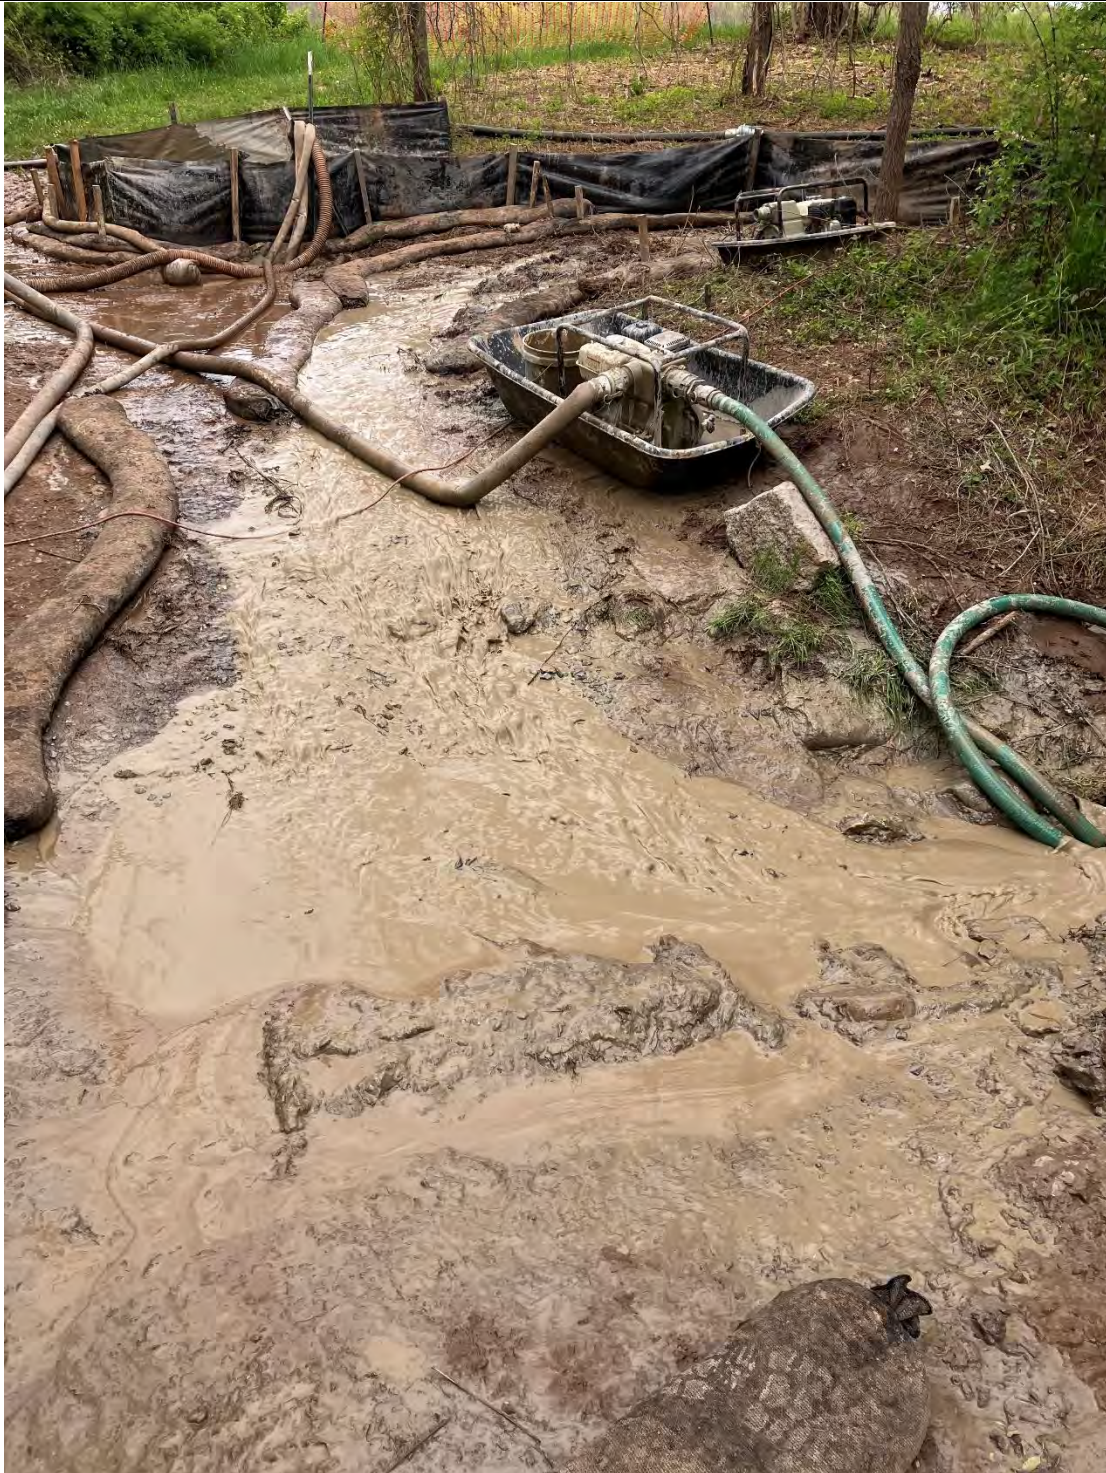
Figure E: The two frac-outs on the western bank of UT to Monocacy River are discharging into the waterway and are not individually contained. These frac-outs are located at Segment 2. The one frac-out is the same one documented in Figure A. Sediment (bentonite) pollution is occurring in the Waters of the State but is contained at a downstream point.
