Maryland Department of Environment
Water and Science Administration
Compliance Program
1800 Washington Blvd, Suite 420
Baltimore, MD 21230-1719
410- 537-3510, 1-800-633-6101

Inspector: Jacob Haglund
AI ID: 172623
Site Name: QLoop LLC - Sage Fiber (Segment 4)
Facility Address: Potomac Edison Row, 39.249374 -77.483653, Fisher Avenue, Poolesville, MD 20842
County: Montgomery County
Start Date/Time: April 04, 2024 11:30 AM
End Date /Time: April 04, 2024 04:00 PM
Media Type(s): NPDES Construction Activity, Nontidal Wetlands, Waterway Construction
Contact(s):

Inspection Date: April 04, 2024
Site Name: QLoop LLC - Sage Fiber
Facility Address: Potomac Edison Row, 39.249374 -77.483653, Fisher Avenue, Poolesville, MD 20842

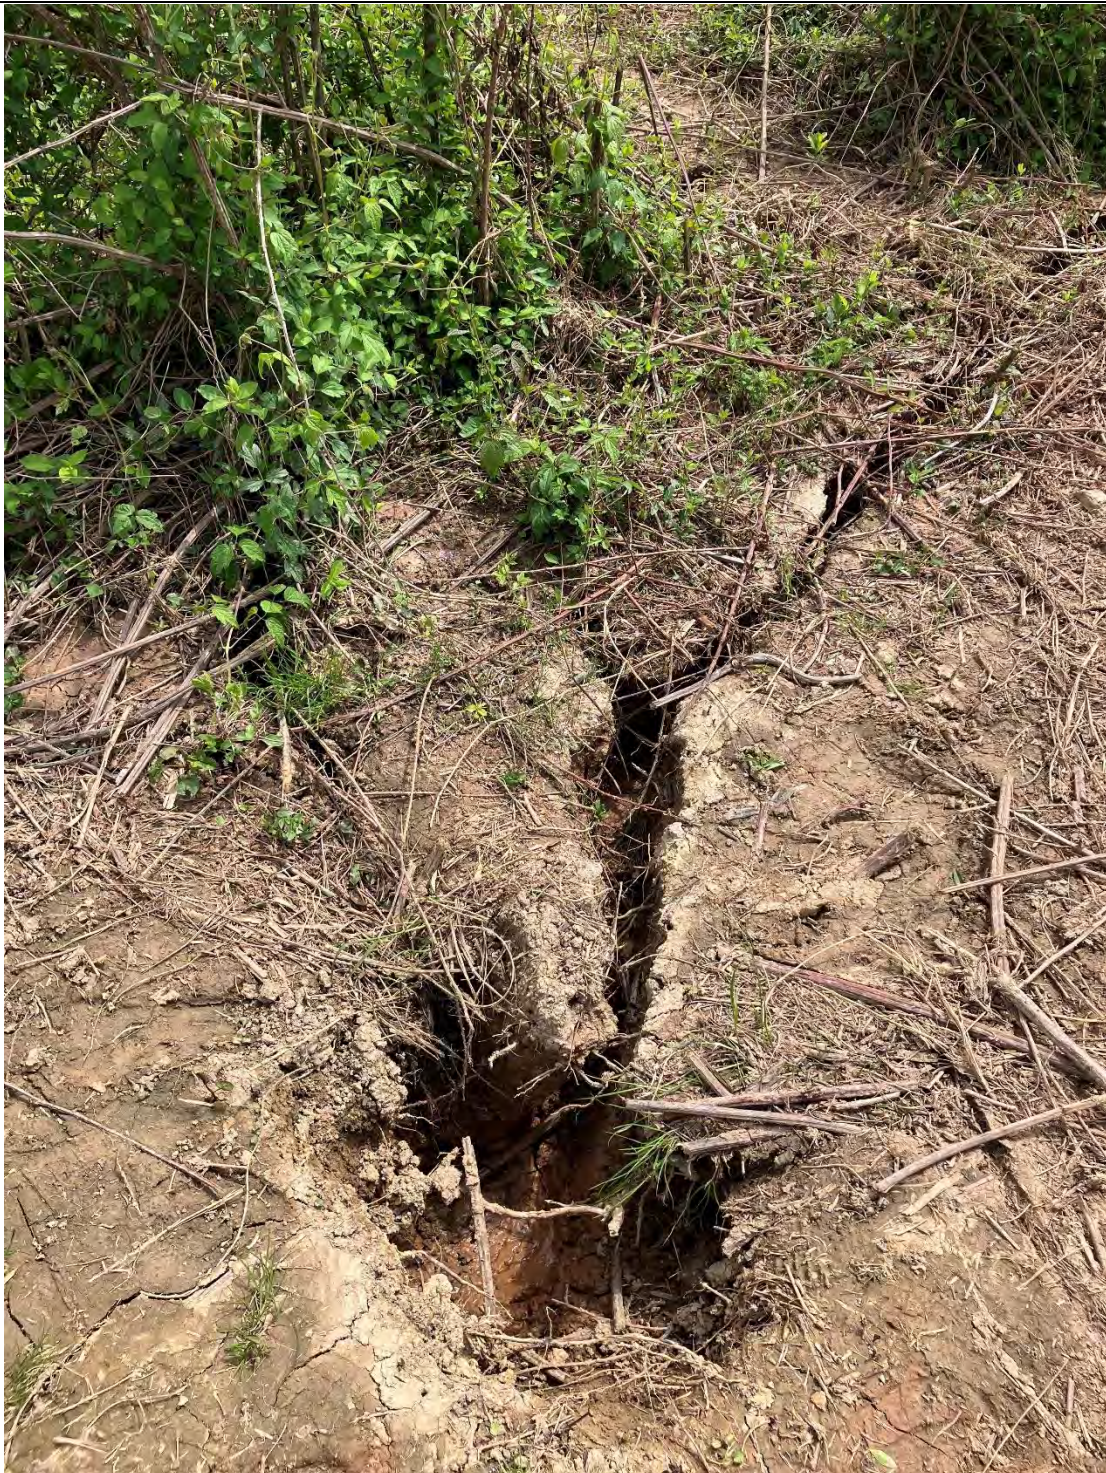
Figure F: There were cracks/fractures in the ground, noticed at the frac-out location in Segment 16 (located at roughly 39.3158900, -77.4996900). Sediment (bentonite) pollution has occurred in the Waters of the State but was contained during the time of the inspection.

- 3) There were cracks/fractures in the ground, noticed at the frac-out location in Segment 16 (located at roughly 39.3158900, -77.4996900). Sediment (bentonite) pollution has occurred in the Waters of the State but was contained during the time of the inspection. // Backfill the cracks/fractures where there was a frac-out with clean soil. Ensure areas outside of the LOD are stabilized on the day of the disturbance. These areas should be stabilized with seed (native floodplain mix) and straw.

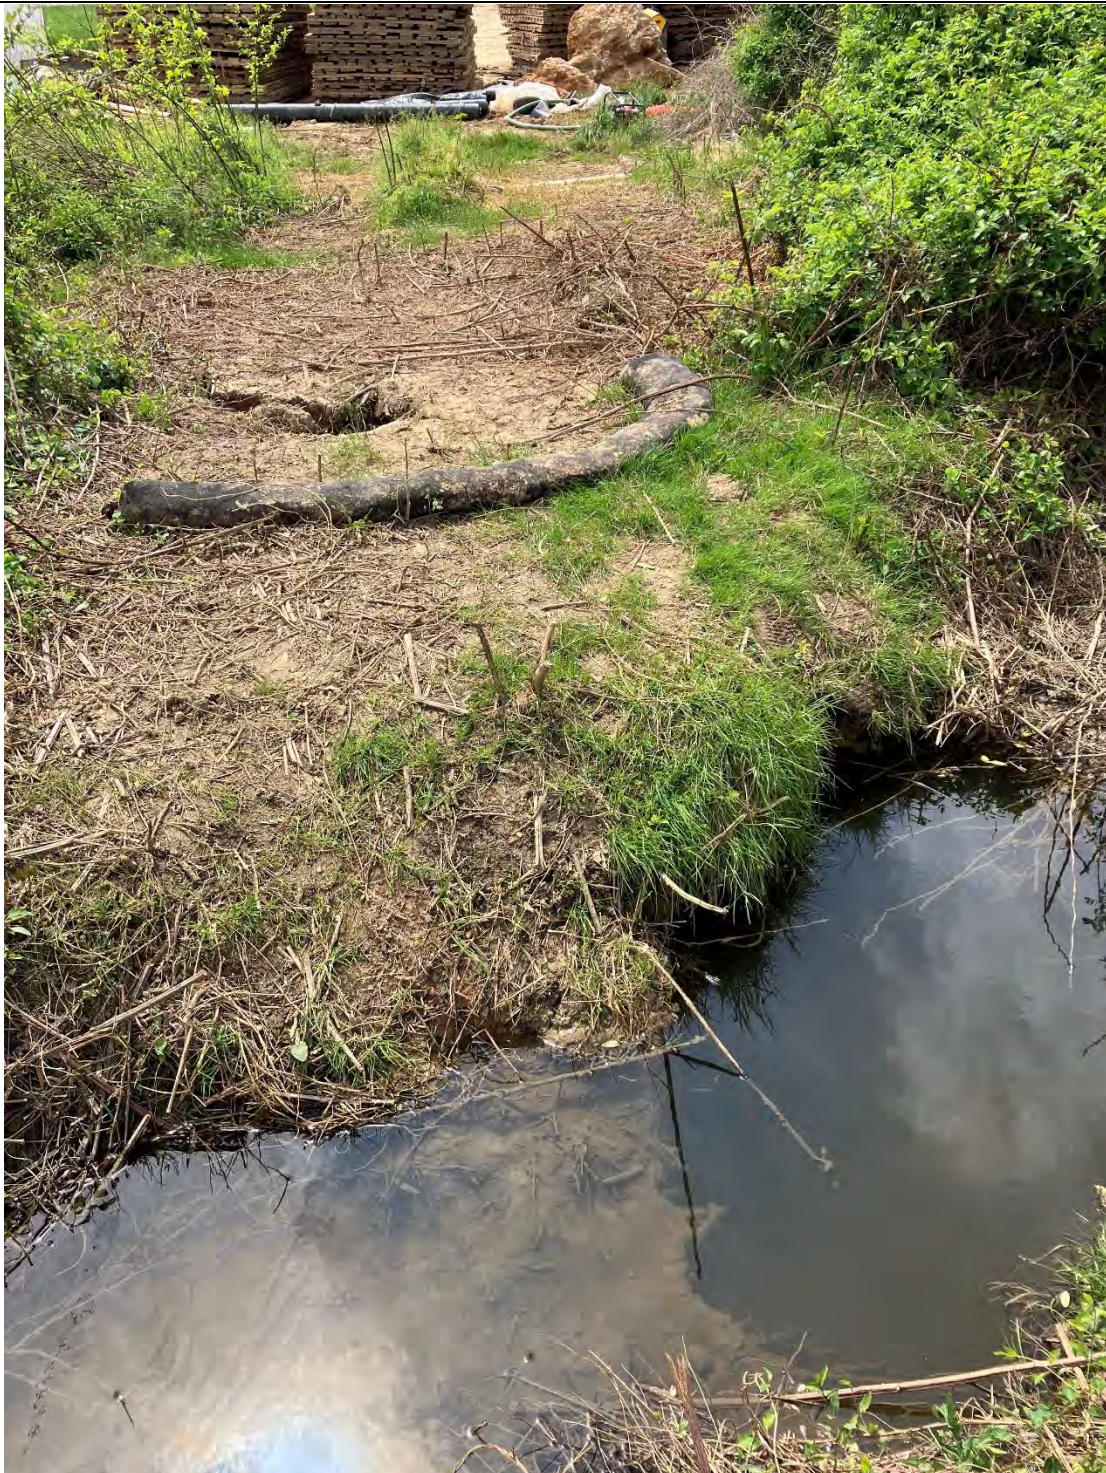
Figure G: There were cracks/fractures in the ground, noticed at the frac-out location in Segment 16 (located at roughly 39.3158900, -77.4996900). This frac-out has been cleaned up but the cracks/fractures have not been stabilized. Sediment (bentonite) pollution has occurred in the Waters of the State but was contained during the time of the inspection.
